Pre-Purchase Condition and Value Survey of the Sailing Vessel

“Weatherly”

September 25 & 27, 2020

Pre-Purchase Condition and Value Survey

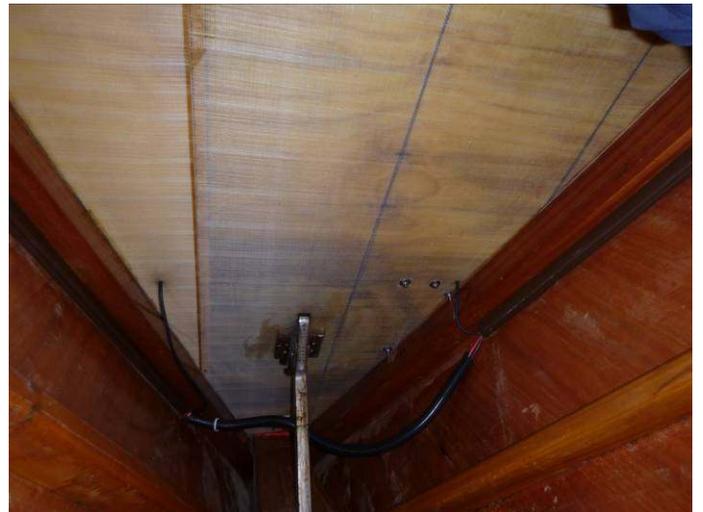
Underside of Forward Deck

- *1 The forward deck appears to have water intrusion into the core from around the headstay chainplate. Discolored core, elevated moisture readings and some soft laminate was noted when percussion sounding from the underside of the deck in the forward locker (see photo). It appears that water has leaked by the chainplate at the stem and migrated aft approximately 6’, with soft laminate in the forward 3’ of this area. Although not immediately necessary, repair is suggested (likely from the underside of the deck).
- *2 The steering cables were excessively loose and should be tightened. The cables are made of Dyneema, and creep is typical and requires frequent adjustment.
- **3 When surveying the hull of the vessel, (2) fine cracks were noted in the outer laminates of the hull forward of the keel. The cracks extended about 3’ on the starboard side and 18” on the port side, and

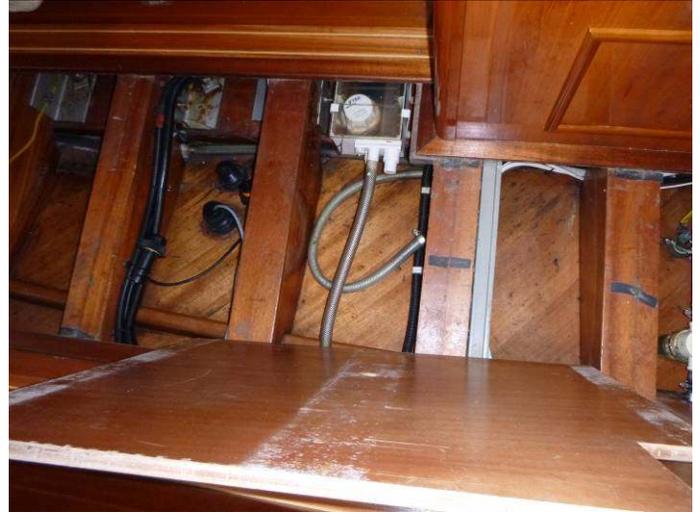
Salon Bilge

General Condition of Bilge and Engine Compartment: Good, Needs General Cleaning

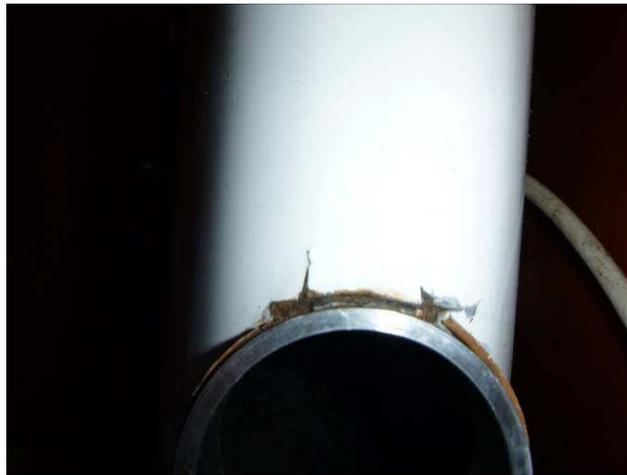
Mast, perimeter of sleeve for mast jacking pin near base

- **1 Some scuffing was noted in the chrome on the boom vang piston, and the dust cover is damaged. Service to the vang is recommended.
- **2 Some small cracks were noted in the reinforcing of the mast just above the sleeve for the mast jacking rod (where it passes through the mast when installed – see photo). The condition visually appears to be in fairing below the paint, but it is recommended that a rigger inspect the area.
