HAZARDOUS / REGULATED MATERIALS SURVEY REPORT

13992 Alma
Detroit, Michigan

April 26, 2019

Hazardous/Regulated Materials Survey Executive Summary¹

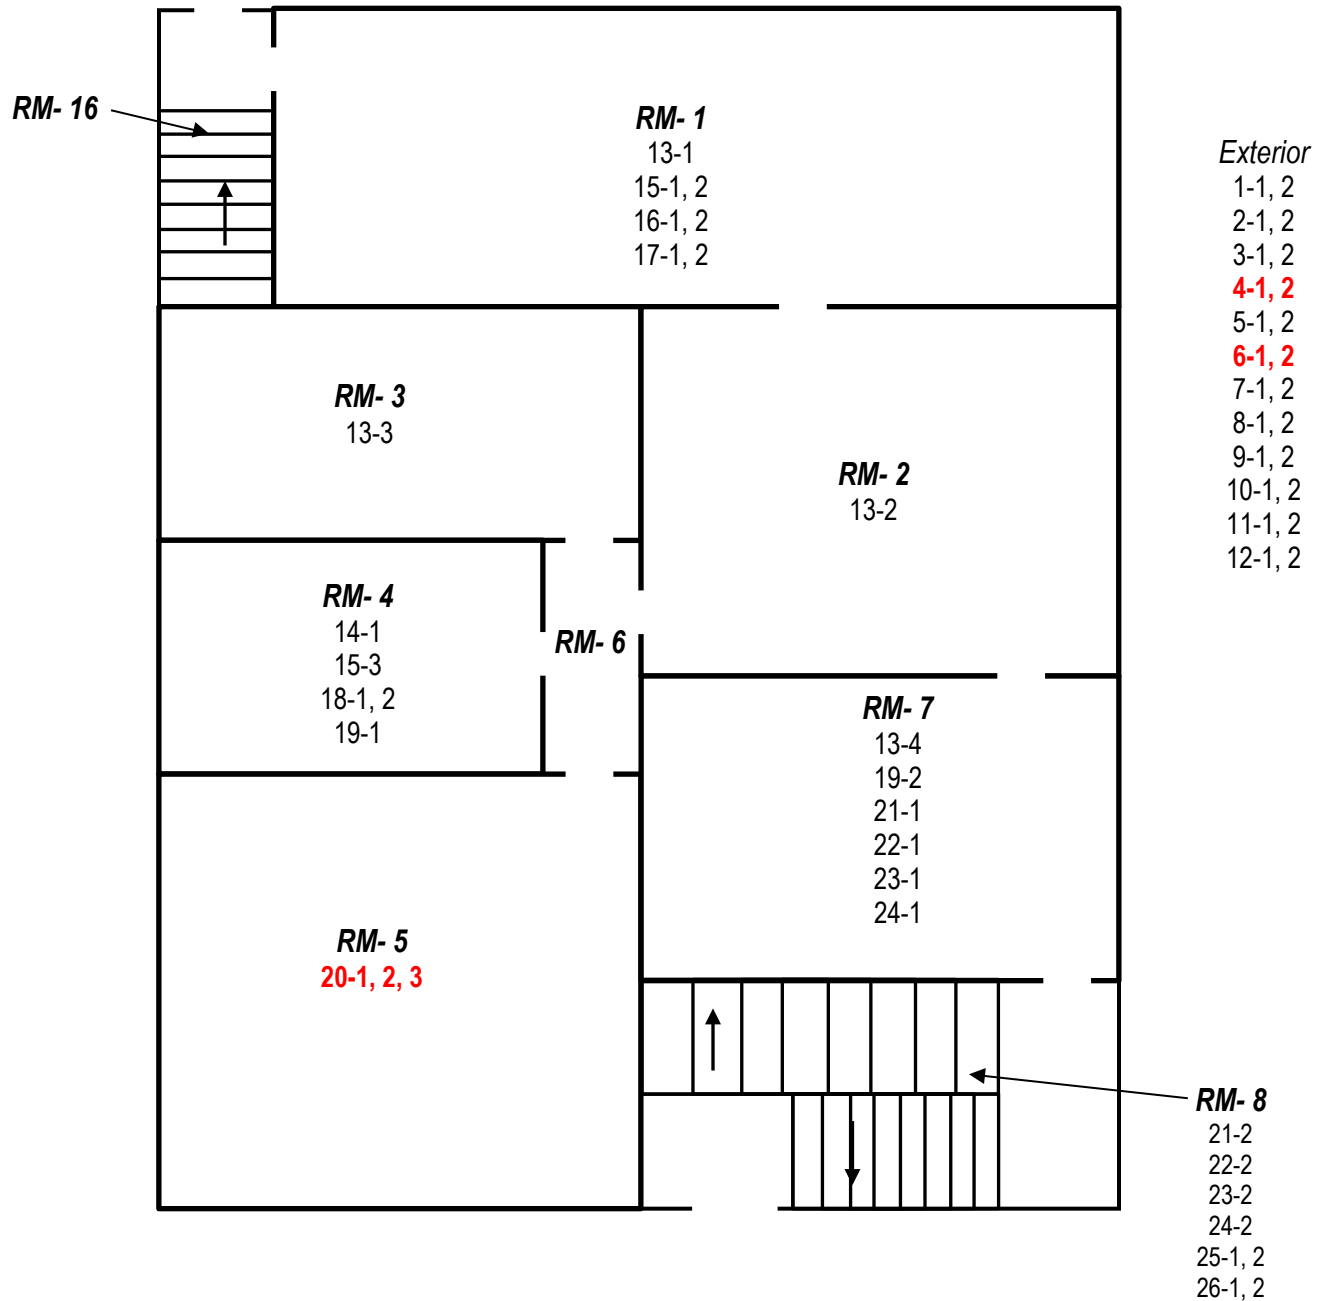
First Floor

Loose Windows with Glaze Observed (Interior and Exterior) and Presumed as an Asbestos Containing Material

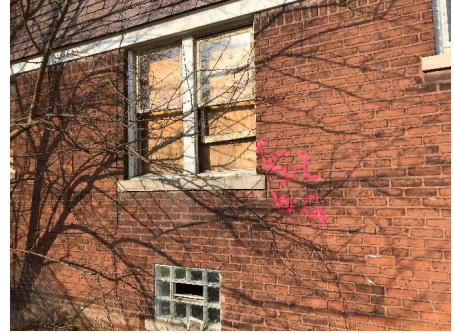
Sample ID: AS 4-1
Notes: Exterior Caulk

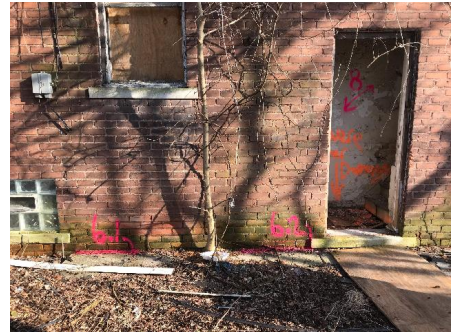
Sample ID: AS 6-1
Notes: Expansion Joint

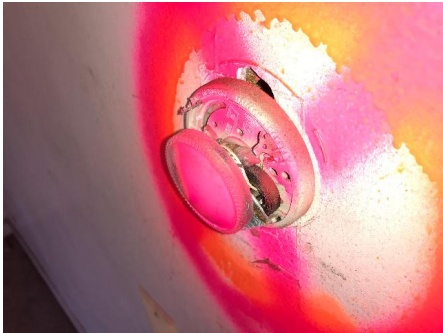
1
Mercury Thermostat
RM-15

The universal waste, hazardous materials, and other regulated materials (see Table 2) must be properly characterized (as necessary) and properly removed from the Site building for recycling and/or disposed of in accordance with Parts 111, 115, or 147 of Michigan Public Act 451 of 1994, as amended. If additional universal wastes, hazardous materials, and other regulated materials are discovered during demolition activities in areas that were determined during this survey to be structurally unsound and unsafe, inaccessible, concealed and/or in buried areas, these materials shall be characterized (as necessary) and properly removed in accordance with the above-mentioned regulations.

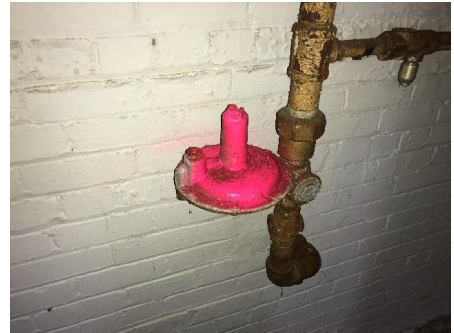
1
Gas Regulator
Basement

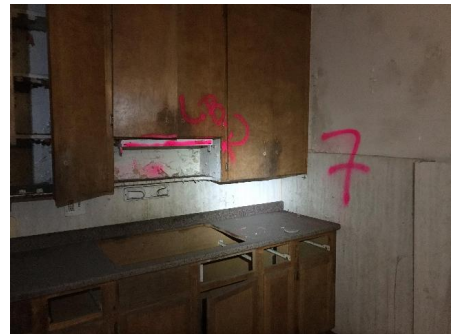
1
Light Ballast
RM-7

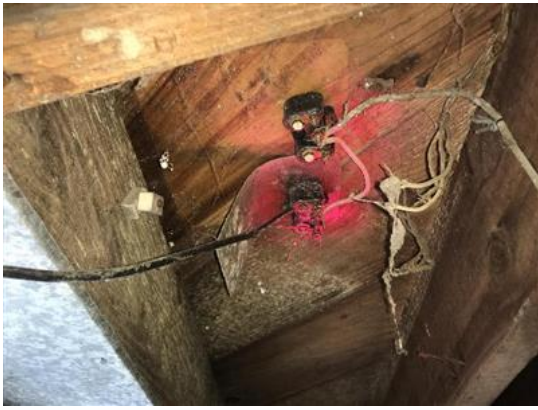
Phone Junction Heat Shield
Basement
1 Each

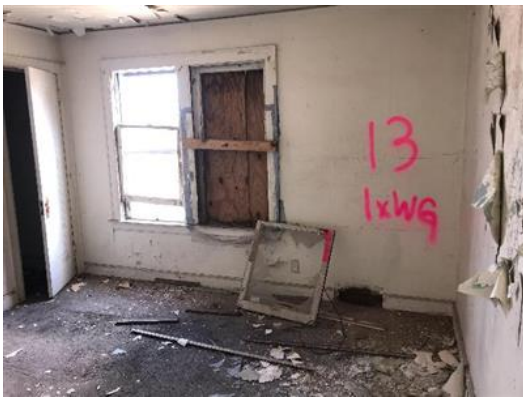
Loose Windows with Glaze
Interior and Exterior
12 Each
