## **PRE-DEMOLITION HAZARDOUS / REGULATED MATERIAL REPORT**

**9937 EVERGREEN  
Detroit, MI 48228**

**REPORT DATE  
April 29, 2022**

| Survey and Inspection Details | |
|---|---|
| Project Number: | 2022 BPO 3.3.2022C1 |

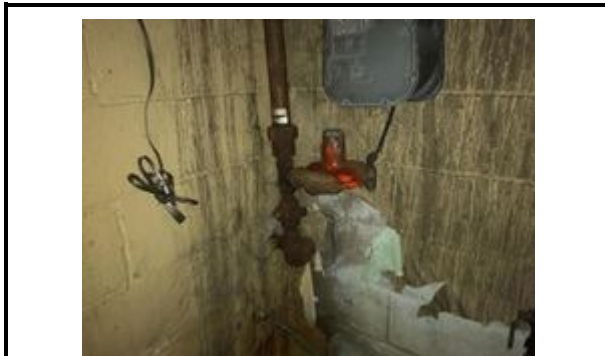
1 Each  
Gas Regulator  
FS-[1]

The universal waste, hazardous materials, and other regulated materials (see Table 2) must be properly characterized (as necessary) and properly removed from the Site building for recycling and/or disposed of in accordance with Parts 111, 115, or 147 of Michigan Public Act 451 of 1994, as amended. If additional universal wastes, hazardous materials, and other regulated materials are discovered during demolition activities in areas that were determined during this survey to be structurally unsound and unsafe, inaccessible, concealed and/or in buried areas, these materials shall be characterized (as necessary) and properly removed in accordance with the above-mentioned regulations.

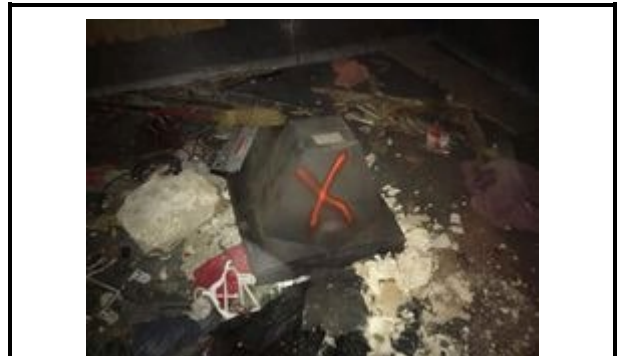
1 Each  
Television  
FS-[7]

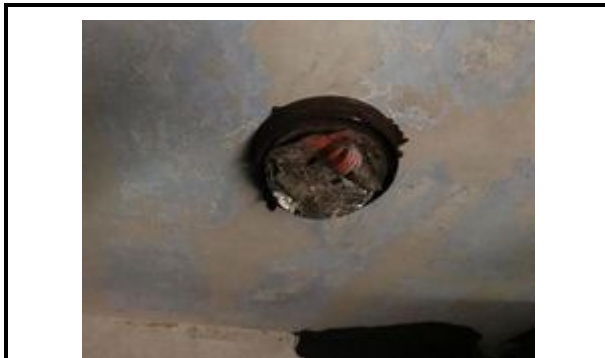
10 Each  
CFL  
FS-[2,3,7,9,6]

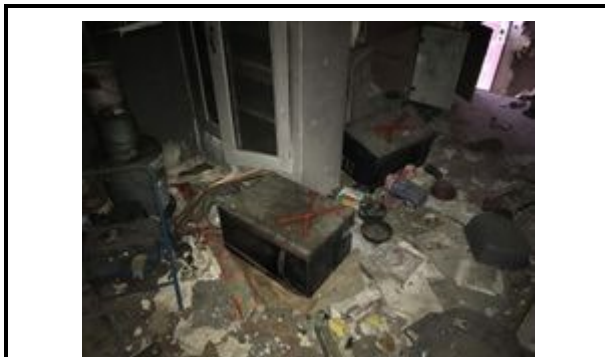
2 Each  
Microwaves  
FS-[3]

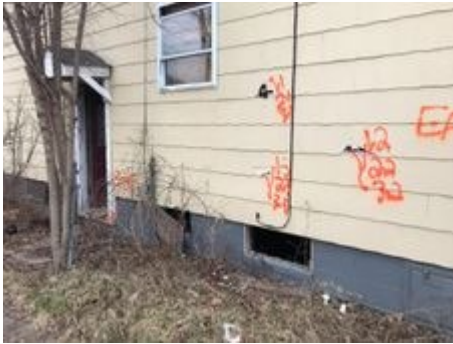
AS 1-1  
Transite

| Sample ID | Material Description | Presumed | Material Classification | Location (FS / EA) | Estimated Quantity |
|---|---|---|---|---|---|
| AS 1-1 | Transite | No | Miscellaneous | EA-[1,2,3,4] | 1900 SF |

| EA-[2] | AS 1-1 | 1 | Transite | Non-Friable | Fair | Miscellaneous | Yes | Chrysotile 10.00% | 1900 SF |

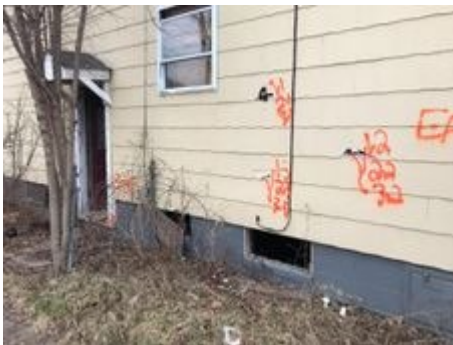
AS 3-1  
Underlayment Strip

| EA-[2] | AS 3-1 | 3 | Underlayment Strip | Non-Friable | Fair | Miscellaneous | No | No Asbestos Detected | 400 SF |
| EA-[2] | AS 3-2 | 3 | Underlayment Strip | Non-Friable | Fair | Miscellaneous | No | Chrysotile 0.50% (PC) | |
| EA-[2] | AS 3-3 | 3 | Underlayment Strip | Non-Friable | Fair | Miscellaneous | No | Chrysotile 0.50% (PC) | |

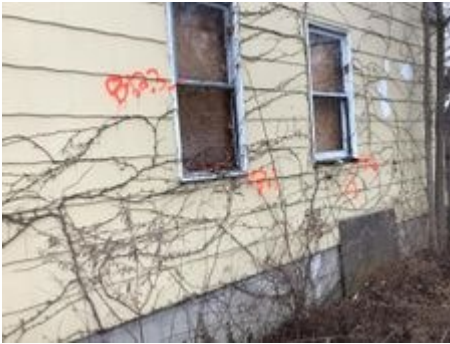
AS 7-1  
Exterior Caulk

| Sample ID | Material Description | Presumed | Material Classification | Location (FS / EA) | Estimated Quantity |
|---|---|---|---|---|---|
| AS 7-1 | Exterior Caulk | No | Miscellaneous | EA-[1,2,3,4] | 300 LF |

| EA-[4] | AS 7-1 | 7 | Exterior Caulk | Non-Friable | Fair | Miscellaneous | Yes | Chrysotile 2.00% (PC) | 300 LF |

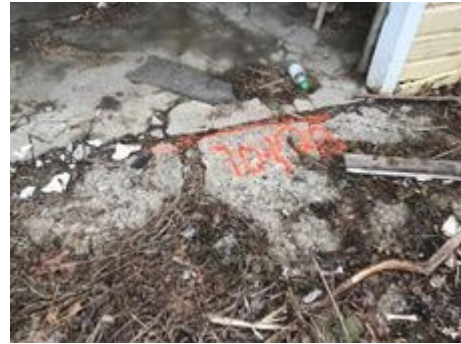
AS 10-1  
Driveway Expansion Joint

| Sample ID | Material Description | Presumed | Material Classification | Location (FS / EA) | Estimated Quantity |
|---|---|---|---|---|---|
| AS 10-1 | Driveway Expansion Joint | No | Miscellaneous | EA-[6] | 30 LF |

| EA-[6] | AS 10-1 | 10 | Driveway Expansion Joint | Non-Friable | Fair | Miscellaneous | Yes | Chrysotile 4.00% | 30 LF |

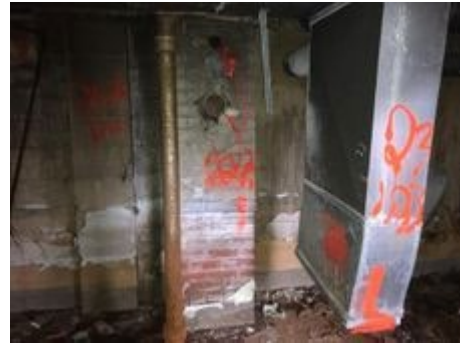
AS 22-1  
Stack Cement

| Sample ID | Material Description | Presumed | Material Classification | Location (FS / EA) | Estimated Quantity |
|---|---|---|---|---|---|
| AS 22-1 | Stack Cement | No | Miscellaneous | FS-[1] | 10 SF |

survey, laboratory analysis found five (5) samples containing greater than 1% asbestos (AS 1-1, AS 7-1, AS 10-1, AS 22-1, AS 24-1). The EPA defines ACM as materials containing greater than 1% asbestos.

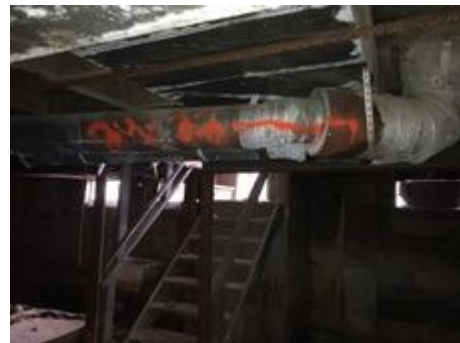
AS 24-1  
Duct Wrap

| Sample ID | Material Description | Presumed | Material Classification | Location (FS / EA) | Estimated Quantity |
|---|---|---|---|---|---|
| AS 24-1 | Duct Wrap | No | TSI | FS-[1] | 35 SF |
