## ***Hazardous/Regulated Materials Survey and Inspection Report***

3889 / 3891 St. Clair Street  
Detroit, MI 48214

| Survey Information | |
|---|---|
| Project Name: | 2018 PSC 4.1.2019D |
| Project Number: | 188BS19177 |

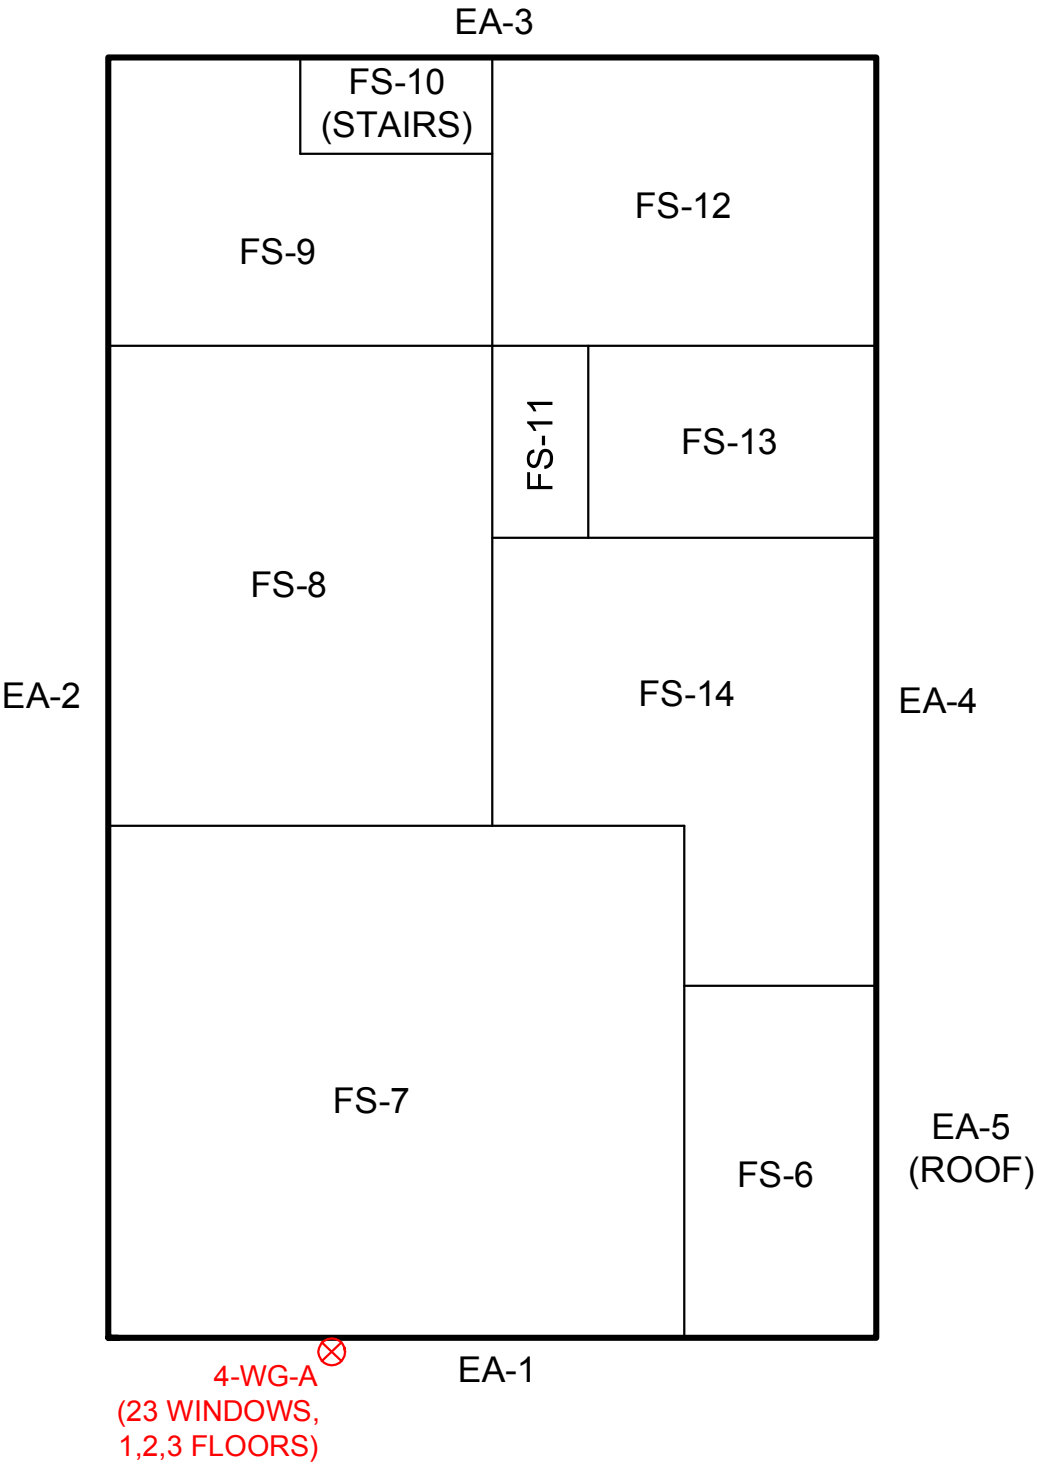
POSITIVE SAMPLE LOCATION
- FS FUNCTIONAL SPACE
- EA EXTERIOR AREA

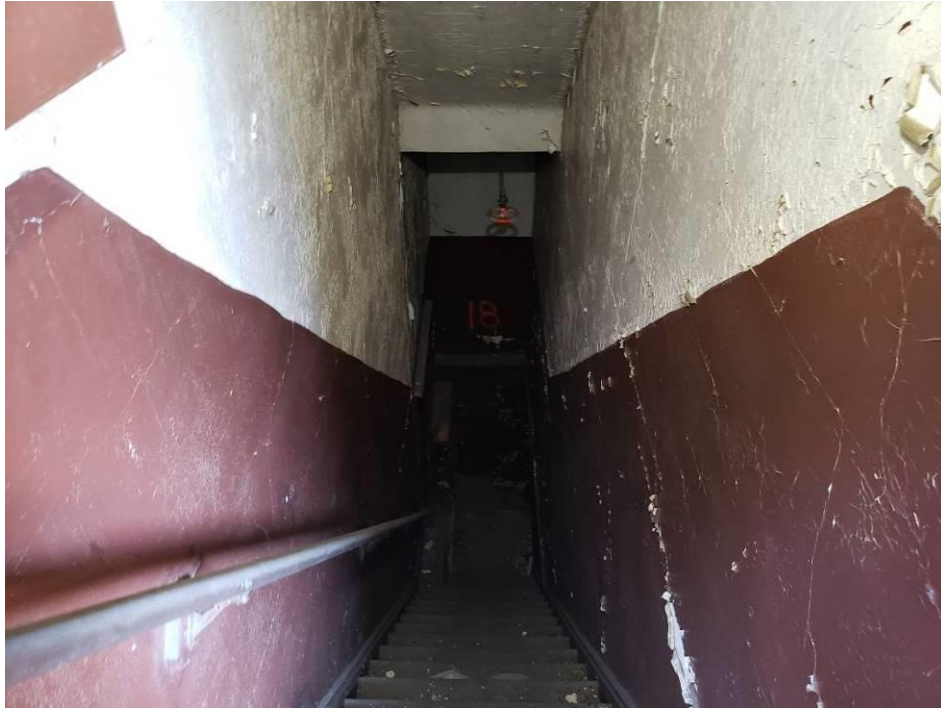
View of FS-18 (2<sup>nd</sup> floor unit) – stairs to basement area

| HA# & Sample # | Material | Functional Space / Exterior Area | Estimated Quantity | EPA Cat. (Friable, CAT I, CAT II) | Mat. Class. (TSI, SM, MM) | Results |
|---|---|---|---|---|---|---|
| 24-MLF-A,B | Multi-Layered Flooring | FS 18 Top Landing | 40 SF | Cat I | MM | ND – White F.T.<br><b>15% Chrysotile – Orange F.T. (Layer 2)</b> |

An asbestos abatement contractor, licensed in the State of Michigan, should remove the materials identified as asbestos containing in Table 1 in accordance with all applicable Local, State, and Federal Requirements prior to demolition.

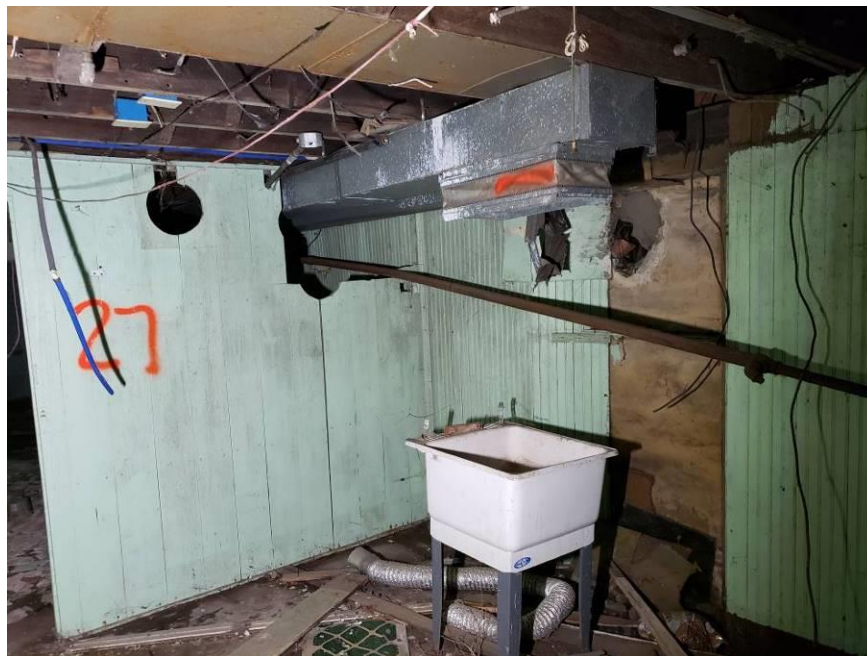
View of FS-27 (basement)

| HA# & Sample # | Material | Functional Space / Exterior Area | Estimated Quantity | EPA Cat. (Friable, CAT I, CAT II) | Mat. Class. (TSI, SM, MM) | Results |
|---|---|---|---|---|---|---|
| 15-MB-A,B,C | Millboard | FS 27 | 12 SF | RACM | TSI | 35% Chrysotile |
| 16-DW-A,B | Duct Wrap | FS 27,28 | 6 SF | RACM | TSI | 30% Chrysotile |

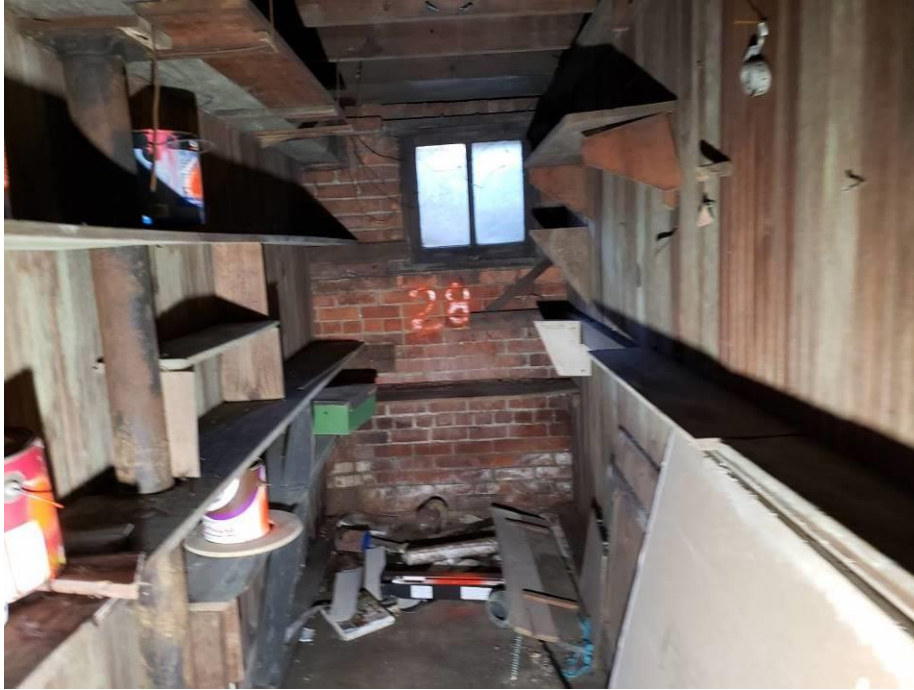
View of FS-28 (basement)

| HA# & Sample # | Material | Functional Space / Exterior Area | Estimated Quantity | EPA Cat. (Friable, CAT I, CAT II) | Mat. Class. (TSI, SM, MM) | Results |
|---|---|---|---|---|---|---|
| 13-HS-A,B,C | Heat Shield | FS 28 | 2 SF | RACM | TSI | 30% Chrysotile |

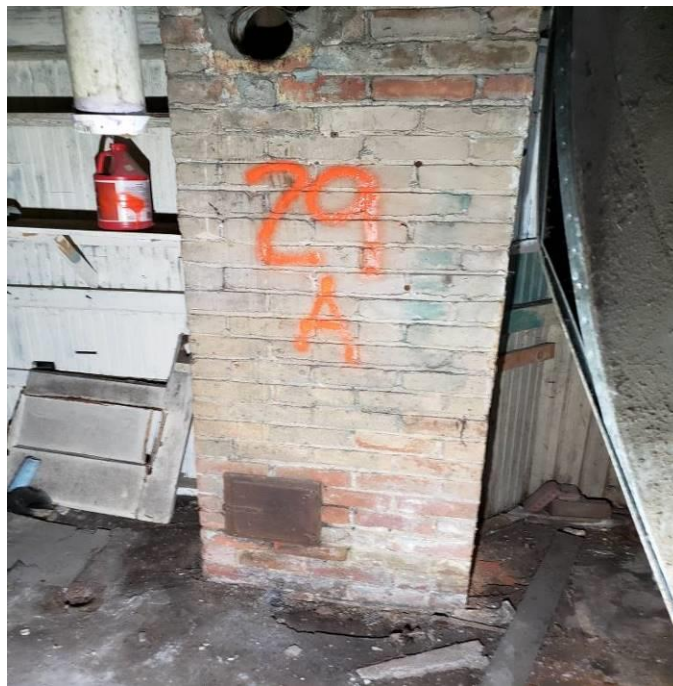
View of FS-29 (chimney stack A)

| HA# & Sample # | Material | Functional Space / Exterior Area | Estimated Quantity | EPA Cat. (Friable, CAT I, CAT II) | Mat. Class. (TSI, SM, MM) | Results |
|---|---|---|---|---|---|---|
| 11-SC-A,B | Stack Cement | FS 29A | 2 SF | Cat II | MM | 3% Chrysotile – Gray (Layer 1)<br>15% Chrysotile – (Layer 2) |

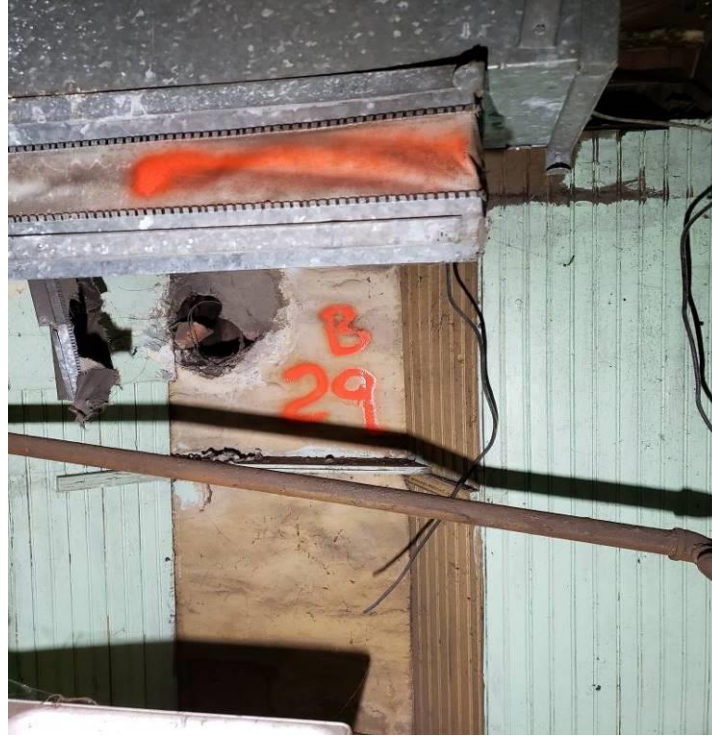
View of FS-29 ( chimney stack B)

| HA# & Sample # | Material | Functional Space / Exterior Area | Estimated Quantity | EPA Cat. (Friable, CAT I, CAT II) | Mat. Class. (TSI, SM, MM) | Results |
|---|---|---|---|---|---|---|
| 12-SC-A,B | Stack Cement | FS 29B | 2 SF | Cat II | MM | 30% Chrysotile |
