Appendix H Geotechnical Analysis: Credit to Existing Levees

Fargo-Moorhead Metropolitan Area Flood Risk Management

Final Feasibility Report and Environmental Impact Statement

July 2011

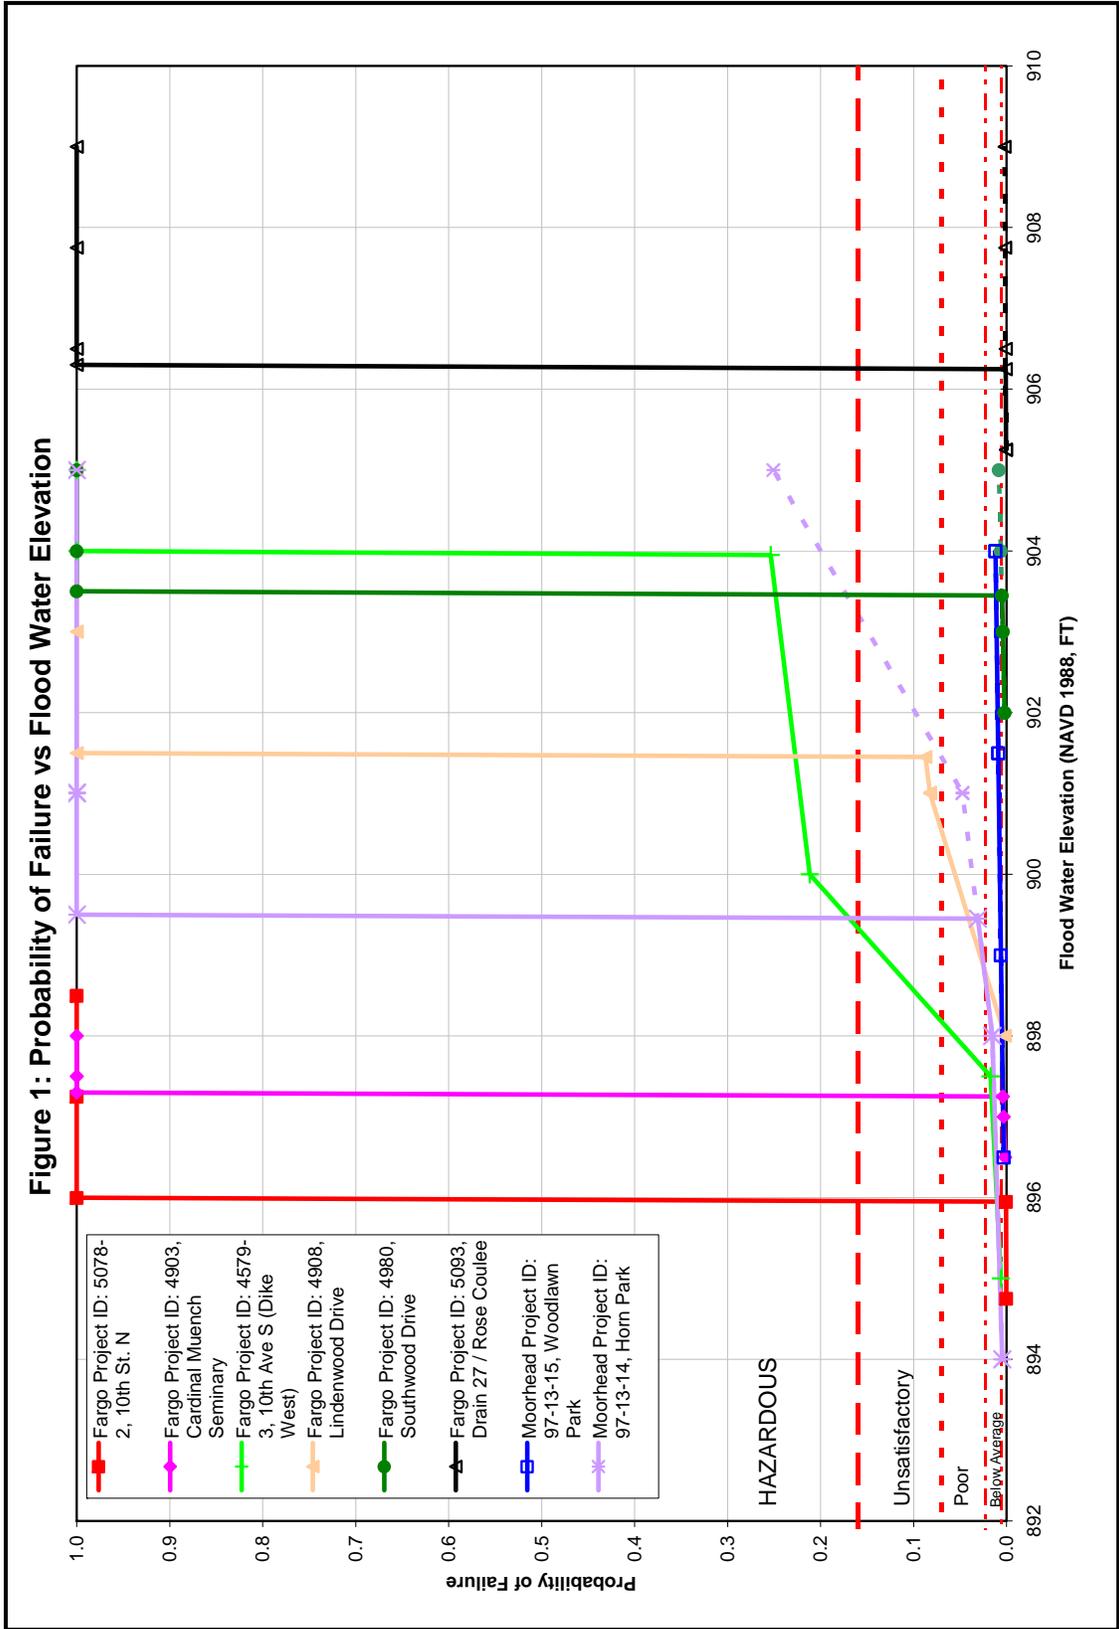
76. The relationship of the probability of failure to flood elevation can be seen in Figure 1. Figure 2 is a similar plot to Figure 1 but shows the relationship of the probability of failure to the height of water on the levee. These plots can also be found in [Attachment H-4](#). The solid lines on the figures indicate the probability of failure when "discontinuities" are accounted for. The dashed lines on the figures indicate the probability of failure without the discontinuities. The performance levels are also indicated on the figures.

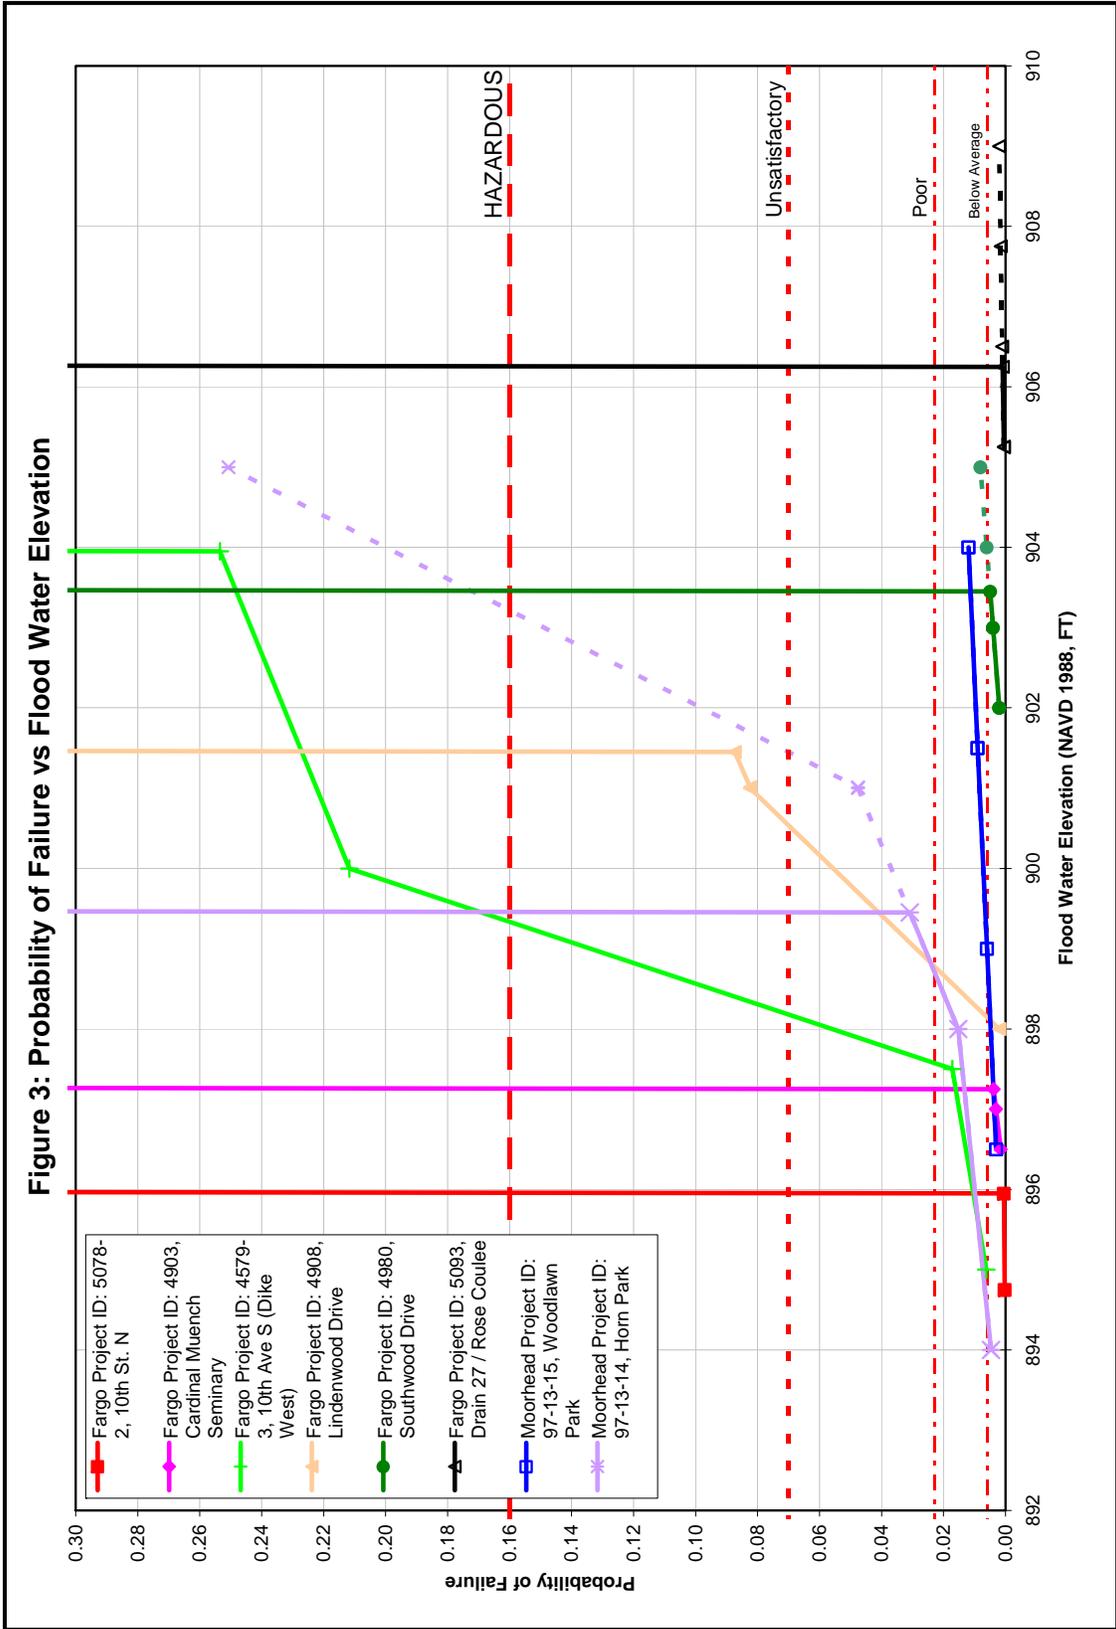
Fargo, which have retaining walls within the dryside slope, the expected performance level prior to the flood waters reaching the discontinuities, is “UNSATISFACTORY” and “HAZARDOUS”, respectively. This relationship is better shown in Figure 3, which only plots the probability of failures to 0.3.
