# **ENVIRONMENTAL SITE ASSESSMENT**

## **DEVELOPMENT LAND**

**CASA GRANDE, ARIZONA AREA**

Subject: Phase I, Environmental Site Assessment  
Development land near Central Arizona  
College, Casa Grande, Arizona Area.

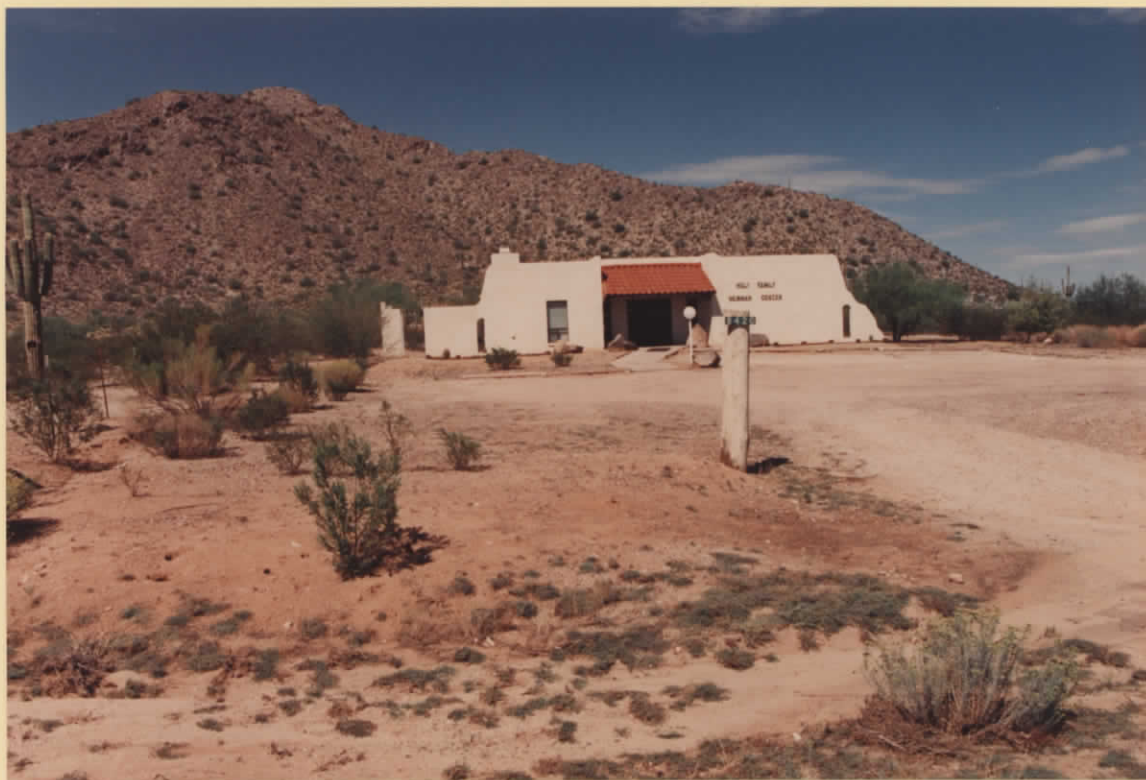
(4) OFF-SITE BUILDING AT SOUTHEAST CORNER OF SITE.  
(SEE SITE PHOTO KEY)

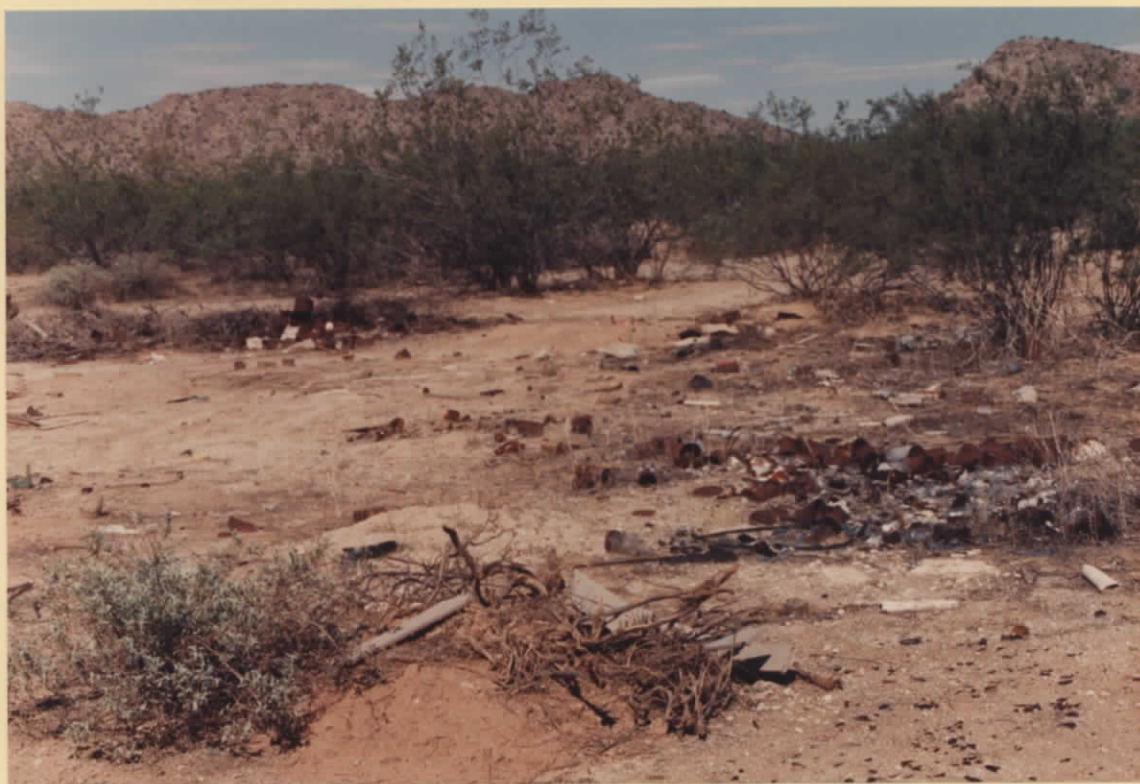
- The vegetation on the site consisted of wild grass, brush, cactus, and desert trees. Typical vegetation on the site is shown in Photographs (1-22). Our engineer did not observe stressed vegetation that would suggest possible contamination of the site.
- The soil on the site appeared to be relatively uniform in color and free of discoloration.
- No dry wells were observed on the site.
- No cracking or depressed areas, suggestive of buried tanks, were observed on the site.
- No trash dumpsters or drums were observed on the site.
- Only minor debris was observed on the site. There were several small areas on the site where wildcat dumping had occurred. The dumping did not appear to have occurred recently. One of the wildcat dumping areas is shown in Photograph (18).

(18) TYPICAL VIEW OF MINOR WILDCAT DUMPING ON SITE.  
(SEE SITE PHOTO KEY)
