Evaluation of Mitigation Measures  
For  
Existing Ground Fissuring  
Within  
TIERRA RICA Subdivision

The East line of the Southeast Quarter of Section 30,  
Township 5, South, Range 7 East, of the Gila and  
Salt River Baseline and Meridian  
Pinal County, Arizona

10 May 1999

Roger L. Ames  
Registered Professional Geologist  
Arizona Registration Number 29186  
2318 East Lakecrest Drive  
Gilbert, Arizona 85234  
Telephone 602-926-4710

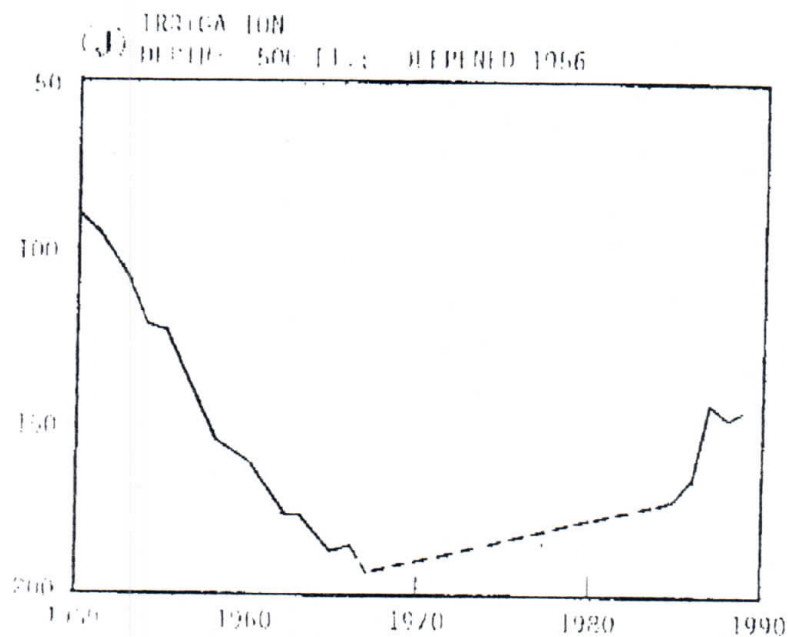
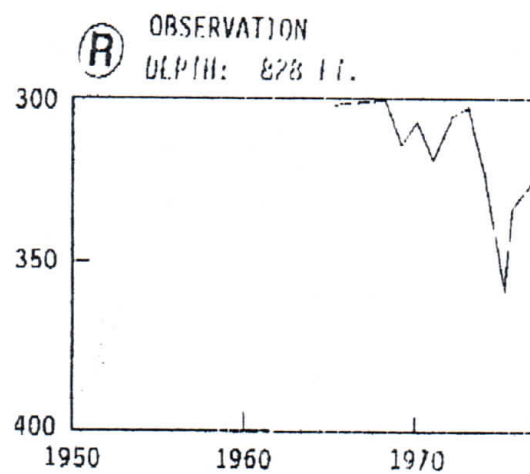
The maximum decrease in the water table in the immediate area of the fissure occurred in 1968 (see Encl. # 3 for hydrograph) and the fissure is thought to have occurred in 1974. The water table has risen between 25 and 50 feet since 1968 (see Encl. # 4). Therefor, the overdraft of groundwater has stopped and the water table has experienced some recharge. Both of these conditions would contribute to the stabilization of the area and tend to prevent any new earth fissures or any rejuvenation of the existing fissure.

HYDROGRAPHS OF THE WATER LEVEL IN SELECTED WELLS SHOWN ON THE MAP  
(Dashed line indicates inferred water level)

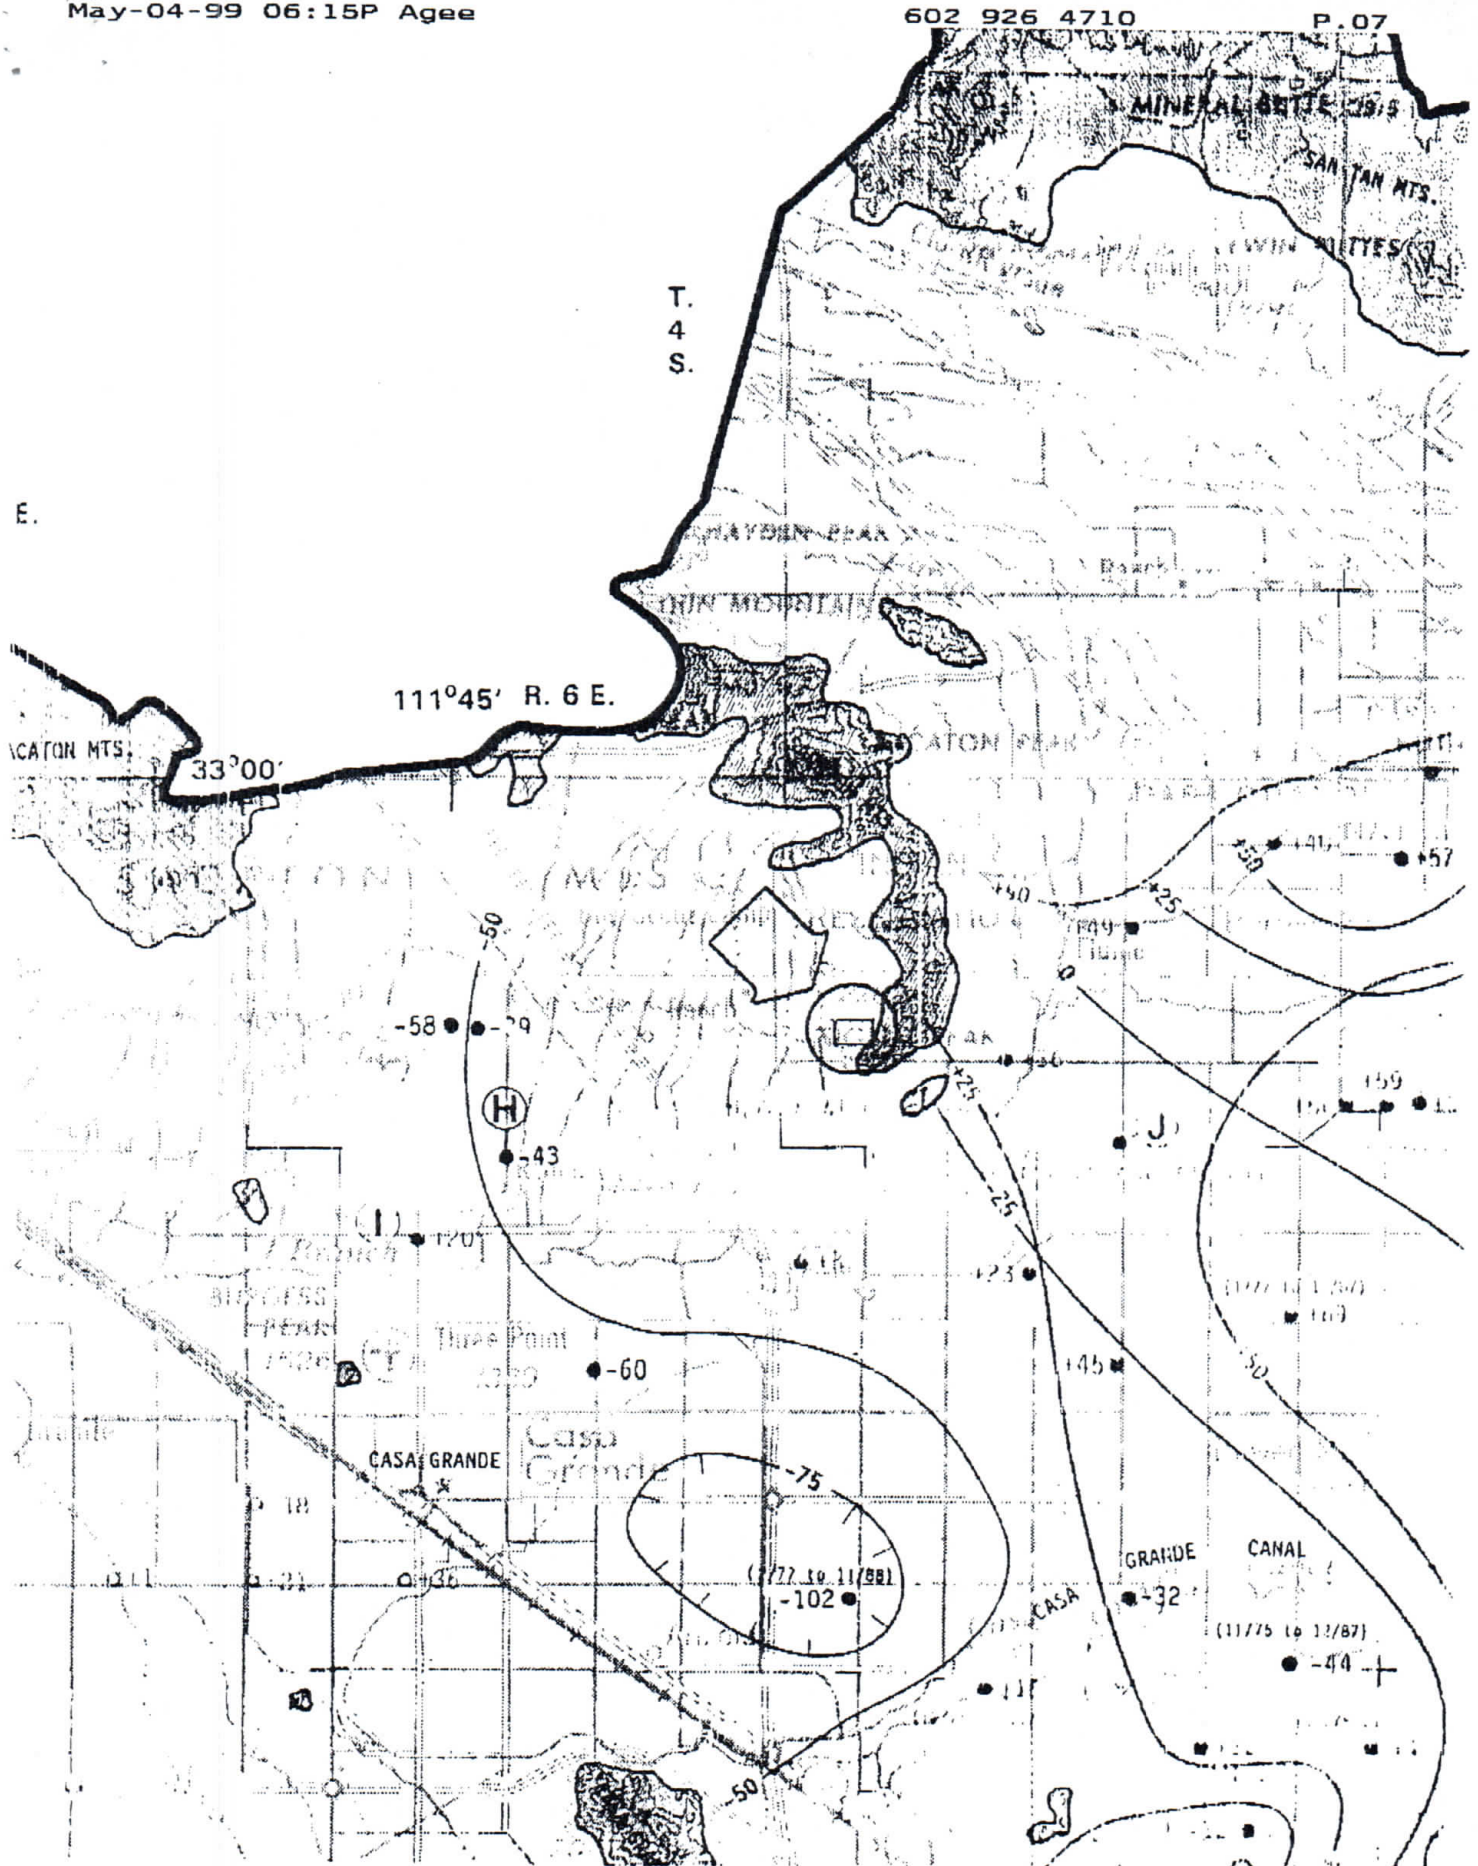
①

Earth fissures are tension cracks that are common in some of Arizona's alluvial basins where ground subsidence has occurred. The subject area has experienced ground subsidence that is attributed to removal of groundwater from the underlying sediments and Earth fissures have developed at the margin of the basin. One of those earth fissures transects the Southeast corner of the proposed subdivision (Encl. # 1) and effects 5 of the lots and the cul-du-sac at the end of the access road.

FIGURE 4. Earth fissures southeast of Sacaton Mountains
