New Jersey Sports & Exposition Authority Drainage Ditch Inspection Report

**The National Flood Insurance Program
Community Rating System**

The New Jersey Sports and Exposition Authority

December 7, 2016

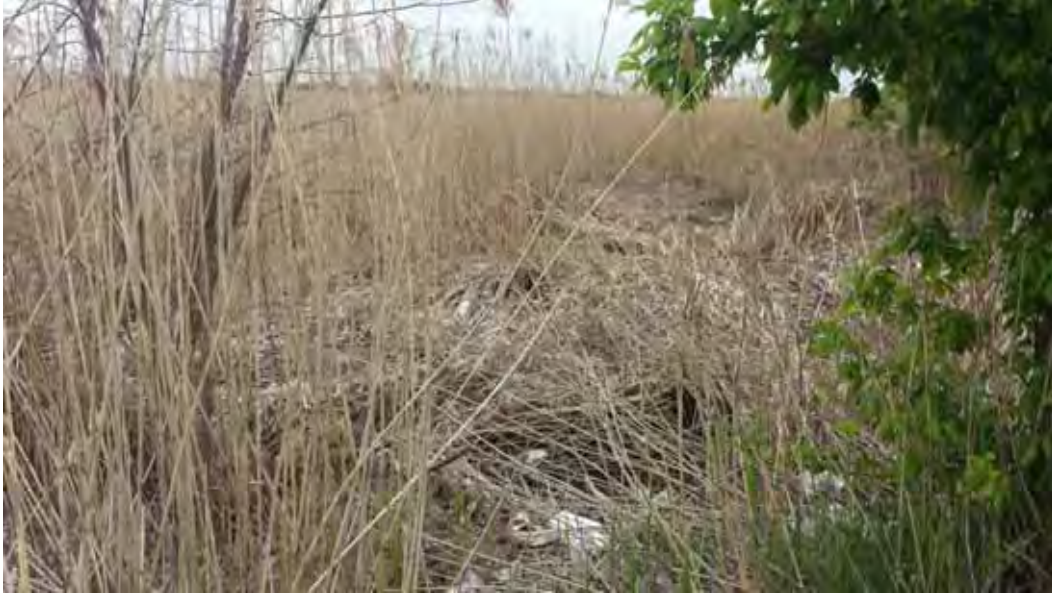
Site ID/Name: Bashes Creek Ditch System (Carlstadt) – Location #1

Figure 1: Downstream view of ditch

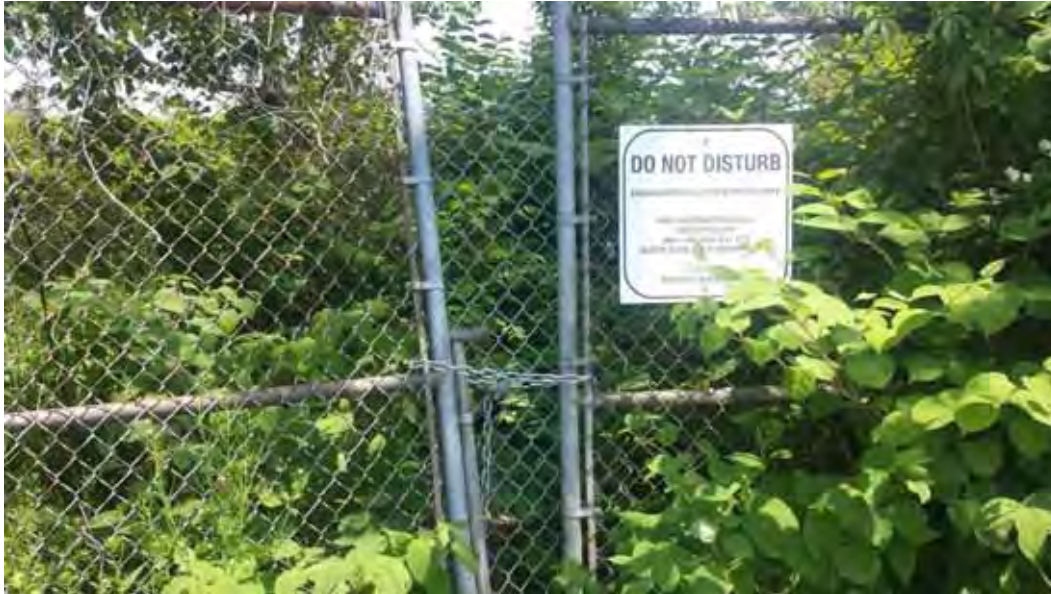
Site ID/Name: Depeyster Creek Ditch System (Secaucus) – Location #1

Figure 1: Downstream view of ditch

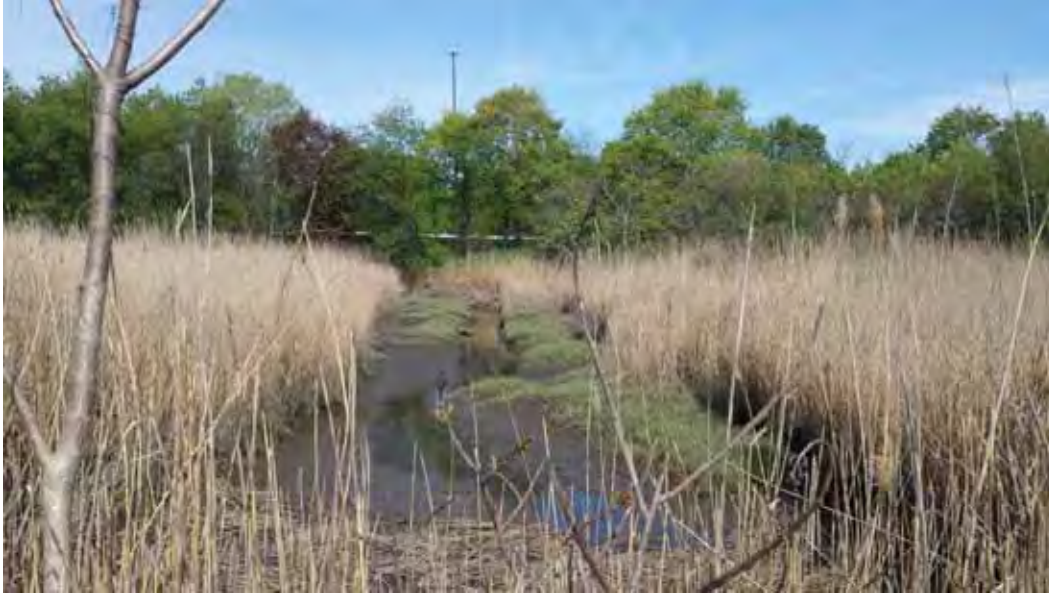
Site ID/Name: Chubb Ave/Wall St W/Polito Ave Ditch System (Lyndhurst) – Location #1

Figure 1: Downstream view of ditch

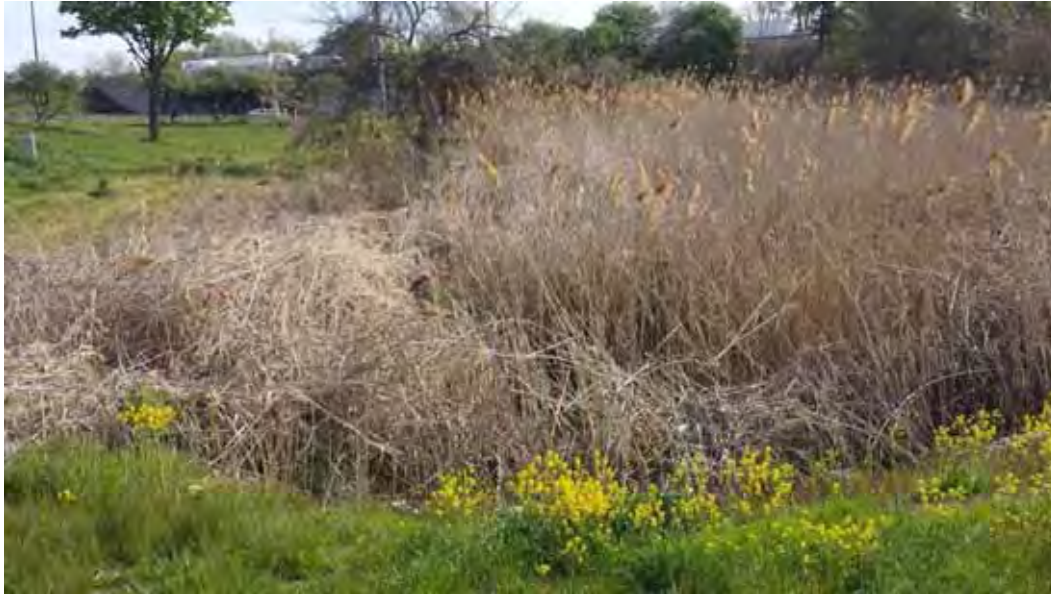
Site ID/Name: Chubb Ave/Wall St W/Polito Ave Ditch System (Lyndhurst) – Location #2

Figure 1: Downstream view of ditch

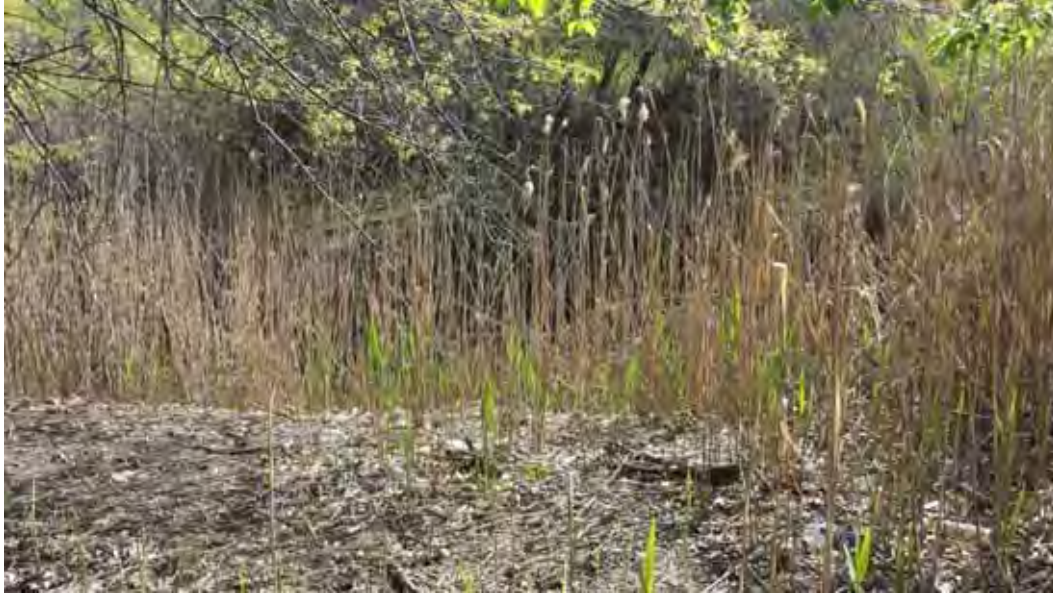
Site ID/Name: Chubb Ave/Wall St W/Polito Ave Ditch System (Lyndhurst) – Location #3

Figure 1: Downstream view of ditch

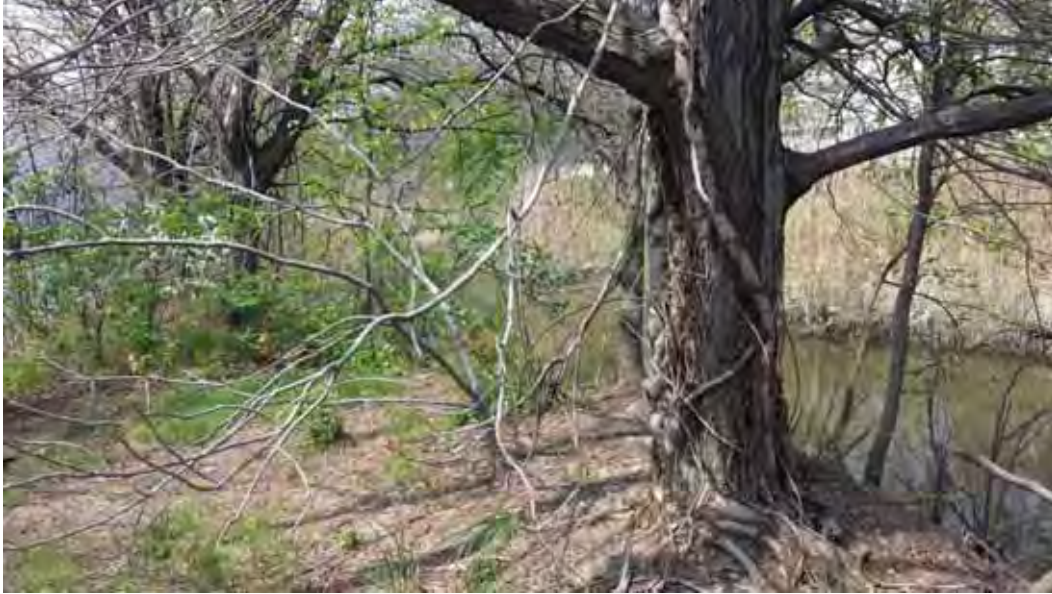
Site ID/Name: Chubb Ave/Wall St W/Polito Ave Ditch System (Lyndhurst) – Location #4

Figure 1: Downstream view of ditch

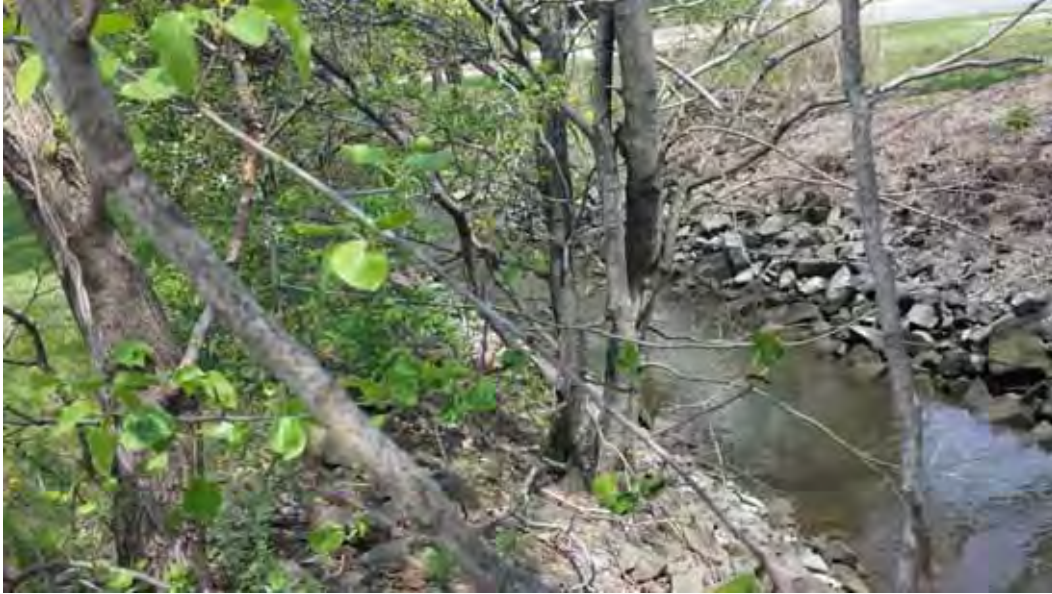
Site ID/Name: Chubb Ave/Wall St W/Polito Ave Ditch System (Lyndhurst) – Location #5

Figure 1: Downstream view of ditch

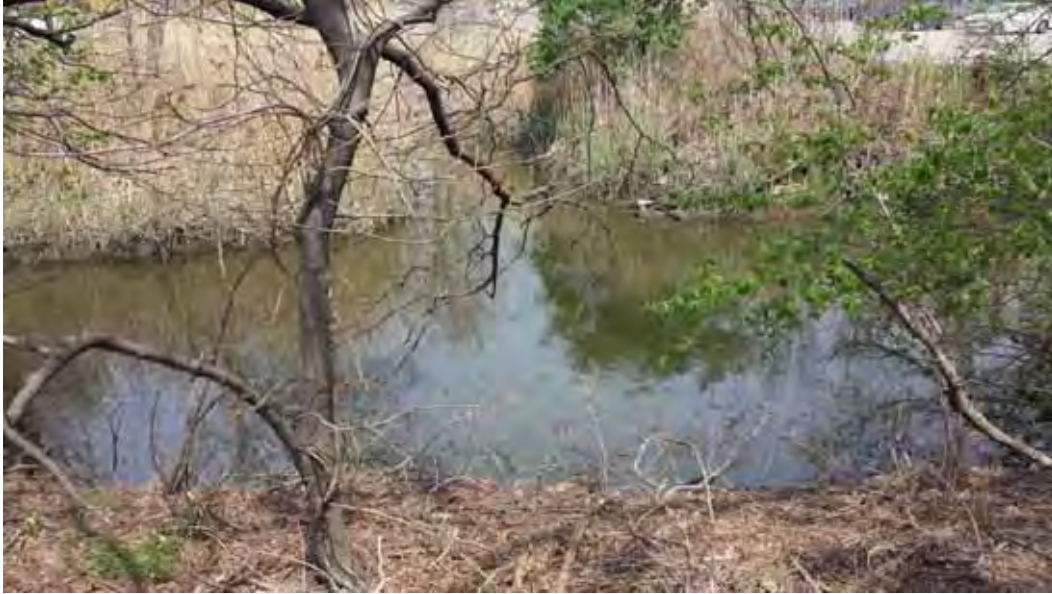
Site ID/Name: Chubb Ave/Wall St W/Polito Ave Ditch System (Lyndhurst) – Location #7

Figure 1: Downstream view of ditch

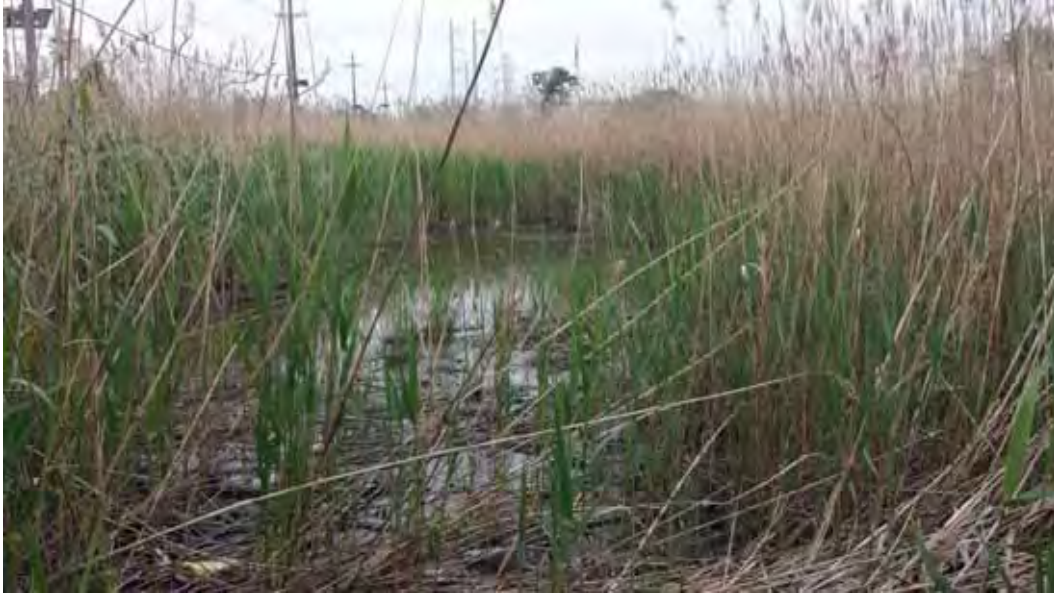
Site ID/Name: Belleman's Creek Ditch System (North Bergen) – Location #3

Figure 1: Downstream view of ditch

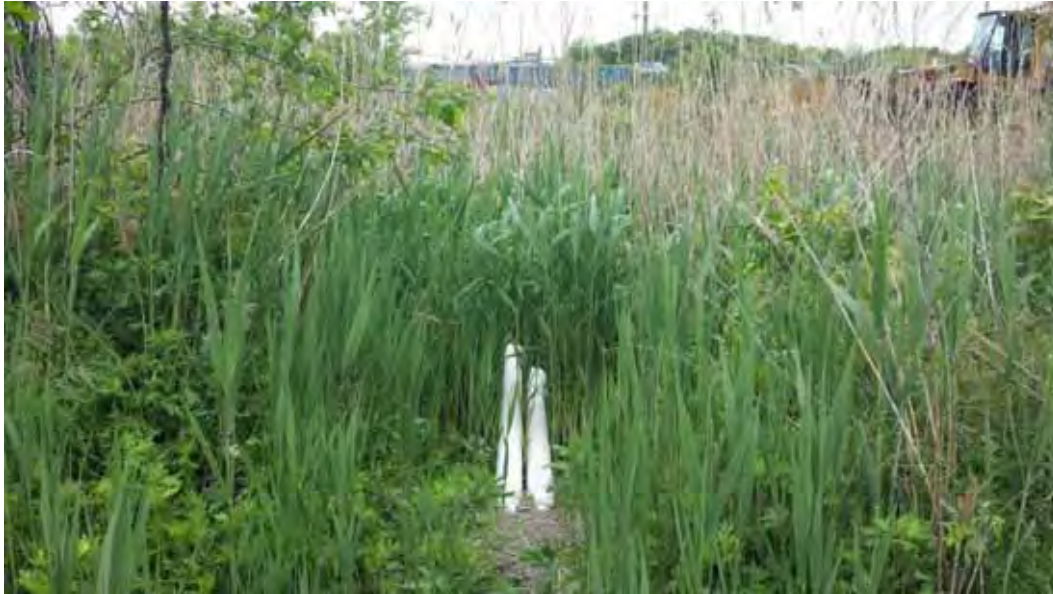
Site ID/Name: Belleman's Creek Ditch System (North Bergen) – Location #4

Figure 1: Downstream view of ditch

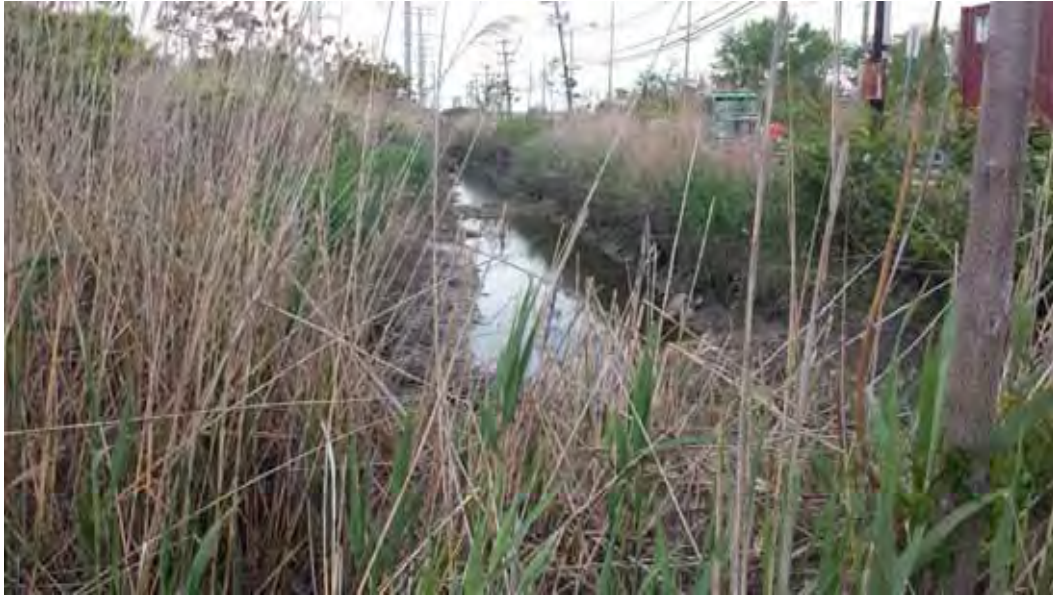
Site ID/Name: Cromakill Creek Ditch System (North Bergen) – Location #2

Figure 1: Downstream view of ditch

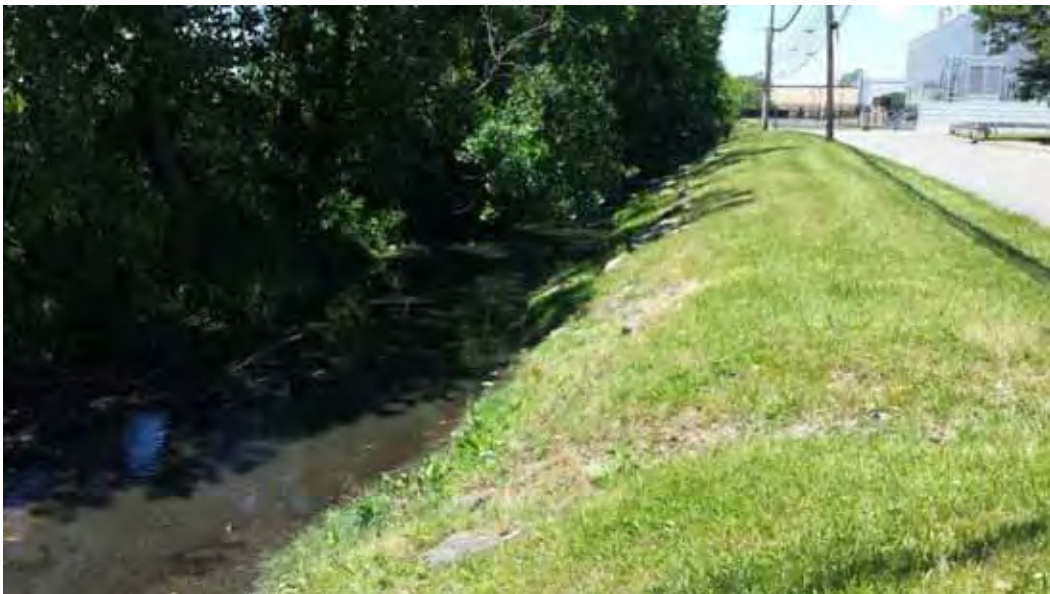
Site ID/Name: Sack's Creek & Golden Ave Ditch System (Secaucus) – Location #8

Figure 1: Upstream view of ditch at culvert
