New Jersey Sports & Exposition Authority Tide Gate Inspection Report

**The National Flood Insurance Program
Community Rating System**

The New Jersey Sports and Exposition Authority

December 7, 2016

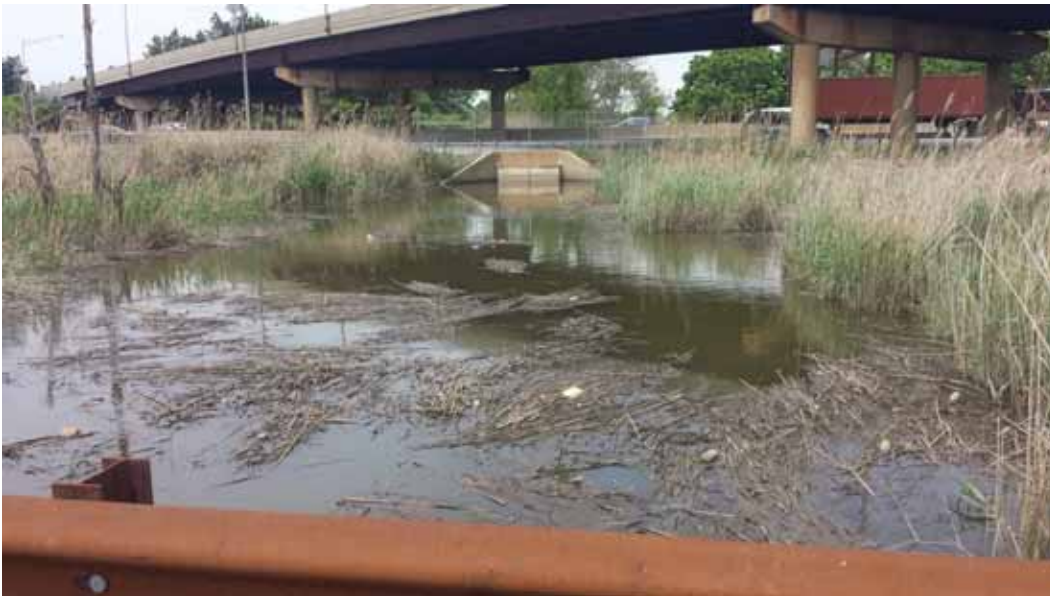
Figure 1: Downstream view from bridge

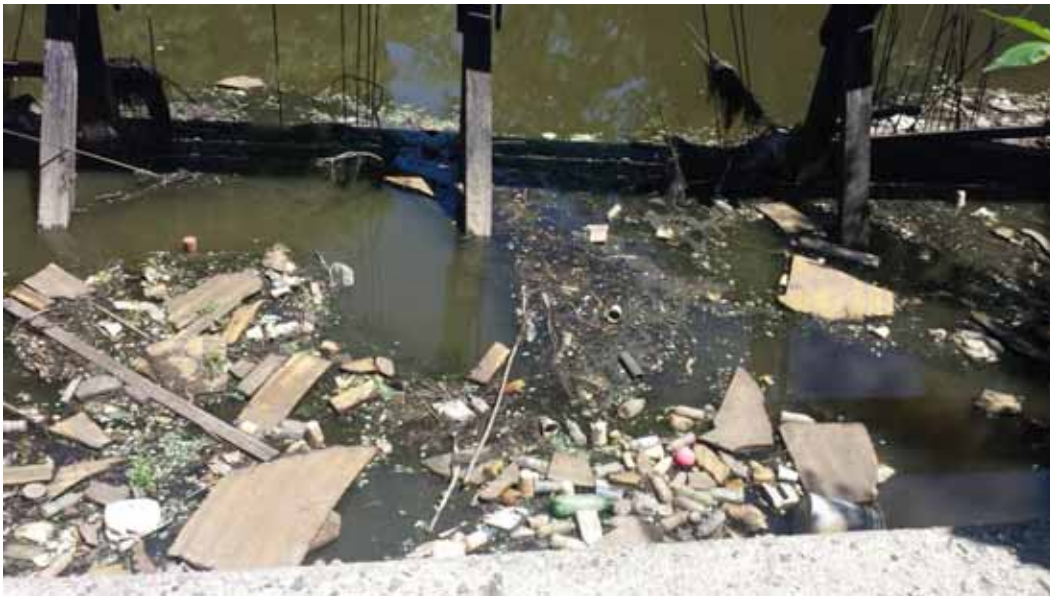
Type of Inspection:		Notes on Condition/Problems:
<input type="checkbox"/> Yearly	<input checked="" type="checkbox"/> Ditch	Debris on upstream side at trash rack.
<input type="checkbox"/> Post-Storm	<input checked="" type="checkbox"/> Tide Gate	
<input type="checkbox"/> Complaint	<input type="checkbox"/> Pump System	
System Designation:		
<input checked="" type="checkbox"/> Natural Stream	<input checked="" type="checkbox"/> Culvert	Notes on Maintenance:
<input type="checkbox"/> Manmade Channel	<input type="checkbox"/> Outfall	Bergen County Mosquito Commission to clear debris
<input type="checkbox"/> Catch Basin	<input type="checkbox"/> Other:	
Overall Functionality:		
<input checked="" type="checkbox"/> Fully Functional	<input type="checkbox"/> High Tide	
<input type="checkbox"/> Functional with Restrictions	<input type="checkbox"/> Low Tide	
<input type="checkbox"/> Non-Functional		
Maintenance Required:		Other Notes:

Figure 1: Upstream view of ditch at tide gate

<input type="checkbox"/> Immediate		
<input type="checkbox"/> Repair		
<input checked="" type="checkbox"/> Continued Upkeep

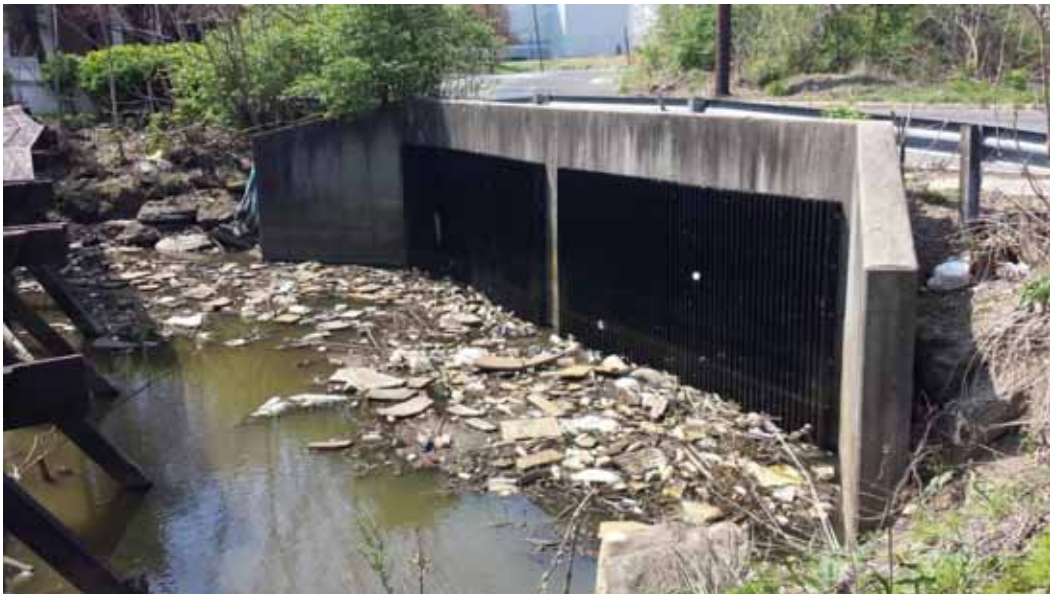
Figure 1: Upstream view of ditch at tide gate

Maintenance Required: <input checked="" type="checkbox"/> Immediate <input type="checkbox"/> Repair <input type="checkbox"/> Continued Upkeep		Other Notes:

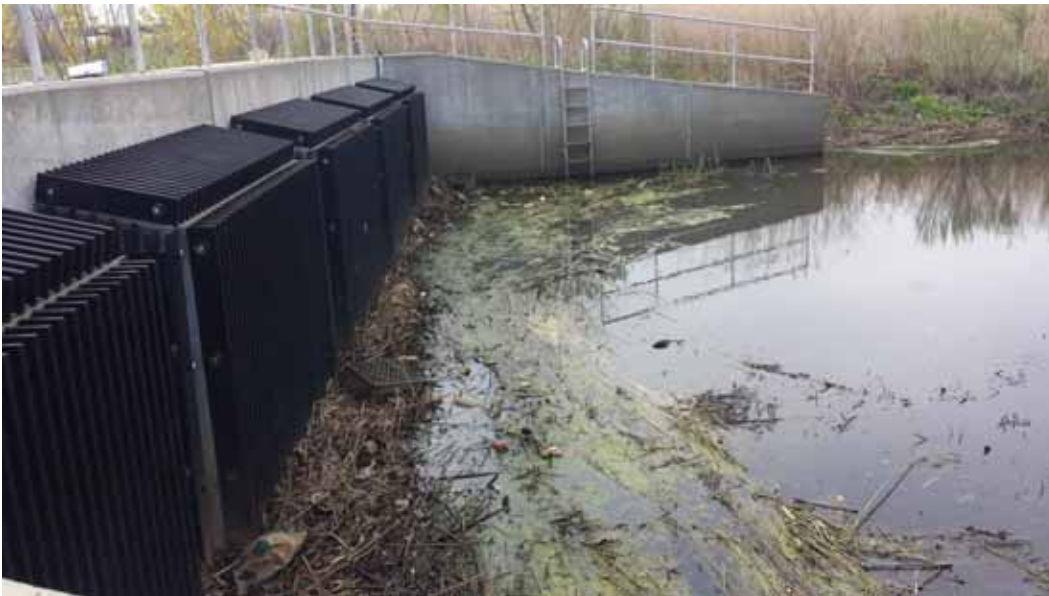
Type of Inspection:		Notes on Condition/Problems:	
<input checked="" type="checkbox"/> Yearly	<input type="checkbox"/> Ditch	Minor debris at upstream trash rack	
<input type="checkbox"/> Post-Storm	<input checked="" type="checkbox"/> Tide Gate		
<input type="checkbox"/> Complaint	<input type="checkbox"/> Pump System		
System Designation:			
<input checked="" type="checkbox"/> Natural Stream	<input type="checkbox"/> Culvert		
<input type="checkbox"/> Manmade Channel	<input type="checkbox"/> Outfall		
<input type="checkbox"/> Catch Basin	<input type="checkbox"/> Other: _____	Notes on Maintenance:	
Overall Functionality:		Low priority for cleaning trash rack	
<input checked="" type="checkbox"/> Fully Functional	<input type="checkbox"/> High Tide		
<input type="checkbox"/> Functional with Restrictions	<input checked="" type="checkbox"/> Low Tide		
<input type="checkbox"/> Non-Functional			
Maintenance Required:

Figure 1: Downstream view of tide gate

<input type="checkbox"/> Immediate		Other Notes:	
<input type="checkbox"/> Repair			
<input checked="" type="checkbox"/> Continued Upkeep

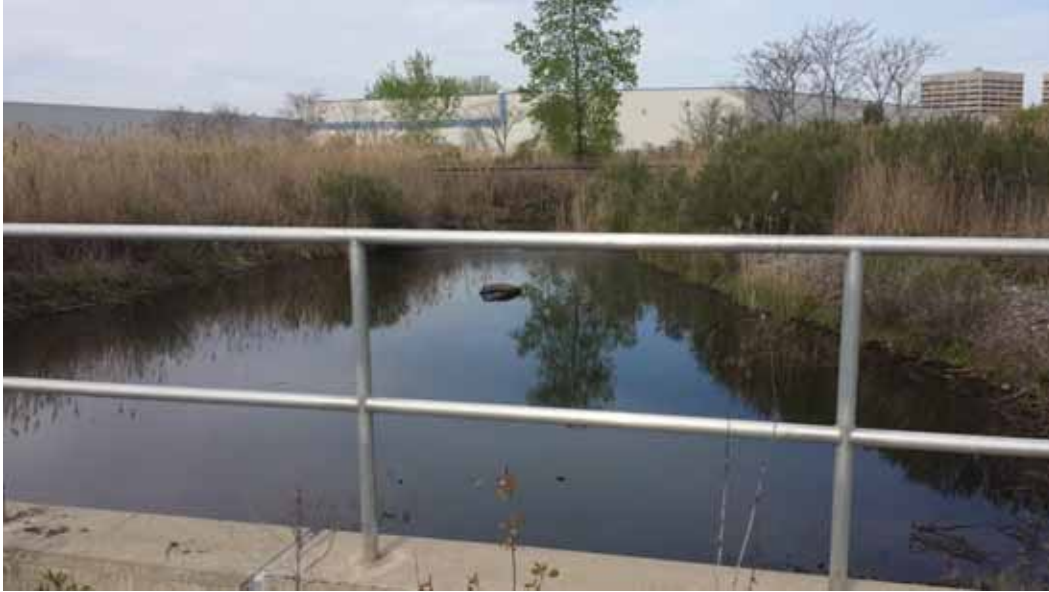
Figure 3: Upstream view from tide gate

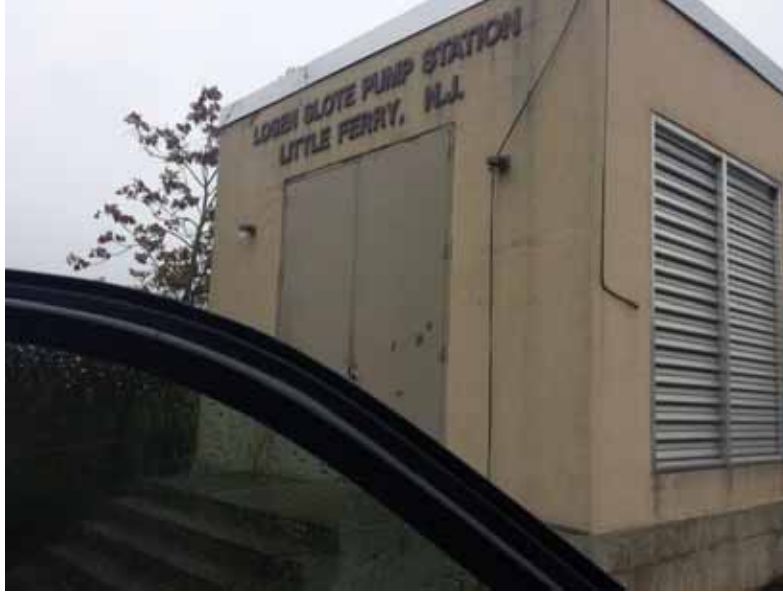
Figure 7: Exterior view of of control room

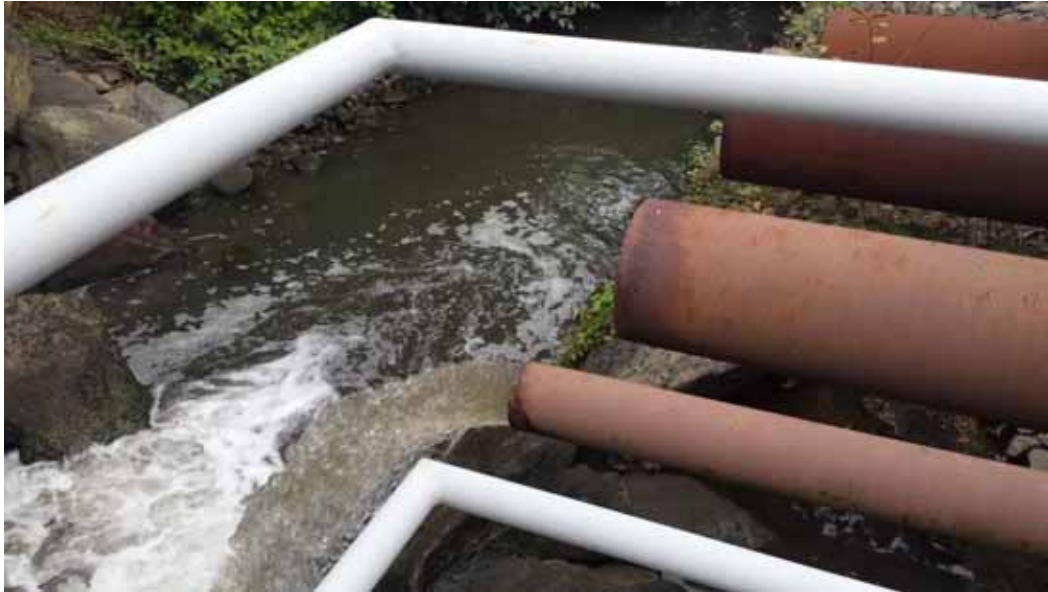
Figure 5: Pit pump in operation
