Sewer Lateral Inspection - Oct 30, 2024

3949 Ohio Ave
Unit C
St. Louis, MO 63118

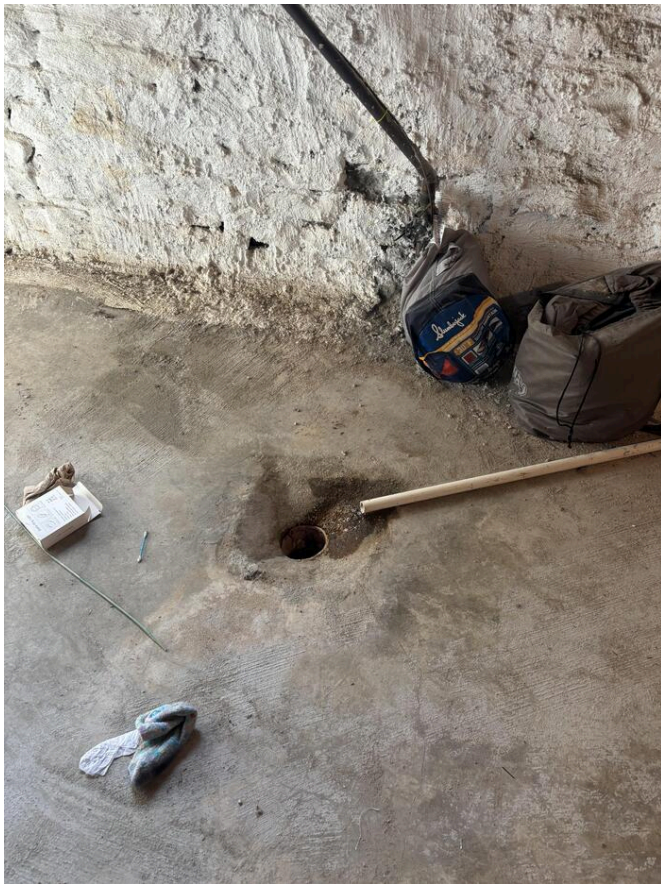
Basement sewer opening.

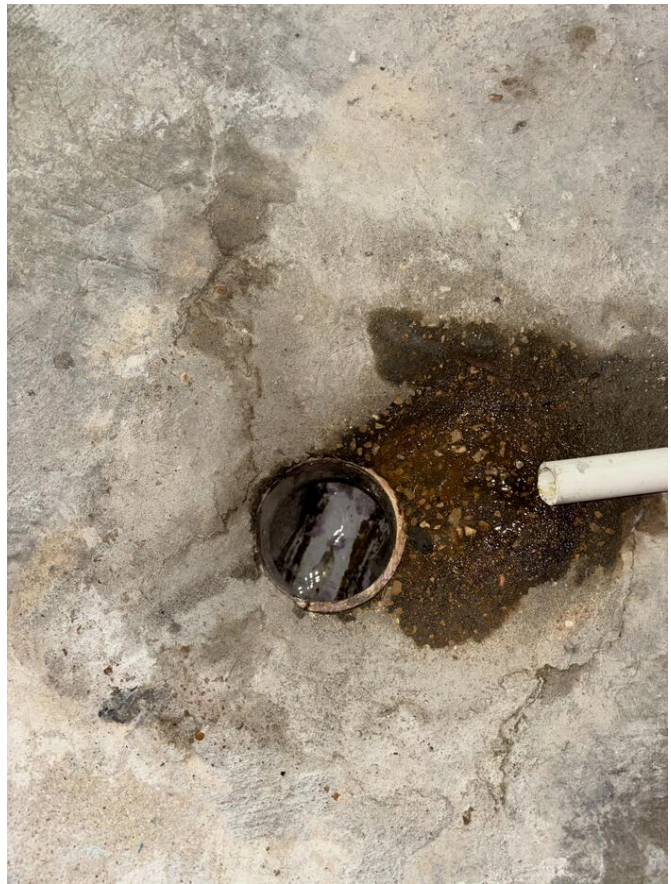
Basement sewer opening.

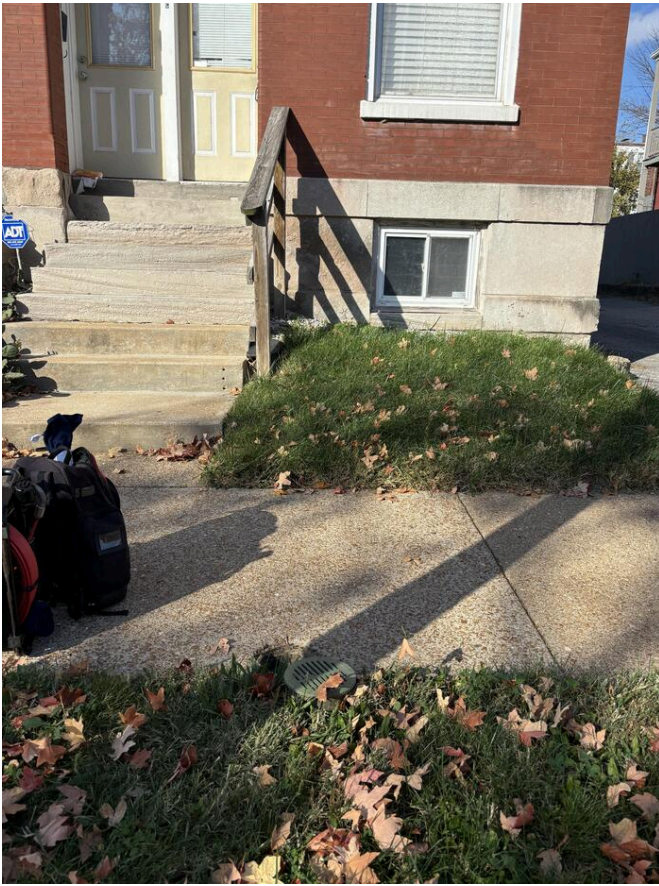
Successful access was achieved through the exterior vent/clean out. Observation of debris buildup within the sewer lateral line after the exterior P-trap. Would recommend having debris cleaned out and the sewer line further inspected to ensure debris was properly cleared and to check condition of the sewer pipe at this location. We also observed a basement sewer opening without a P-trap. This may allow sewer gasses/smells into the home. Would recommend having this further evaluated and corrected as necessary by a qualified plumbing professional.

Exterior cleanout/P-trap access.
