RE: ADEQ letter of June 7, 2001  
Engineering Review File No. 20010167  
Los Montanas Phase I

PERCOLATION AND SOILS TESTING

**LAS MONTANAS**

A SUBDIVISION IN PINAL COUNTY ARIZONA

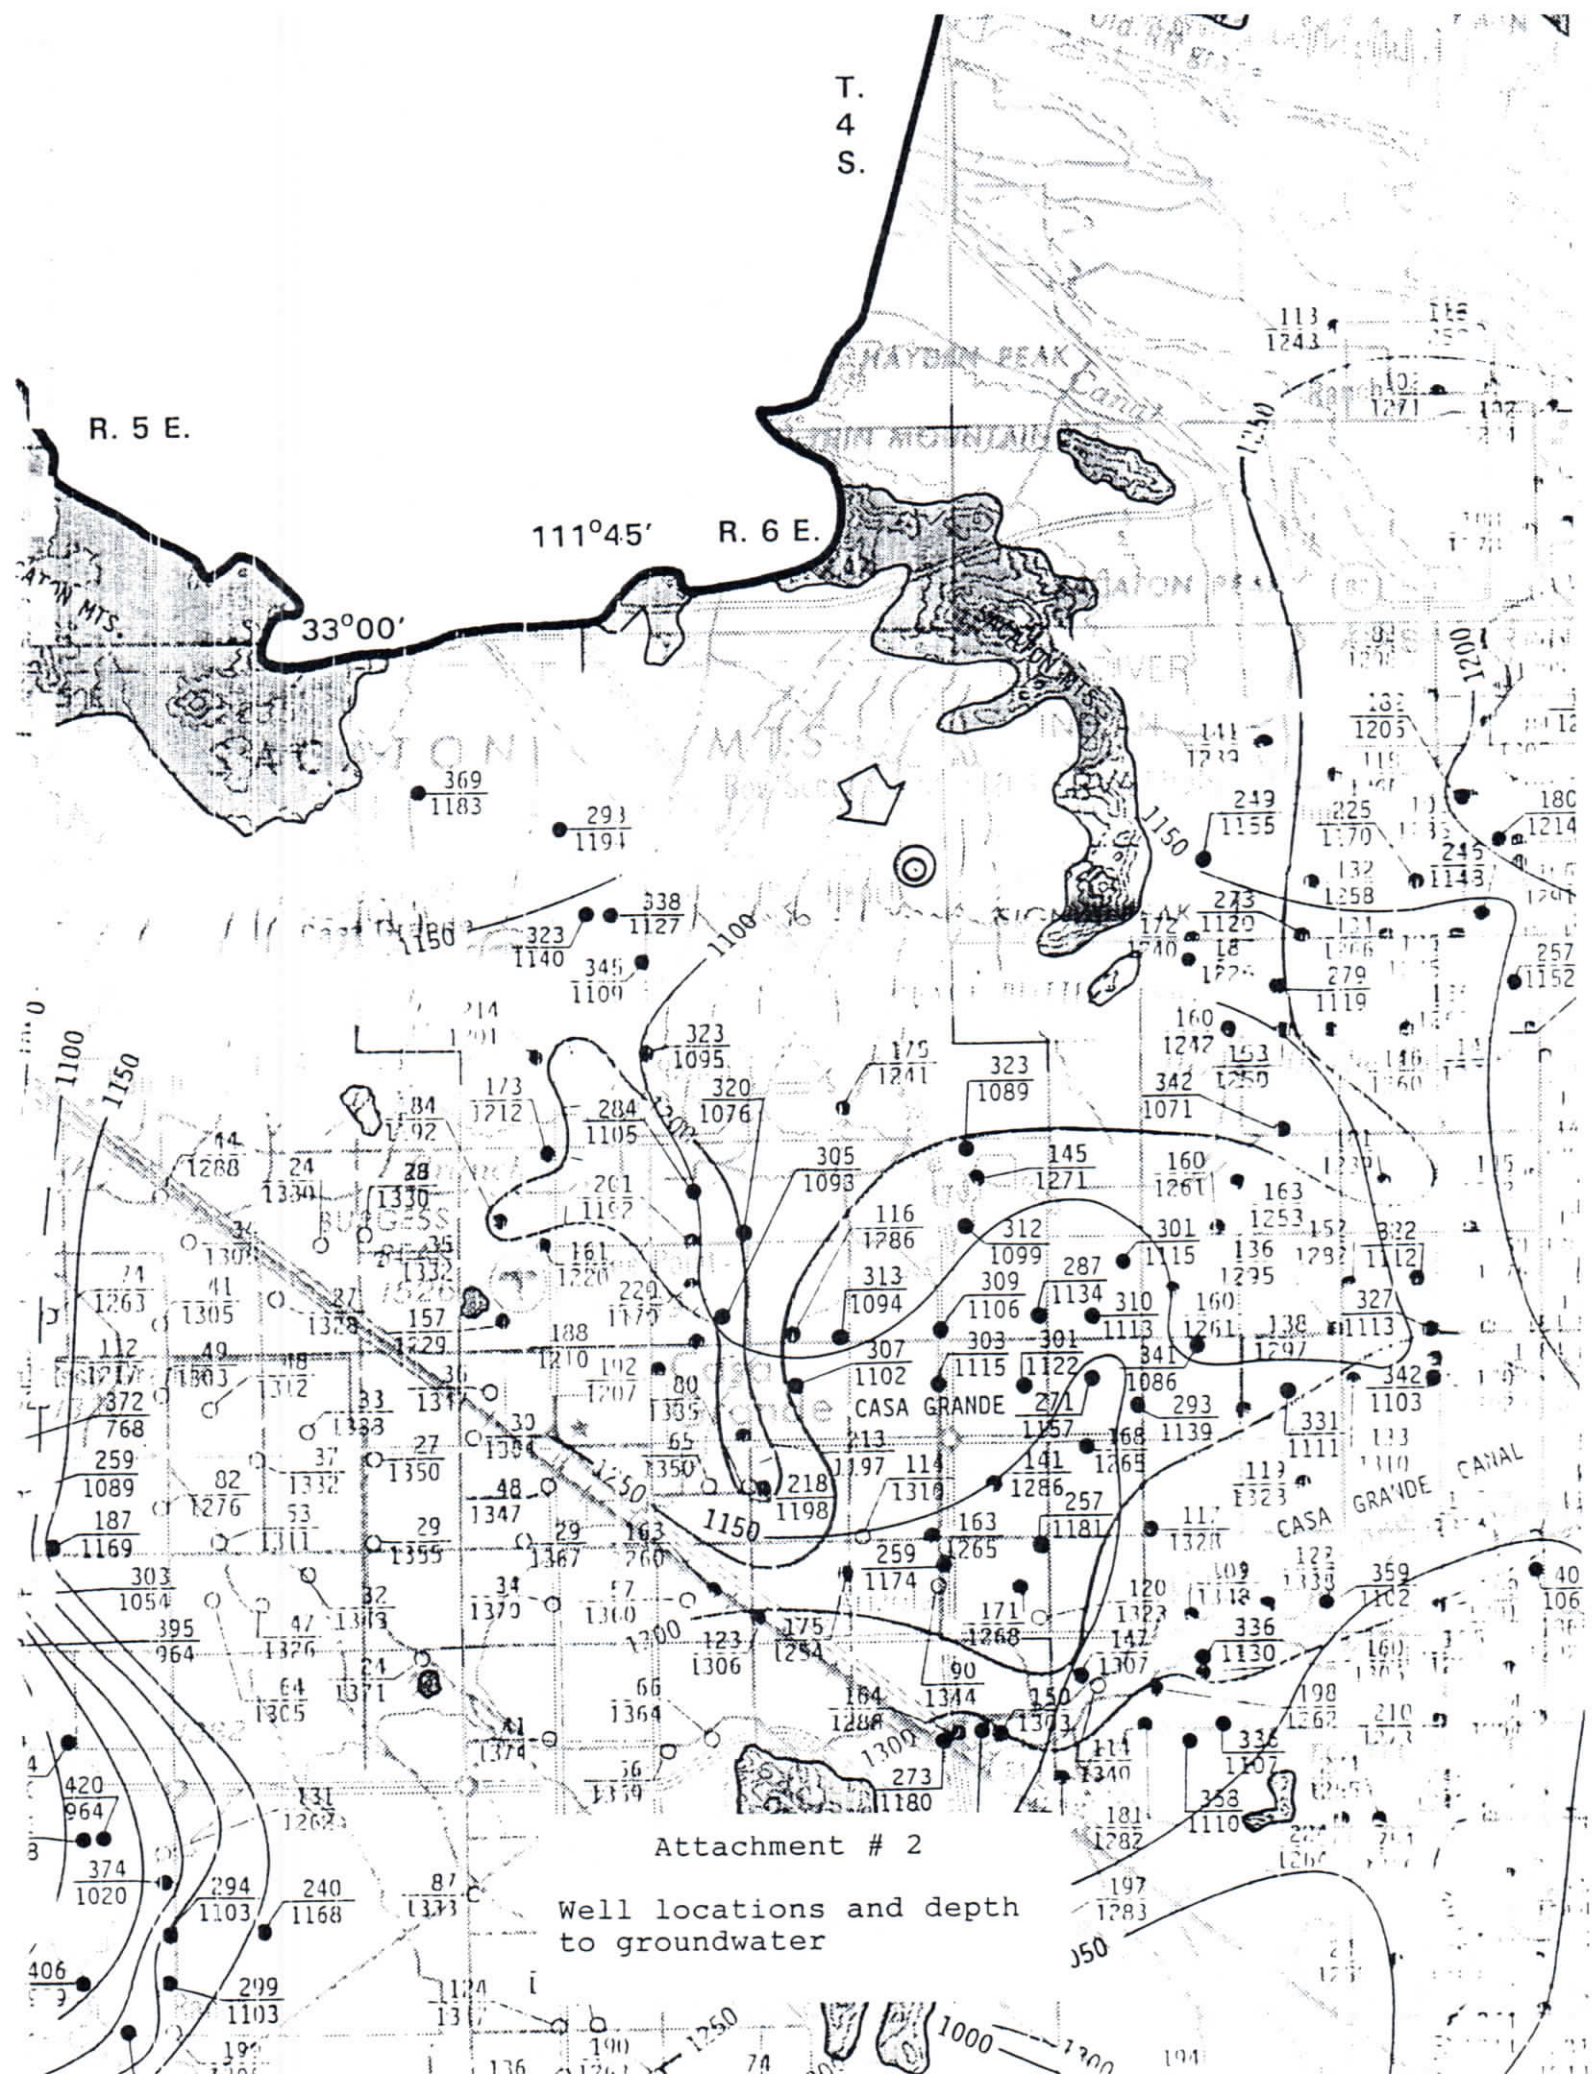
Enclosure # 1

Data from the Arizona Department of Water Resources Hydrologic map series Report Number 23 (attachment # 2) indicates that groundwater in the area is in excess of 100 feet and flows to the Southwest. There is an Earth fissure that crosses the subdivision and is the subject of a separate report. The Earth fissure has the potential to provide direct communication to the water table and the setback restrictions of 100 feet from this feature should be strictly enforced.

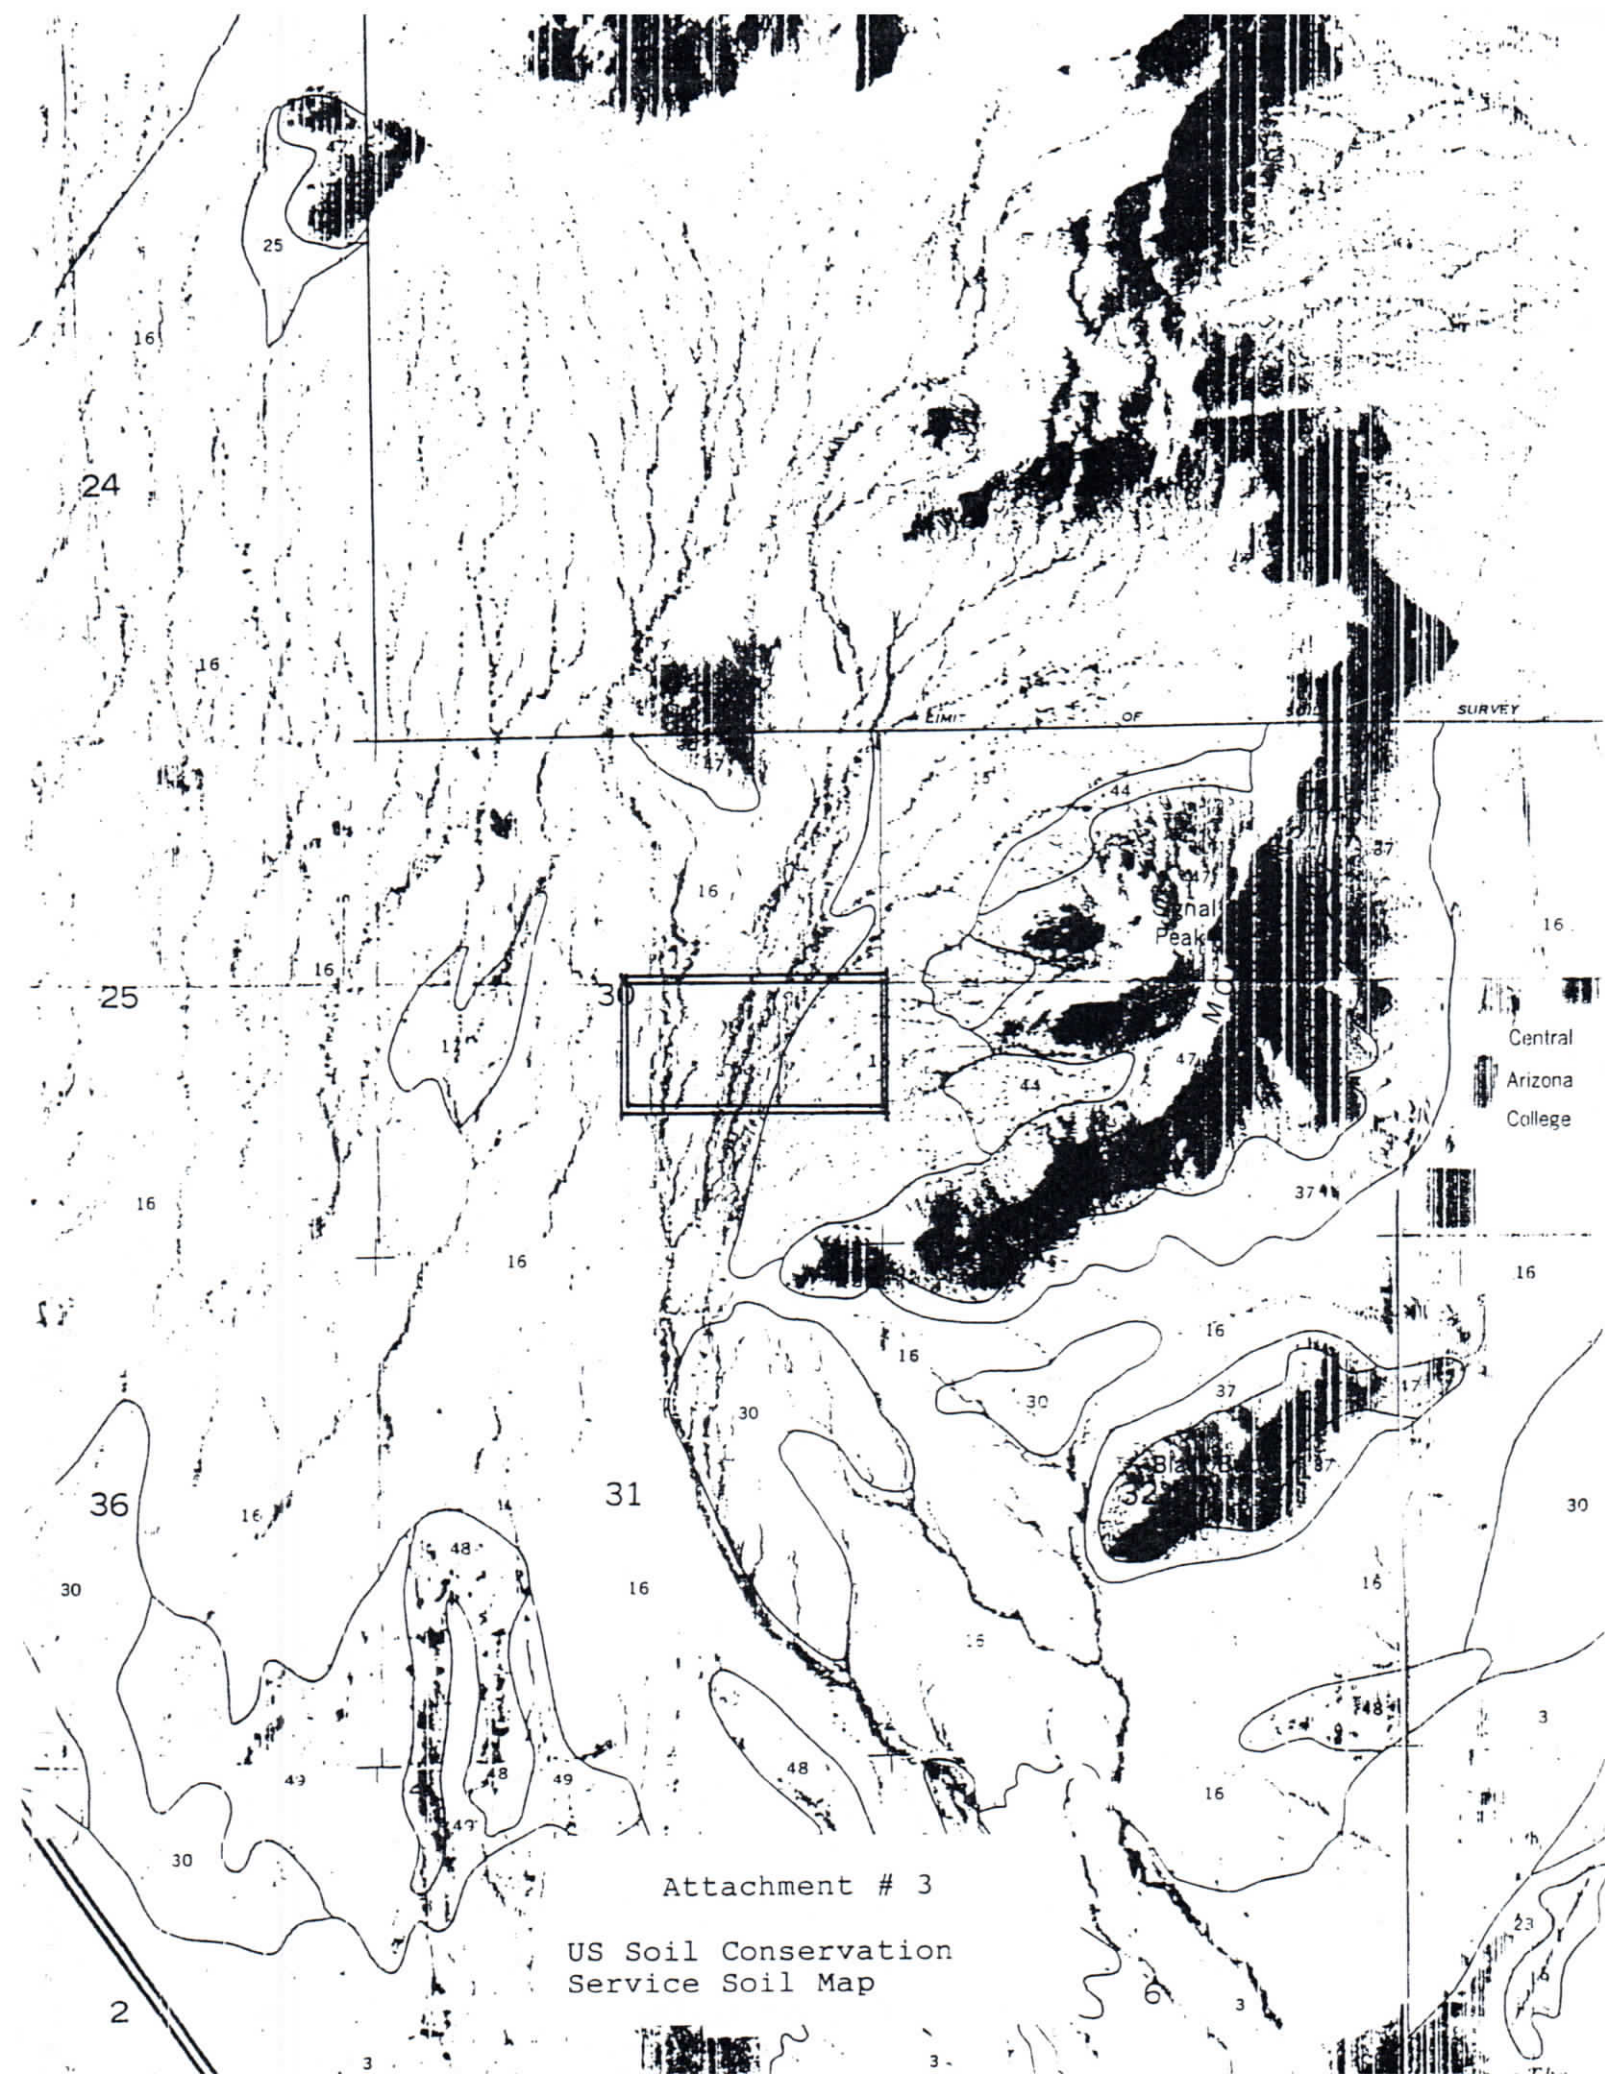
Attachment # 3  
US Soil Conservation  
Service Soil Map

The enclosed information is from the U. S. Soil Conservation Service, Soil Survey of Pinal County, Arizona, Western Part. The soil survey map, sheet no. 11 included with this letter shows that the soils are units 15 and 57 as described in the soils report. These are large and consistent units that have uniform characteristics through out the area where they occur.

Unit 15 is the Denure Series and unit 47 is the Vaiva Series. The Soil Conservation Service has done extensive testing of these units and it is consistent with the on-site testing accomplished by myself. The SCS test results are included with this letter.
