GEOTECHNICAL ENGINEERING STUDY

Proposed Deseret Peak Grantsville

NW of the Intersection of Lamb Lane and SR 112
Grantsville, Utah

CMT Project No. 900217

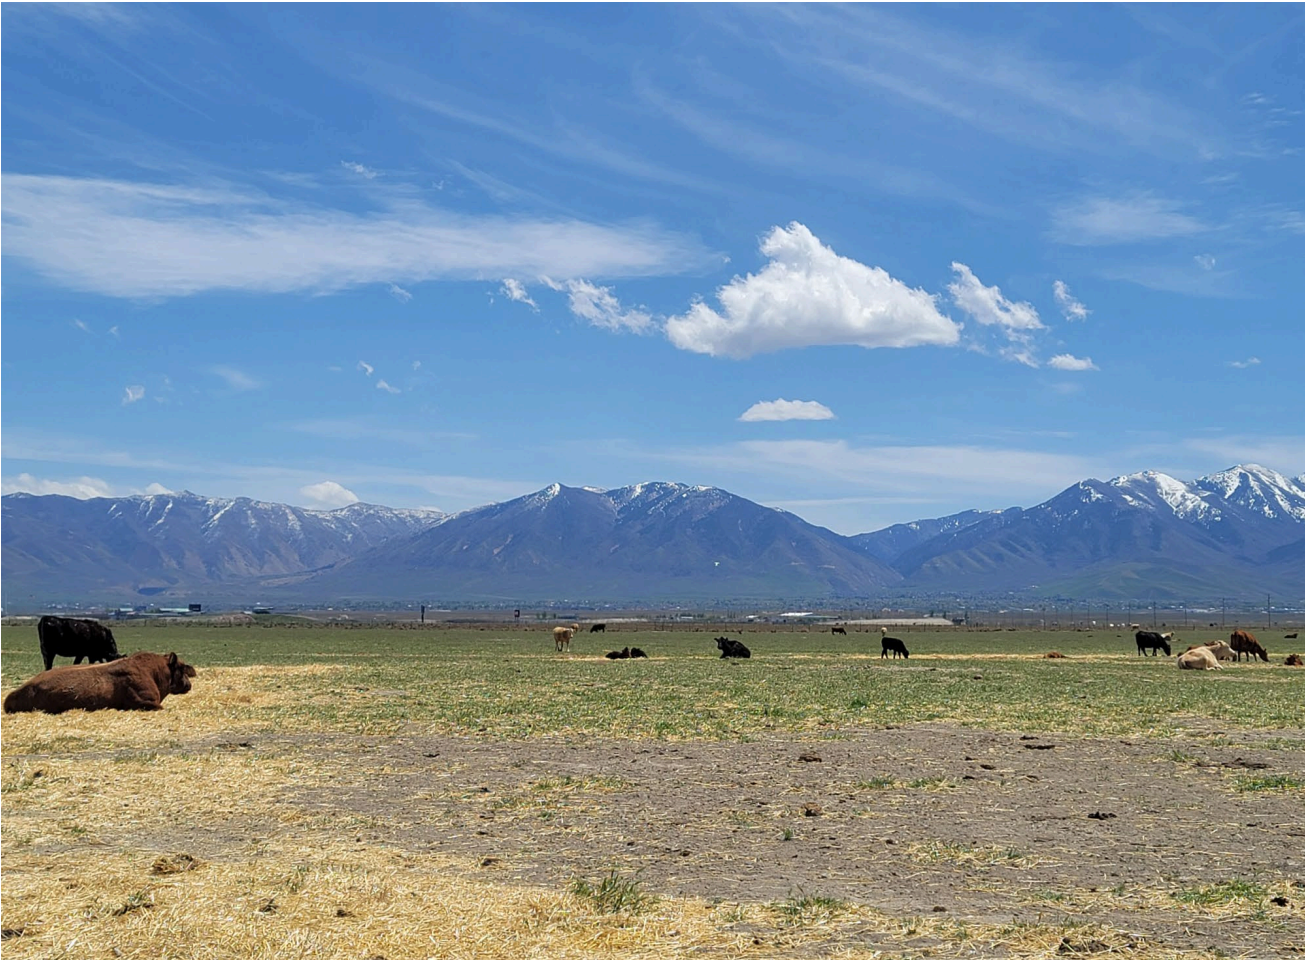
Photo 1. Looking across the site property currently utilized for grazing.
