Project Profile

Marriott Long Wharf Hotel
Boston, MA

Sika Sarnafil Helps High-End Hotel Stay High and Dry

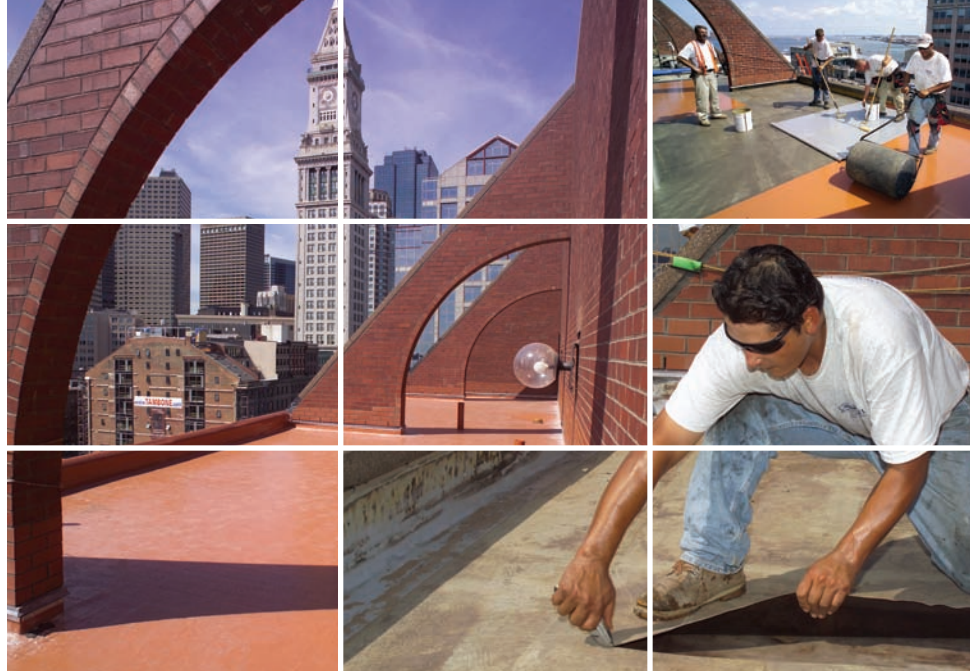
The new Sika Sarnafil membrane installed at the Marriott Long Wharf, Boston, MA. At right, a worker cuts the old membrane, which was recycled and will go back into new membrane production.
