Pre-Purchase Condition and Value Survey of the Sailing Vessel

“Weatherly”

September 25 & 27, 2020

Pre-Purchase Condition and Value Survey

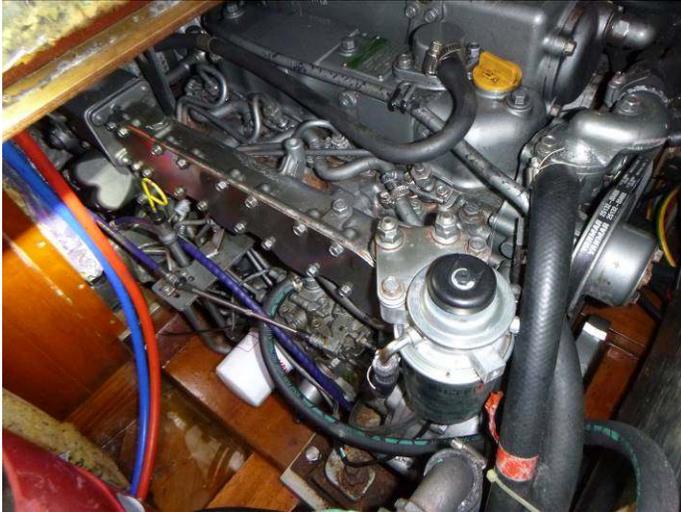
Engine

The vessels engine was run for a period of 2 hours while on sea trial and at the dockside portion of the survey. During this time, all belts, hoses, and fluids were checked. The fuel and exhaust systems were also visually inspected where accessible. The engine and engine compartment as a whole were inspected for general condition, evidence of leaks, and other evidence of necessary maintenance. An infrared thermal scan of the engines heat exchanger, head, manifold, and riser was also performed utilizing a *Flir* infrared thermal imager. All temperature readings were within normal limits unless otherwise noted below. During the sea trial, all gages equipped on the vessel were also watched to ensure normal operation. The engine reached 3940 rpm's during full throttle operation (rated 3800 minimum), with a maximum engine temperature of 168°. During this time, the engine ran smoothly and did not smoke.
