New Jersey Sports & Exposition Authority Drainage Ditch Inspection Report

**The National Flood Insurance Program
Community Rating System**

The New Jersey Sports and Exposition Authority

December 7, 2016

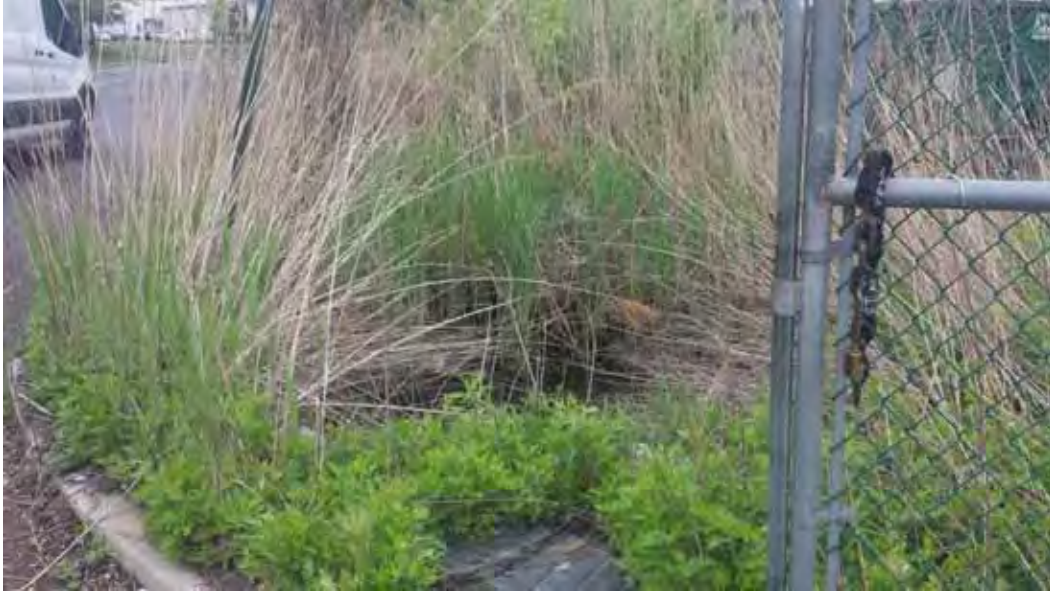
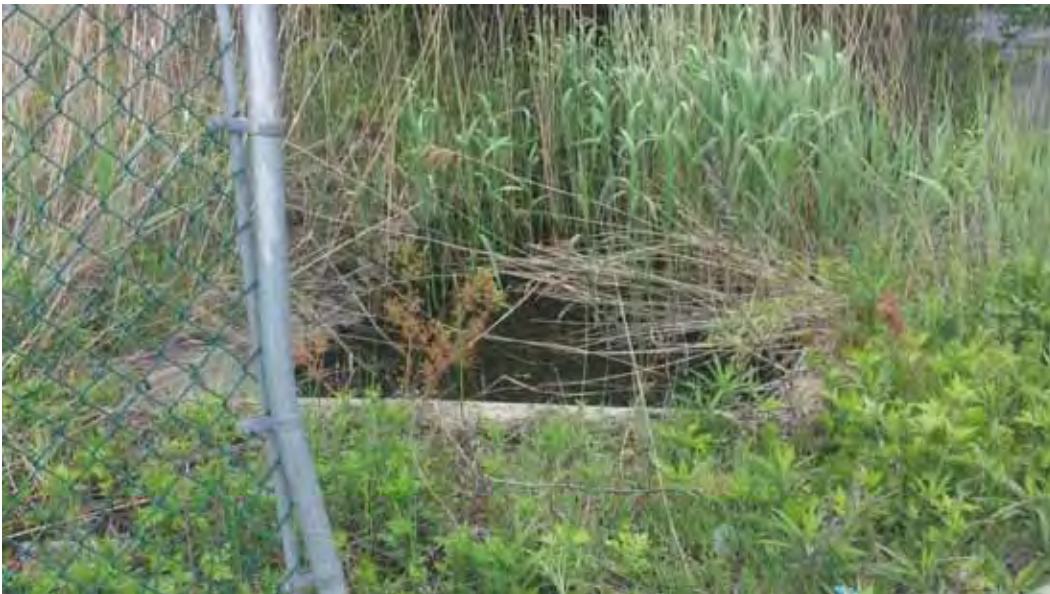
Site ID/Name: Asia Place Ditch System (Lyndhurst) – Location #1

Figure 1: Downstream view of ditch

Figure 2: Downstream view of ditch

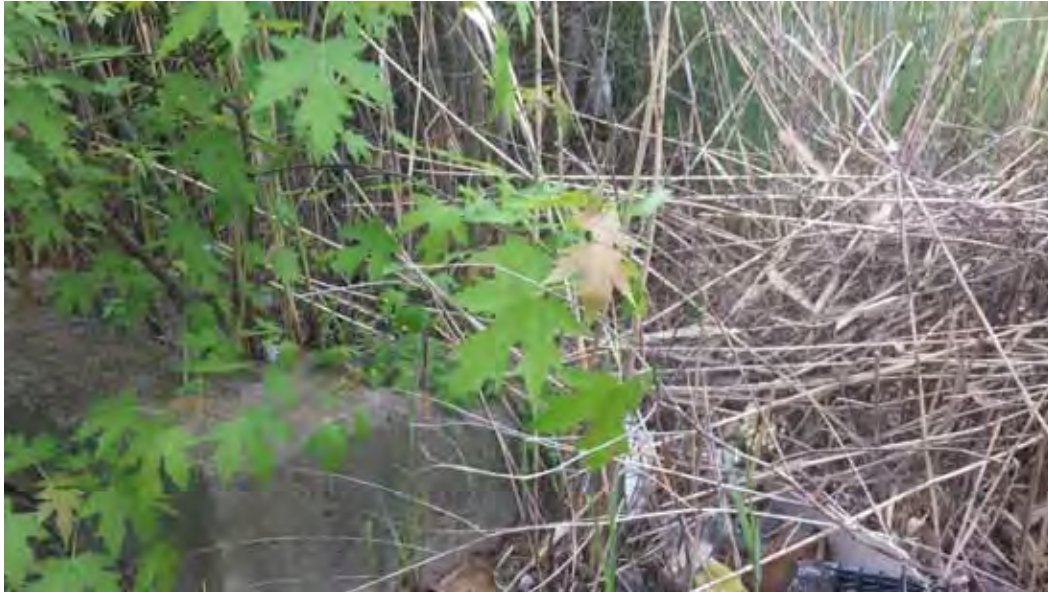
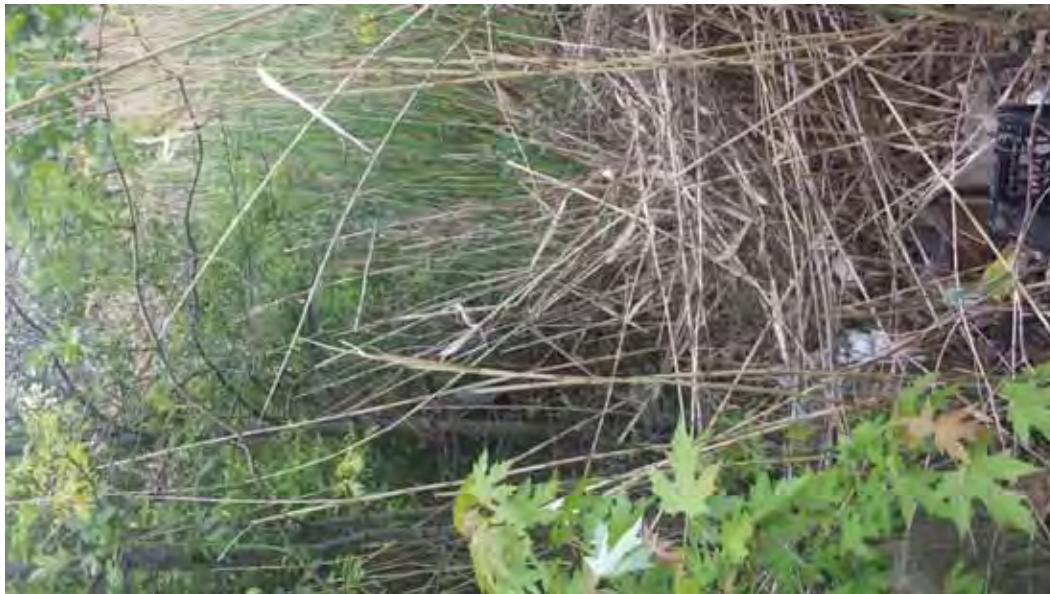
Site ID/Name: Asia Place Ditch System (Lyndhurst) – Location #2

Figure 1: Downstream view of ditch

Figure 2: Downstream view of ditch

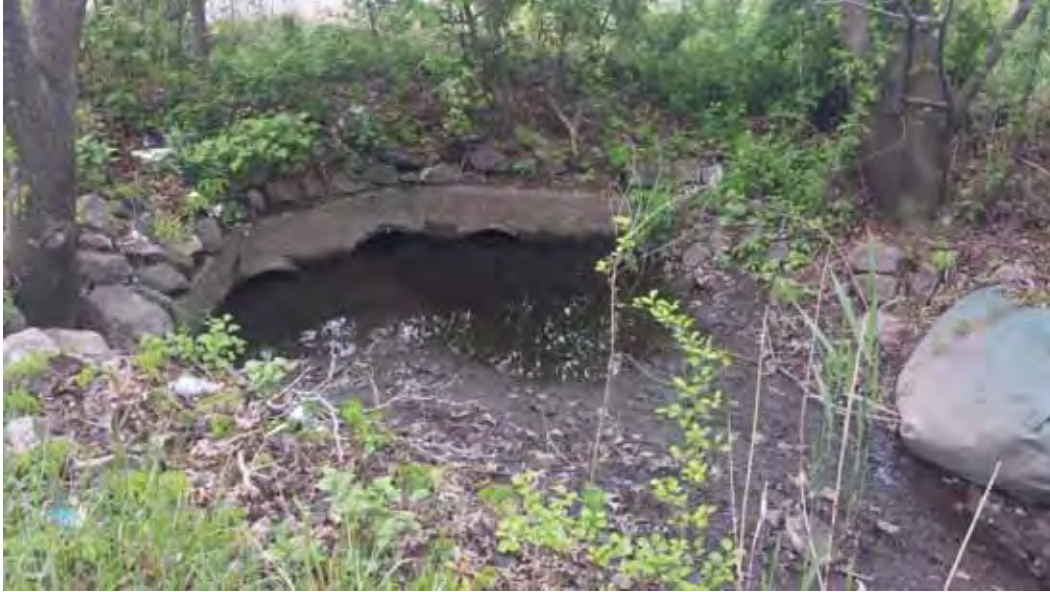
Site ID/Name: Asia Place Ditch System (Lyndhurst) – Location #3

Figure 1: Upstream view of ditch

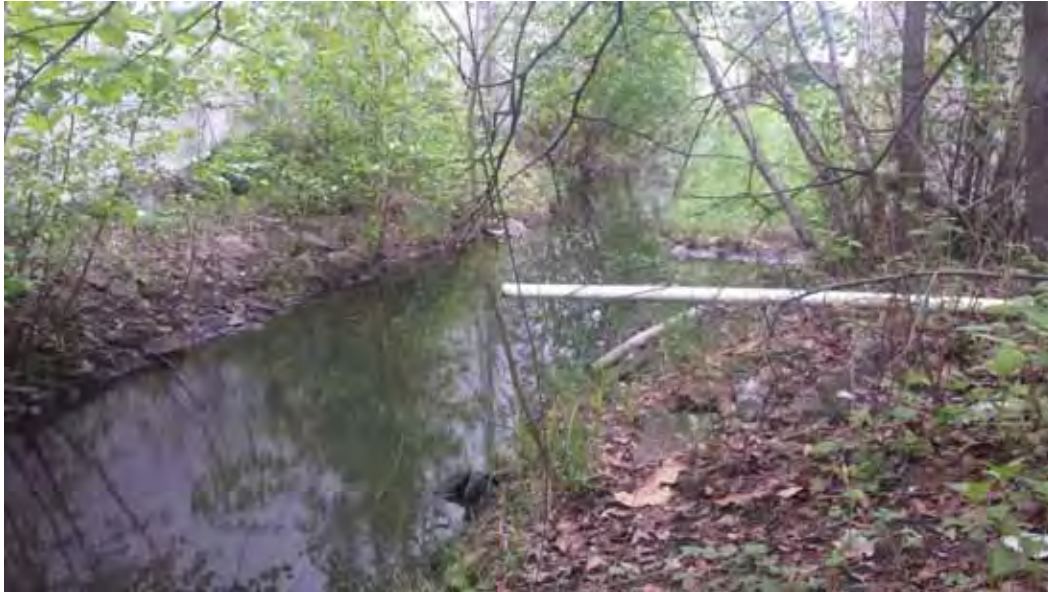
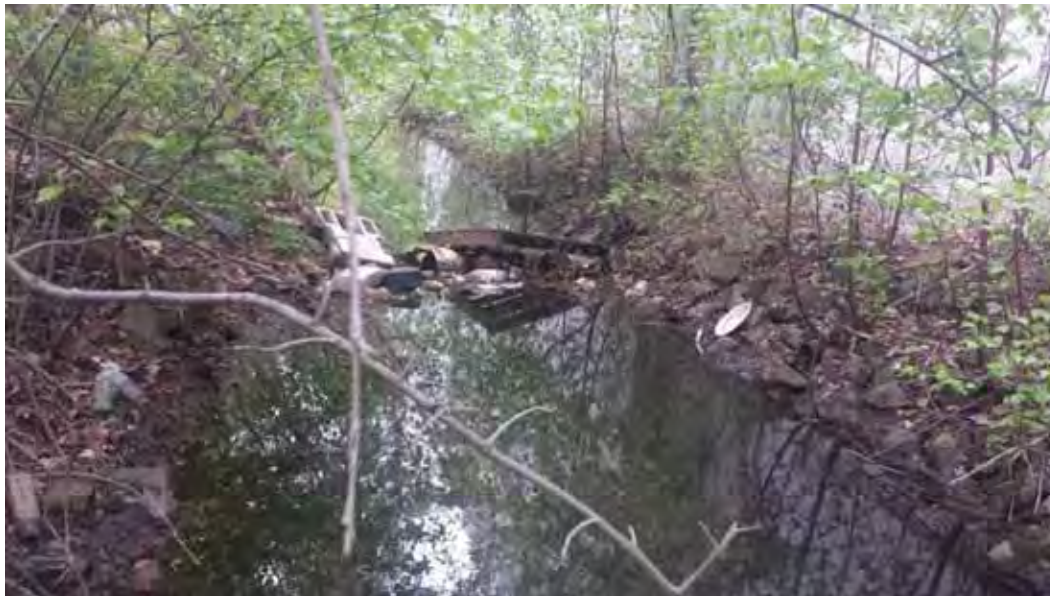
Site ID/Name: Asia Place Ditch System (Lyndhurst) – Location #4

Figure 1: Downstream view of ditch

Figure 2: Upstream view of ditch

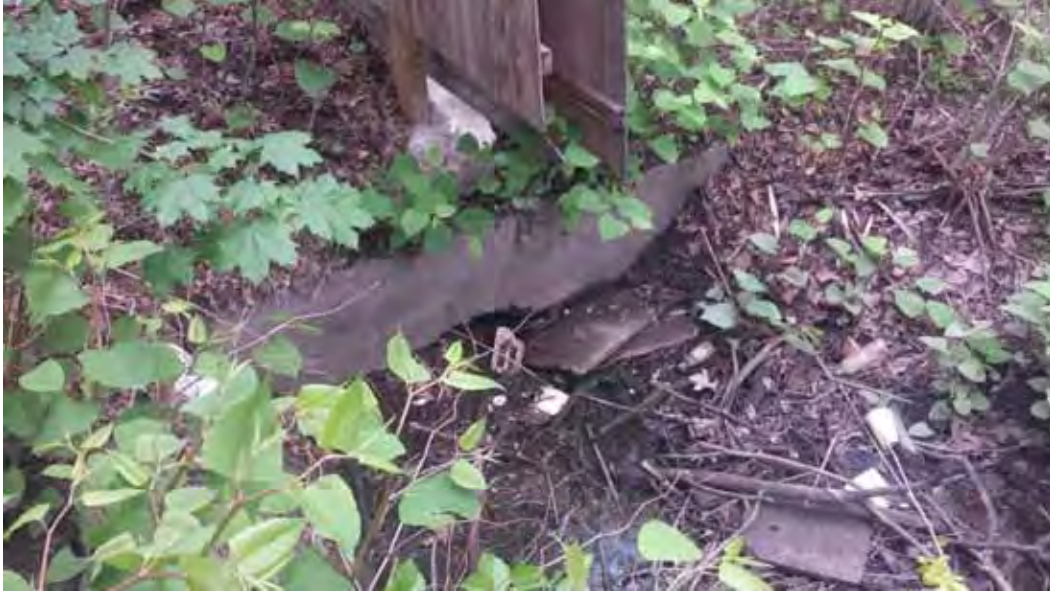
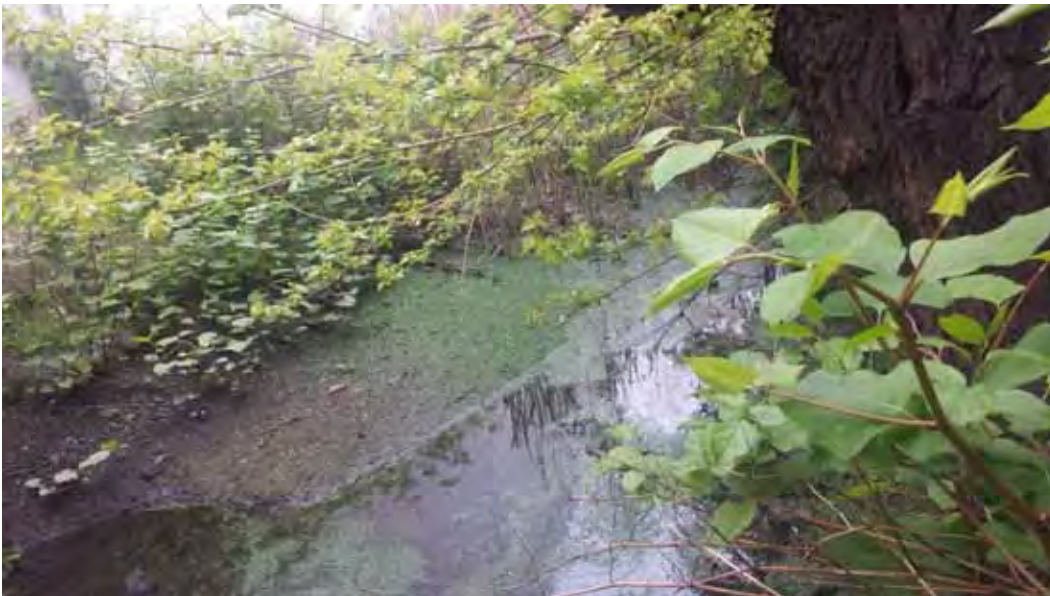
Site ID/Name: Asia Place Ditch System (Lyndhurst) – Location #5

Figure 1: Downstream view of ditch

Figure 2: Downstream view of ditch

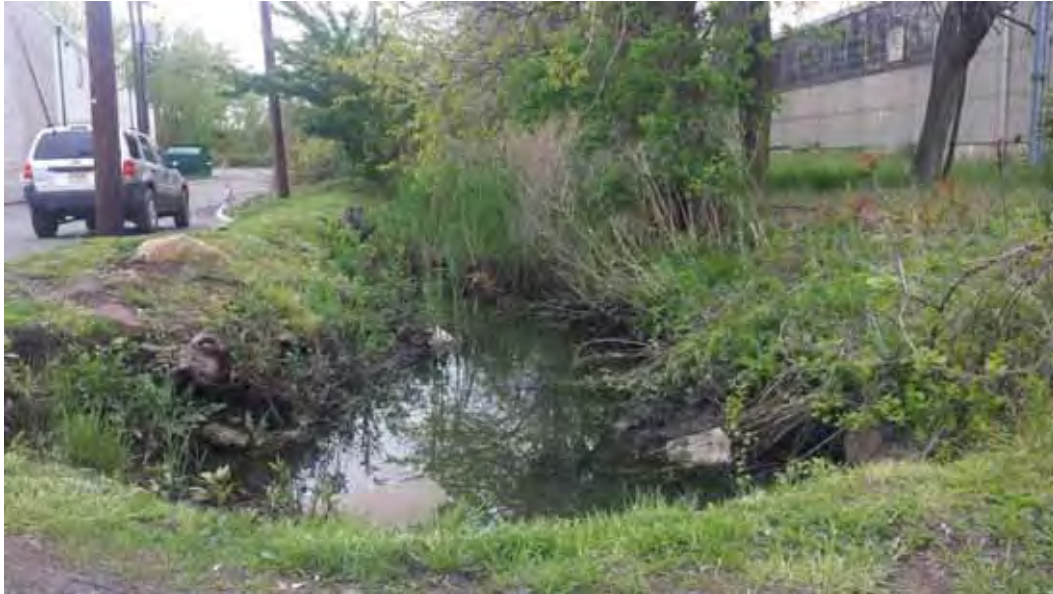
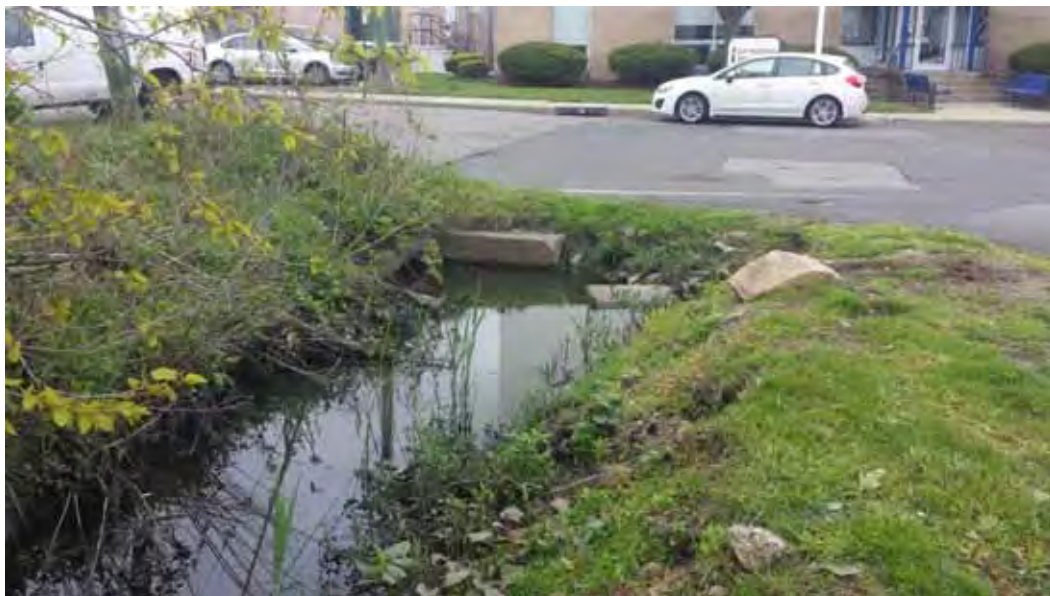
Site ID/Name: Asia Place Ditch System (Lyndhurst) – Location #6

Figure 1: Downstream view of ditch at culvert

Figure 2: Upstream view of ditch at culvert

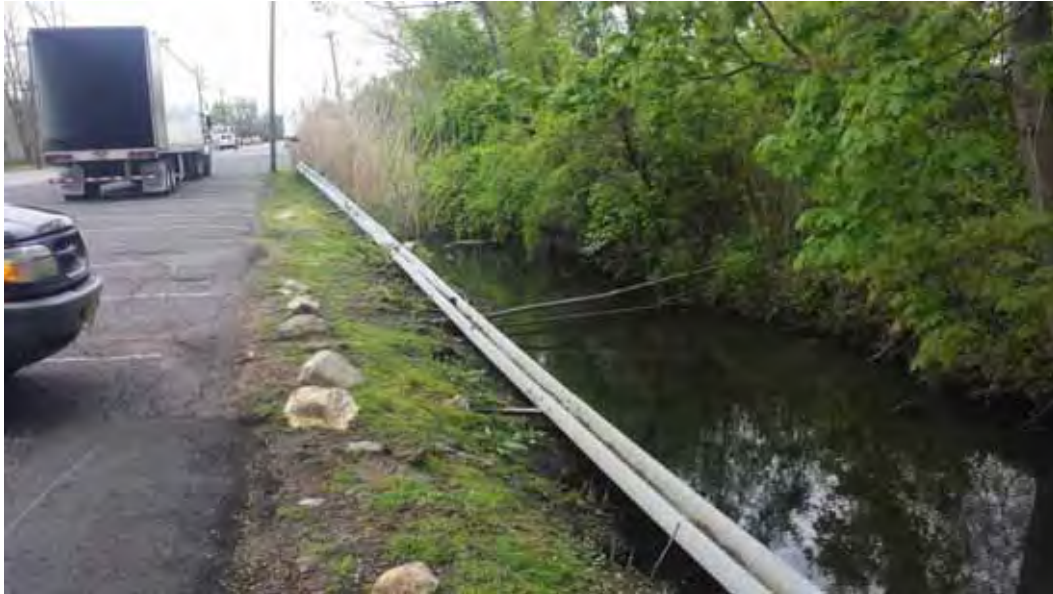
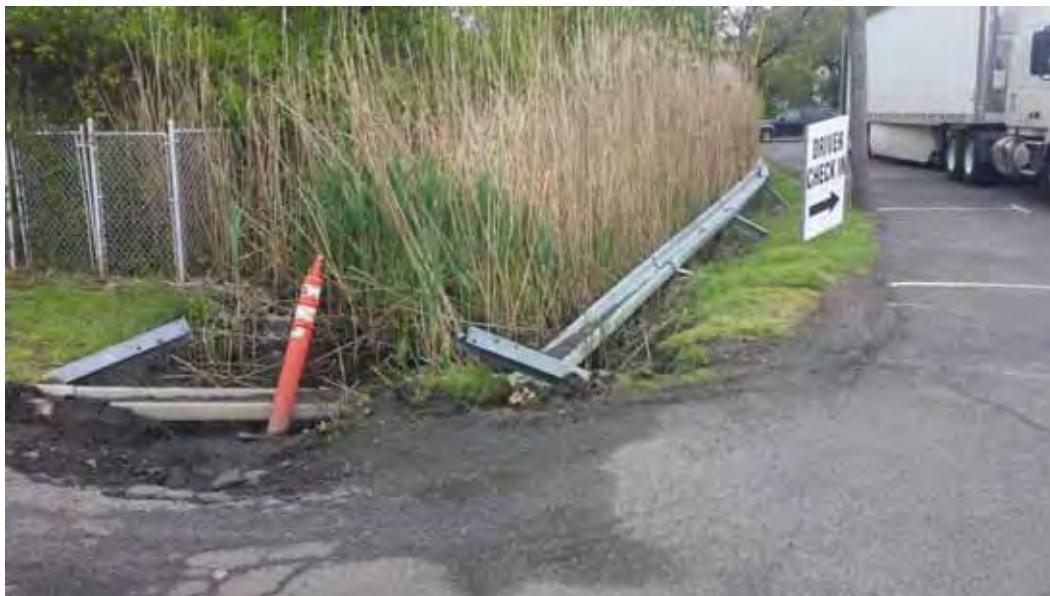
Site ID/Name: Asia Place Ditch System (Lyndhurst) – Location #7

Figure 1: Upstream view of ditch

Figure 2: Downstream view of ditch at culvert

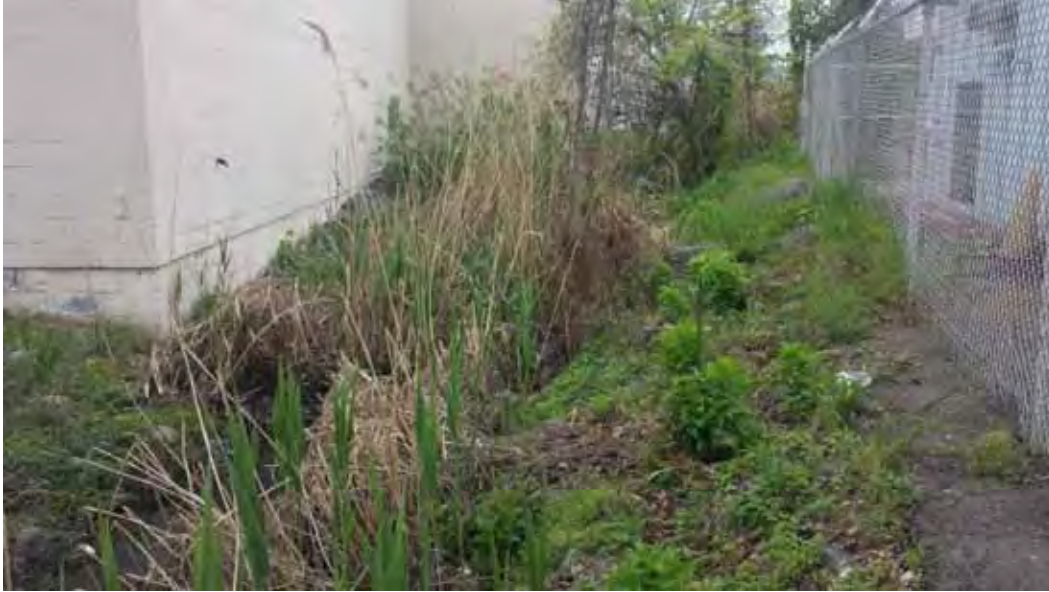
Site ID/Name: Asia Place Ditch System (Lyndhurst) – Location #8

Figure 1: Downstream view of ditch

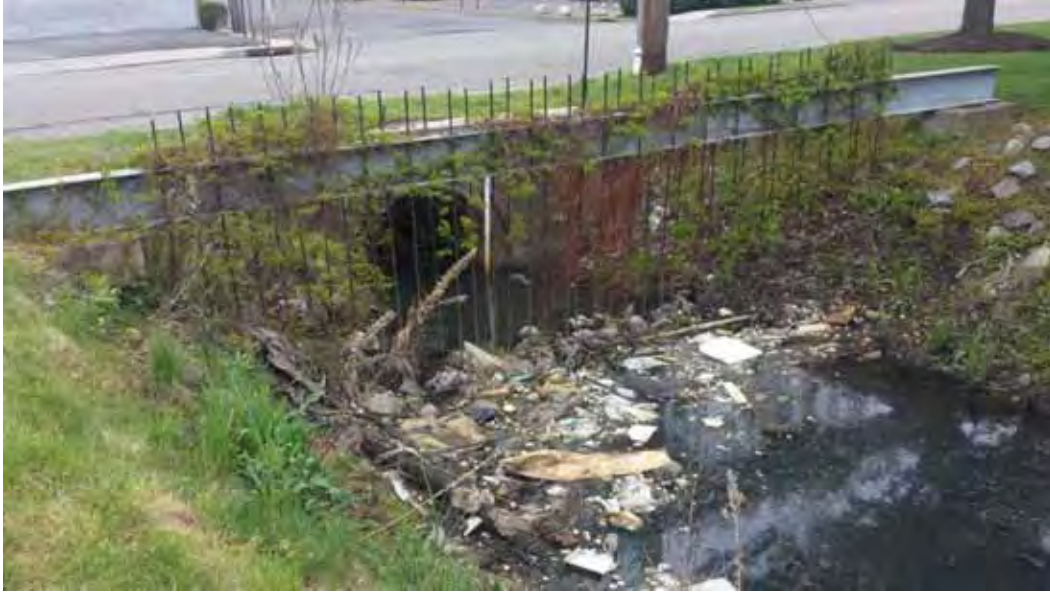
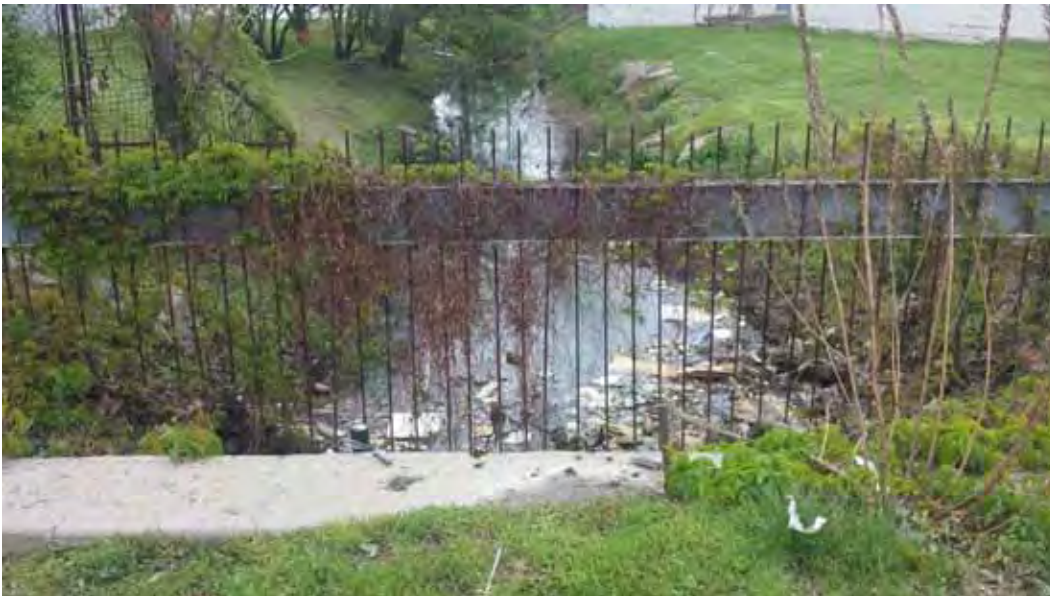
Site ID/Name: Asia Place Ditch System (Lyndhurst) – Location #9

Figure 1: Downstream view of culvert

Figure 2: Upstream view of ditch at culvert

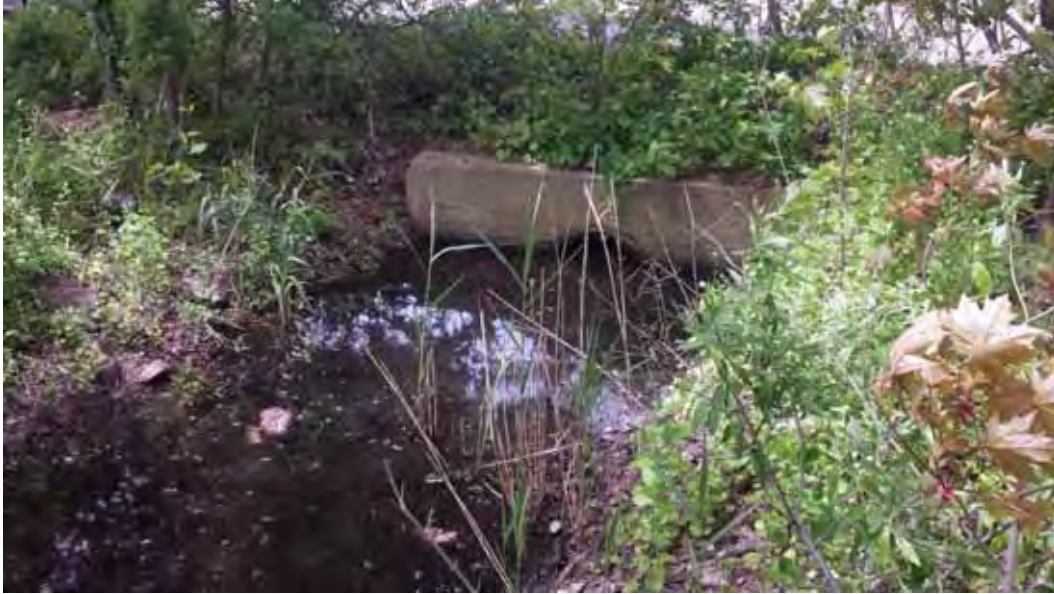
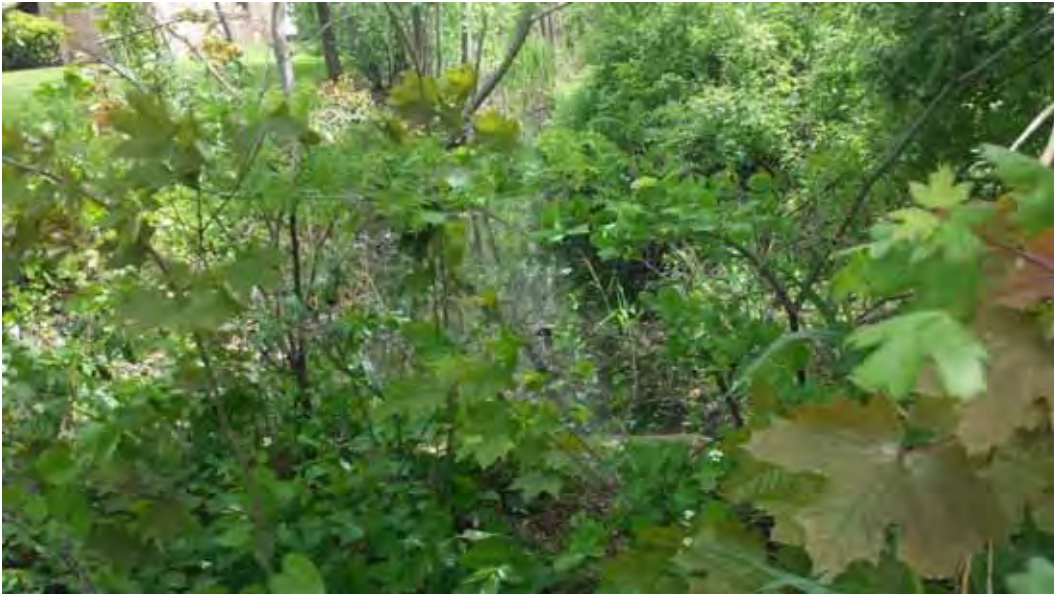
Site ID/Name: Bashes Creek Ditch System (Carlstadt) – Location #2

Site ID / Name: Bashes Creek Ditch System (Carlstadt) – Location #2
Location: Block 128 Lot 8
Description:
Date: 5/10/16 **Time of Inspection:** 2 : 00 AM/PM
Tide Conditions: (Low/High) **Time of Tide Event:** 1 : 17 AM/PM
Conditions: 68 degrees, sunny (Rain, Snow, High Wind, Cloudy, Sunny, etc.)
Inspected By: Fawzia Shapiro & Jeff Zielinski

Maintenance Required: <input type="checkbox"/> Immediate <input type="checkbox"/> Repair <input checked="" type="checkbox"/> Continued Upkeep		Other Notes:

Figure 1: Upstream view of ditch

Figure 2: Downstream view of ditch

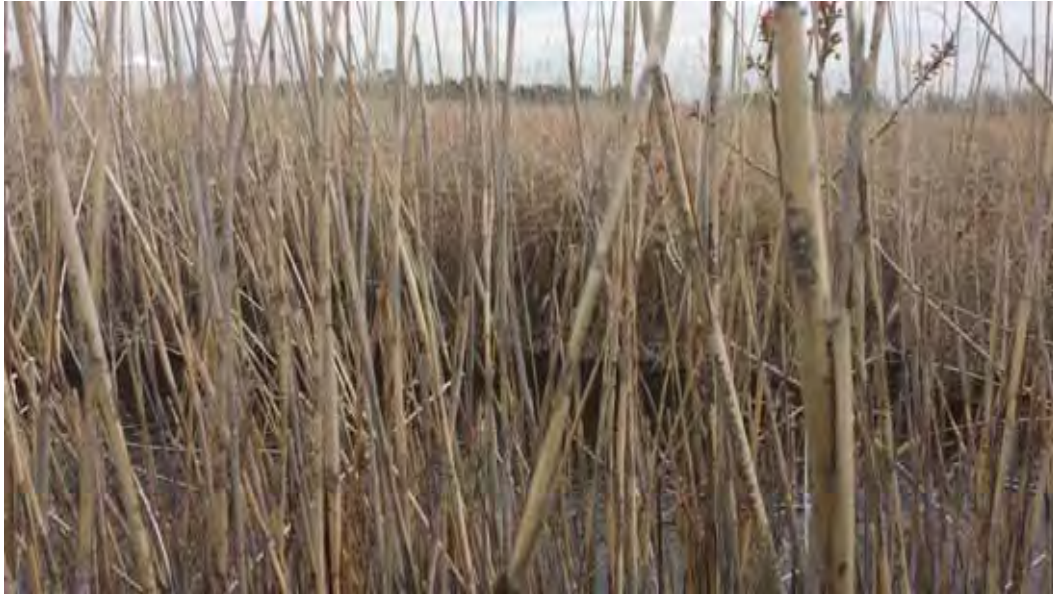
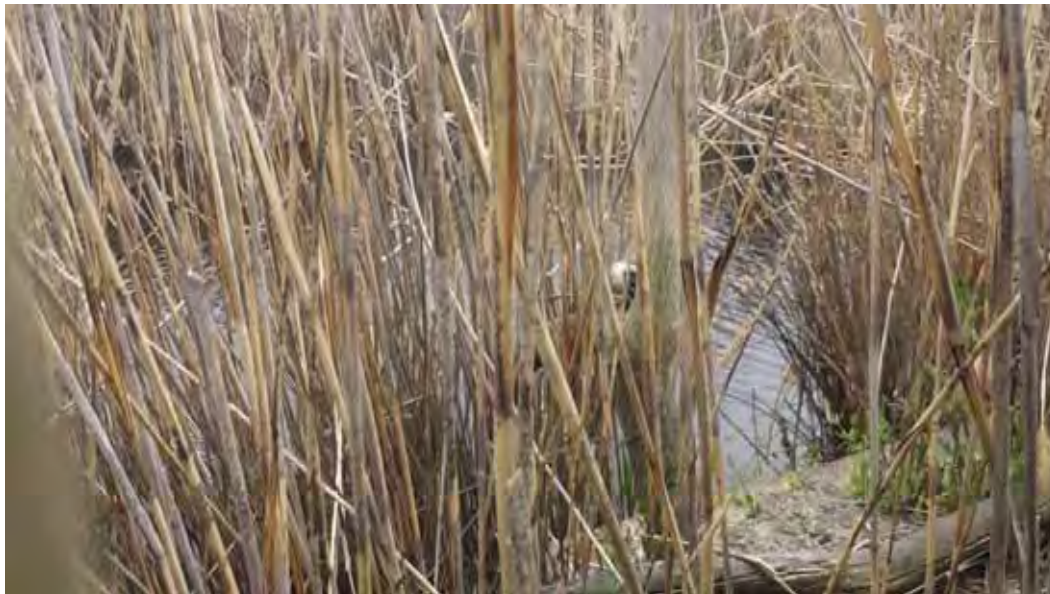
Site ID/Name: Bashes Creek Ditch System (Carlstadt) – Location #3

Site ID / Name: Bashes Creek Ditch System (Carlstadt) – Location #3
Location: Block 128 Lot 12
Description:
Date: 5/10/16 **Time of Inspection:** 2 : 10 AM/PM
Tide Conditions: (Low/High) **Time of Tide Event:** 1 : 17 AM/PM
Conditions: 68 degrees, sunny (Rain, Snow, High Wind, Cloudy, Sunny, etc.)
Inspected By: Fawzia Shapiro & Jeff Zielinski

Type of Inspection: <input checked="" type="checkbox"/> Yearly <input type="checkbox"/> Post-Storm <input type="checkbox"/> Complaint <input checked="" type="checkbox"/> Ditch <input type="checkbox"/> Tide Gate <input type="checkbox"/> Pump System		Notes on Condition/Problems: Banks are overgrown, but ditch is clear No debris Notes on Maintenance: Other Notes:
System Designation: <input checked="" type="checkbox"/> Natural Stream <input type="checkbox"/> Manmade Channel <input type="checkbox"/> Catch Basin <input type="checkbox"/> Culvert <input type="checkbox"/> Outfall <input type="checkbox"/> Other:		
Overall Functionality: <input checked="" type="checkbox"/> Fully Functional <input type="checkbox"/> Functional with Restrictions <input type="checkbox"/> Non-Functional <input type="checkbox"/> High Tide <input type="checkbox"/> Low Tide		
Maintenance Required: <input type="checkbox"/> Immediate <input type="checkbox"/> Repair <input checked="" type="checkbox"/> Continued Upkeep

Figure 1: Upstream view of ditch

Figure 2: Downstream view of ditch

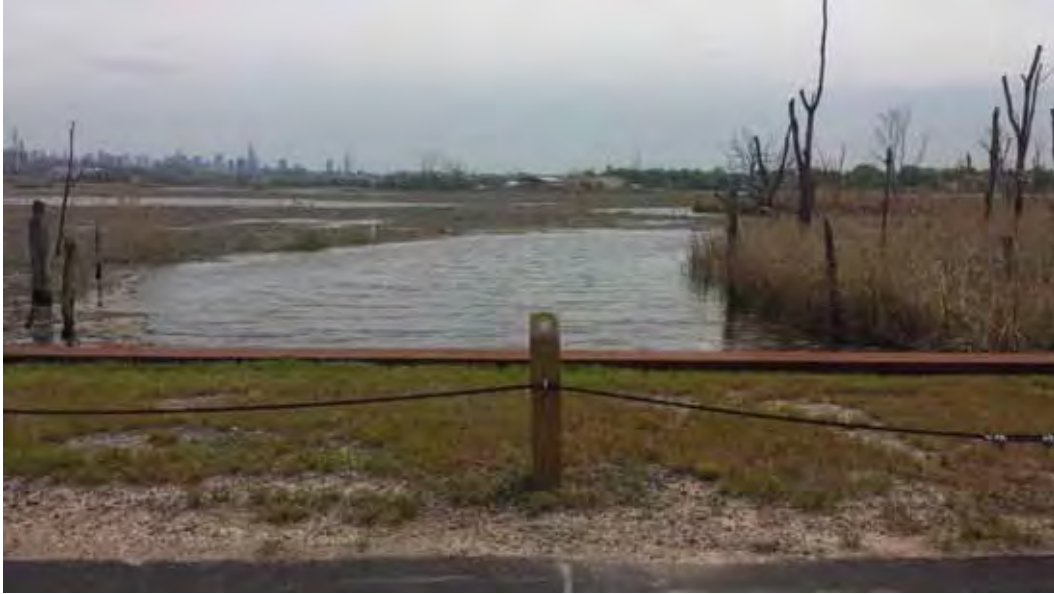
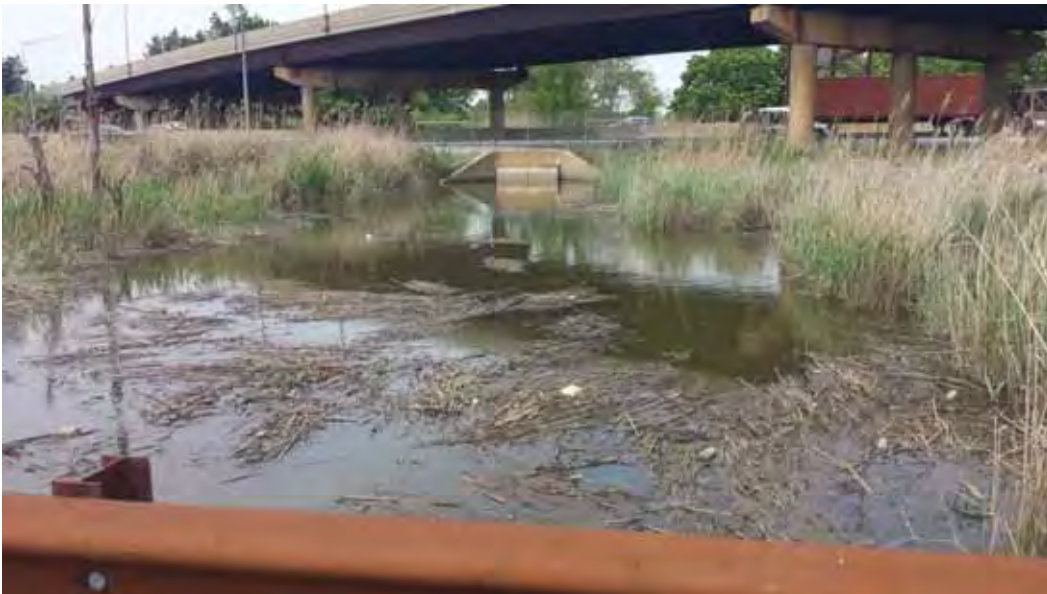
Site ID/Name: Bashes Creek Ditch System (Carlstadt) – Location #4

Site ID / Name: Bashes Creek Ditch System (Carlstadt) – Location #4
Location: Block 137 Lot 2
Description: Bashes Creek Tide Gate
Date: 5/10/16 **Time of Inspection:** 1 : 15 AM/PM
Tide Conditions: (Low/High) **Time of Tide Event:** 1 : 17 AM/PM
Conditions: 68 degrees, sunny (Rain, Snow, High Wind, Cloudy, Sunny, etc.)
Inspected By: Fawzia Shapiro & Jeff Zielinski

Maintenance Required: <input type="checkbox"/> Immediate <input type="checkbox"/> Repair <input checked="" type="checkbox"/> Continued Upkeep	Other Notes:

Figure 1: Downstream view from bridge

Figure 2: Upstream view of tide gate from bridge

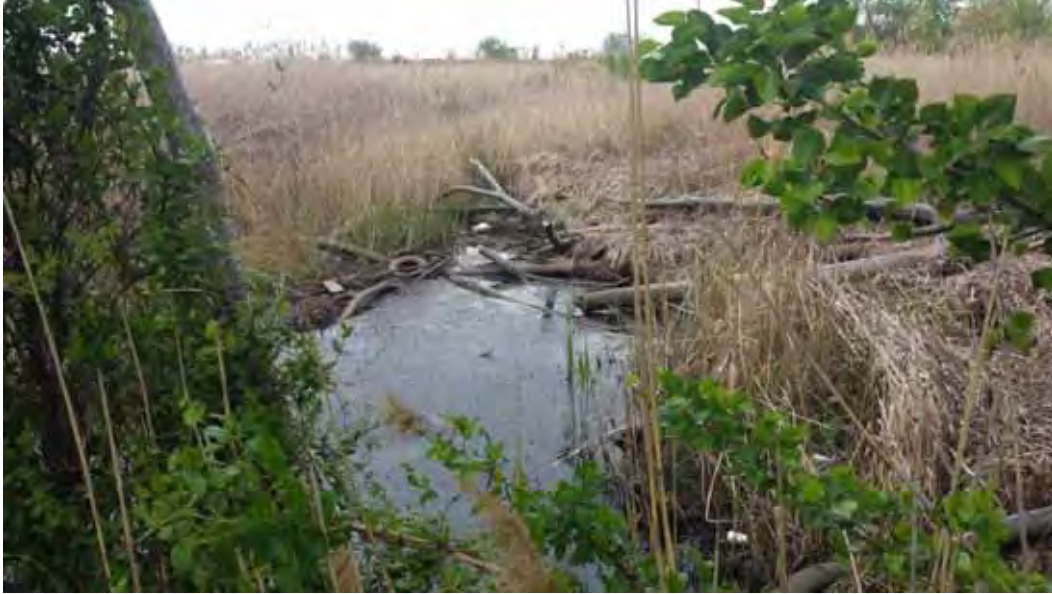
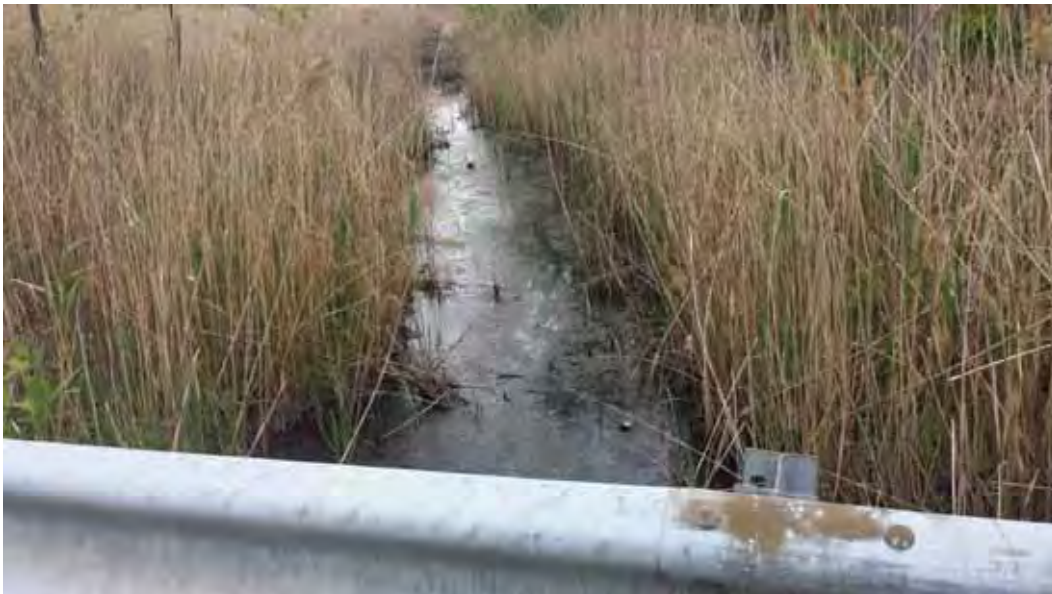
Site ID/Name: Moonachie Creek Ditch System (Carlstadt) – Location #1

Site ID / Name: Moonachie Creek Ditch System (Carlstadt) – Location #1
Location: Block 131 Lot 6
Description:
Date: 5/10/16 **Time of Inspection:** 2 : 40 AM/PM
Tide Conditions: (Low/High) **Time of Tide Event:** 1 : 17 AM/PM
Conditions: 68 degrees, sunny (Rain, Snow, High Wind, Cloudy, Sunny, etc.)
Inspected By: Fawzia Shapiro & Jeff Zielinski

Type of Inspection: <input checked="" type="checkbox"/> Yearly <input type="checkbox"/> Post-Storm <input type="checkbox"/> Complaint <input checked="" type="checkbox"/> Ditch <input type="checkbox"/> Tide Gate <input type="checkbox"/> Pump System		Notes on Condition/Problems: Upstream - Ditch is clear Downstream - Large tree limbs in ditch, but not impeding flow
System Designation: <input checked="" type="checkbox"/> Natural Stream <input type="checkbox"/> Manmade Channel <input type="checkbox"/> Catch Basin <input checked="" type="checkbox"/> Culvert <input type="checkbox"/> Outfall <input type="checkbox"/> Other:		Notes on Maintenance:
Overall Functionality: <input type="checkbox"/> Fully Functional <input checked="" type="checkbox"/> Functional with Restrictions <input type="checkbox"/> Non-Functional <input type="checkbox"/> High Tide <input type="checkbox"/> Low Tide		Other Notes:
Maintenance Required: <input type="checkbox"/> Immediate <input type="checkbox"/> Repair <input checked="" type="checkbox"/> Continued Upkeep

Figure 1: Downstream view of ditch

Figure 2: Upstream view of ditch

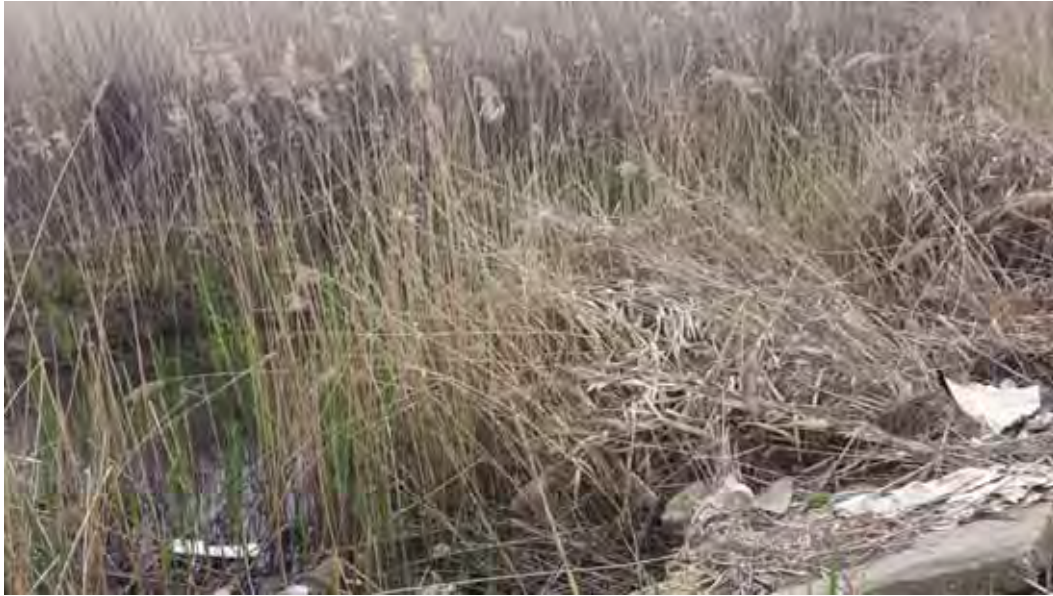
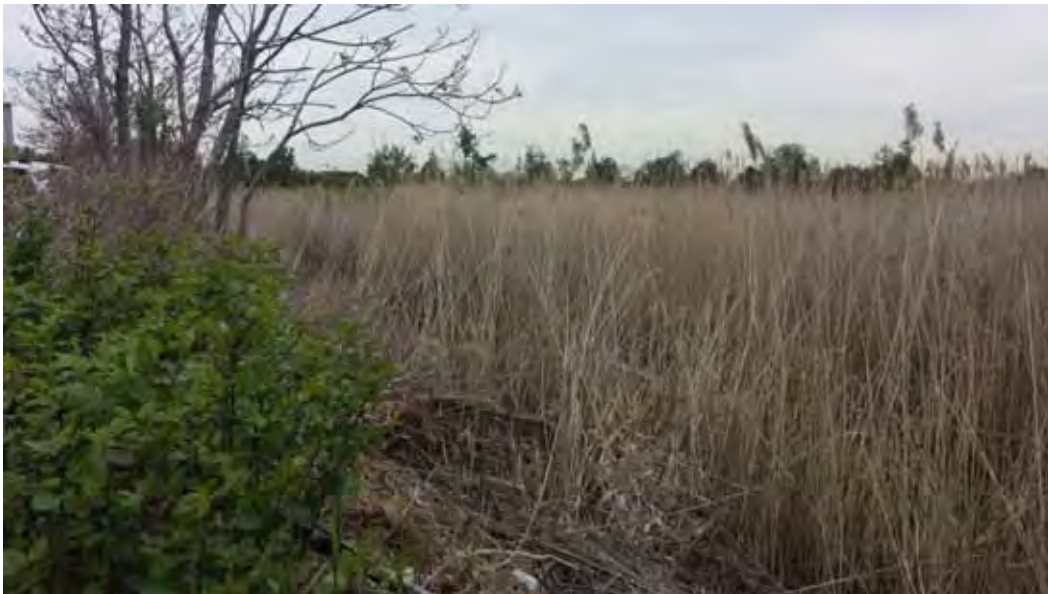
Site ID/Name: Moonachie Creek Ditch System (Carlstadt) – Location #2

Site ID / Name:	Moonachie Creek Ditch System (Carlstadt) – Location #2				
Location:	Block 131	Lot 4			
Description:					
Date:	5/10/16	Time of Inspection:	2	:	30 AM/PM
Tide Conditions:	(Low/High)	Time of Tide Event:	1	:	17 AM/PM
Conditions:	68 degrees, sunny	(Rain, Snow, High Wind, Cloudy, Sunny, etc.)			
Inspected By:	Fawzia Shapiro & Jeff Zielinski

Figure 1: Upstream view of ditch

Figure 2: Downstream view of ditch

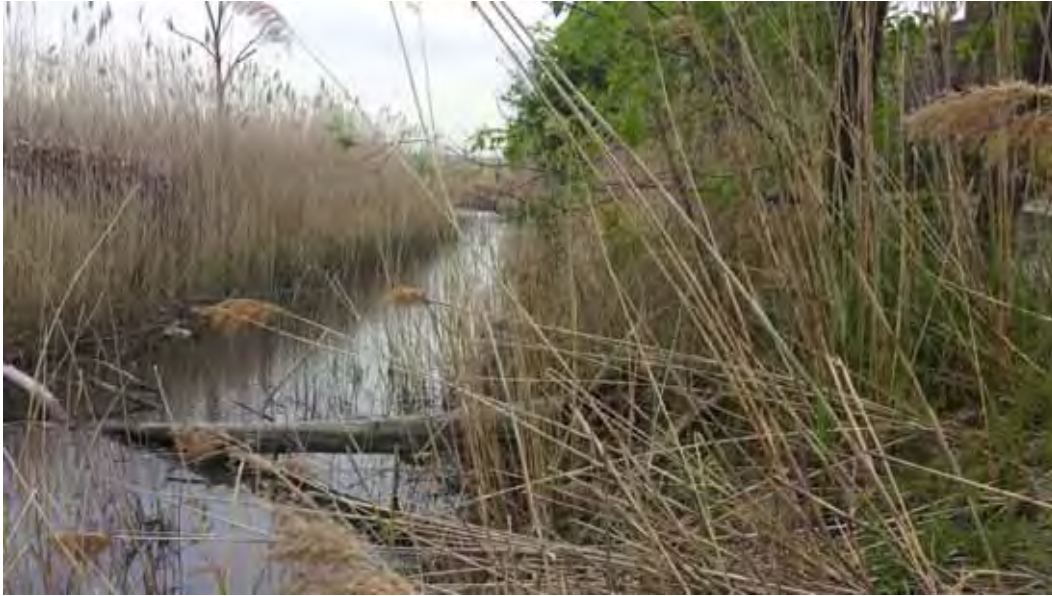
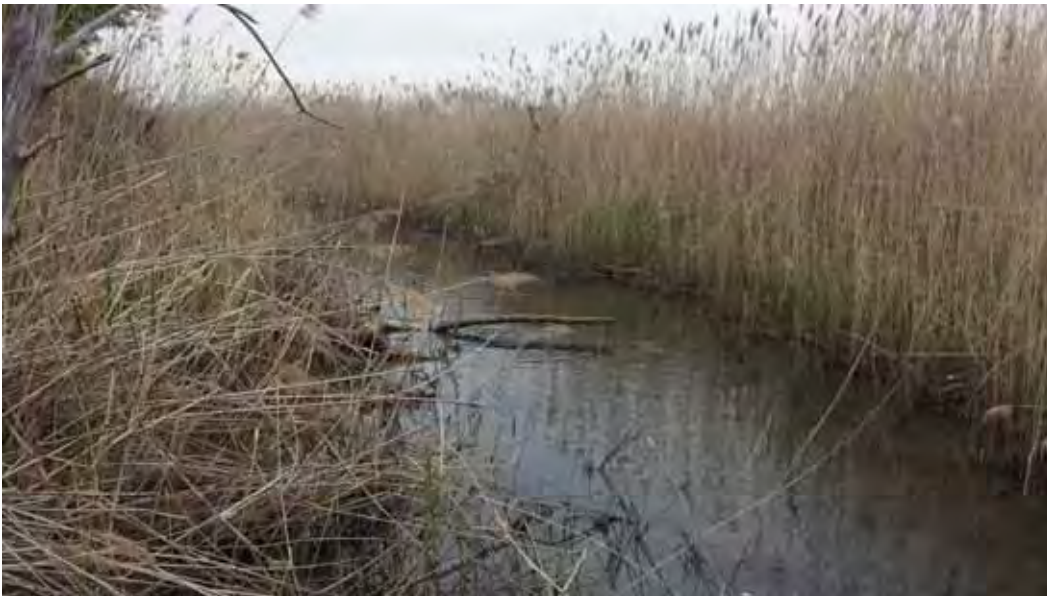
Site ID/Name: Moonachie Creek Ditch System (Carlstadt) – Location #3

Figure 1: Upstream view of ditch

Figure 2: Downstream view of ditch

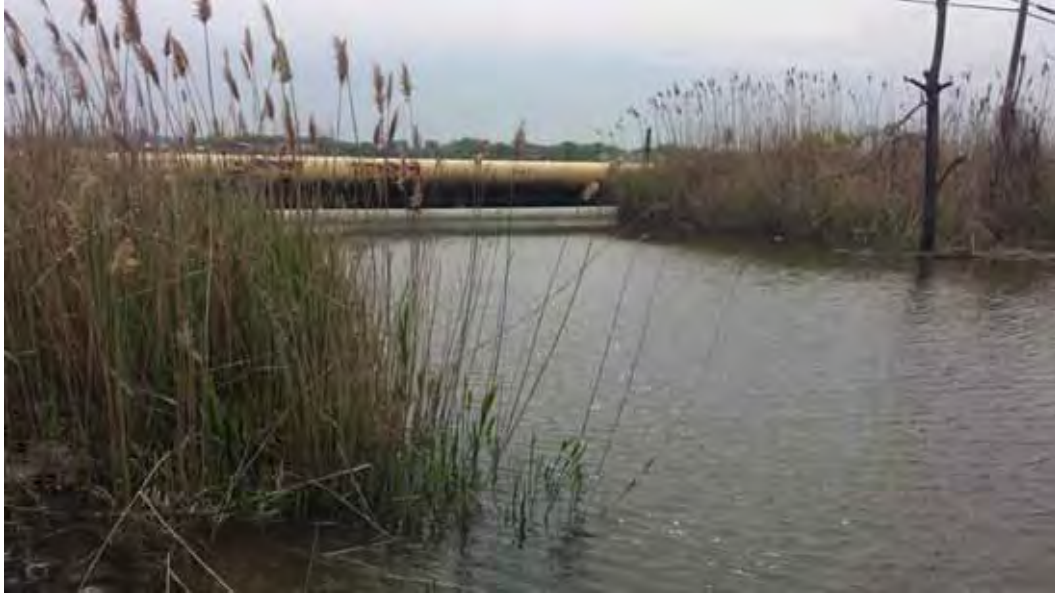
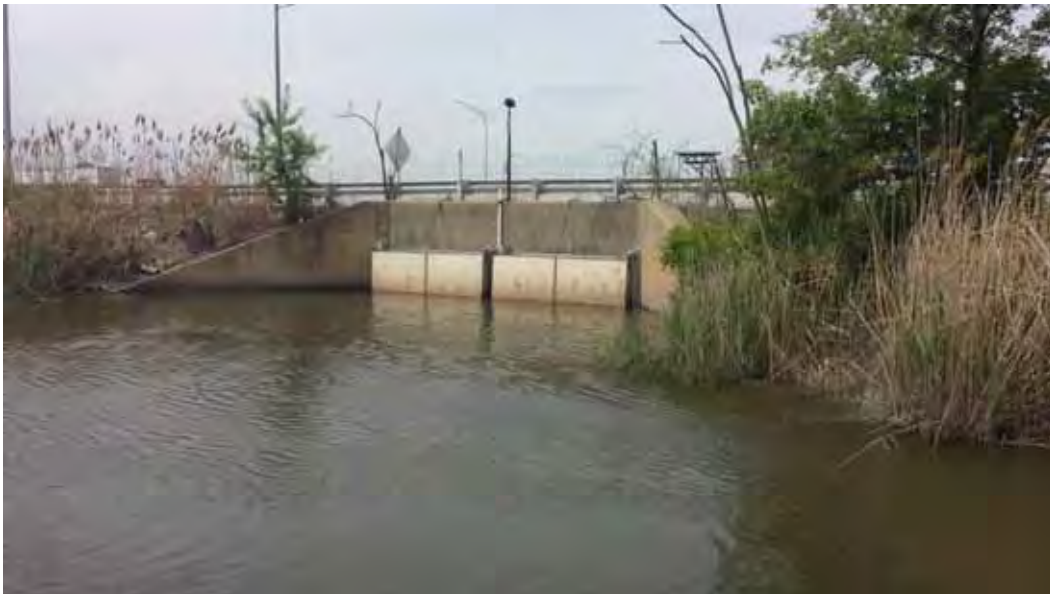
Site ID/Name: Moonachie Creek Ditch System (Carlstadt) – Location #4

Site ID / Name: Moonachie Creek Ditch System (Carlstadt) – Location #4
Location: Block 128 Lot 20
Description: Upper Moonachie Creek Tide Gate
Date: 5/10/16 **Time of Inspection:** 1 : 00 AM/PM
Tide Conditions: (Low/High) **Time of Tide Event:** 1 : 17 AM/PM
Conditions: 68 degrees, sunny (Rain, Snow, High Wind, Cloudy, Sunny, etc.)
Inspected By: Fawzia Shapiro & Jeff Zielinski

Type of Inspection: <input checked="" type="checkbox"/> Yearly <input type="checkbox"/> Post-Storm <input type="checkbox"/> Complaint <input checked="" type="checkbox"/> Ditch <input checked="" type="checkbox"/> Tide Gate <input type="checkbox"/> Pump System		Notes on Condition/Problems: Ditch is clear No debris Tide gate is fully functional
System Designation: <input checked="" type="checkbox"/> Natural Stream <input type="checkbox"/> Manmade Channel <input type="checkbox"/> Catch Basin <input type="checkbox"/> Culvert <input type="checkbox"/> Outfall <input type="checkbox"/> Other:		Notes on Maintenance:
Overall Functionality: <input checked="" type="checkbox"/> Fully Functional <input type="checkbox"/> Functional with Restrictions <input type="checkbox"/> Non-Functional <input type="checkbox"/> High Tide <input type="checkbox"/> Low Tide		
Maintenance Required: <input type="checkbox"/> Immediate <input type="checkbox"/> Repair <input checked="" type="checkbox"/> Continued Upkeep		Other Notes:

Figure 1: Downstream view from tide gate

Figure 2: Upstream view of tide gate

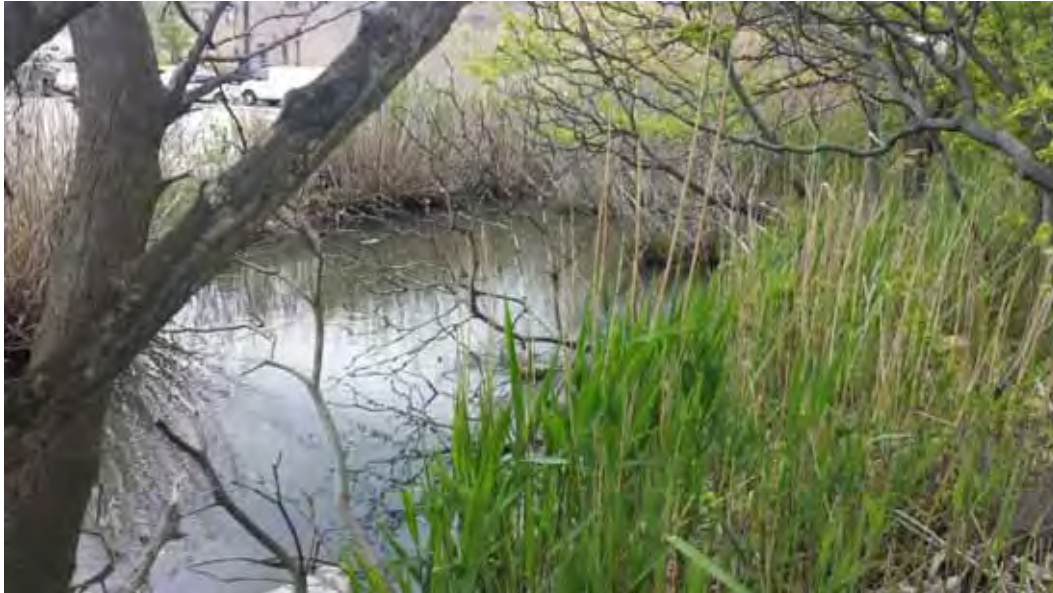
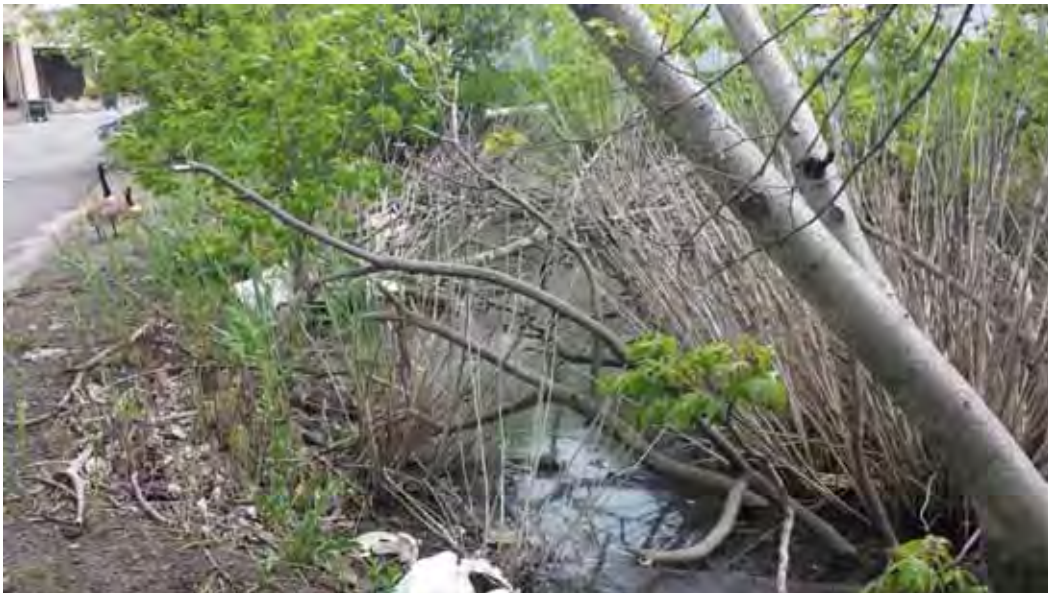
Figure 1: Upstream view of ditch

Figure 2: Downstream view of ditch
