New Jersey Sports & Exposition Authority Drainage Ditch Inspection Report

**The National Flood Insurance Program
Community Rating System**

The New Jersey Sports and Exposition Authority

December 7, 2016

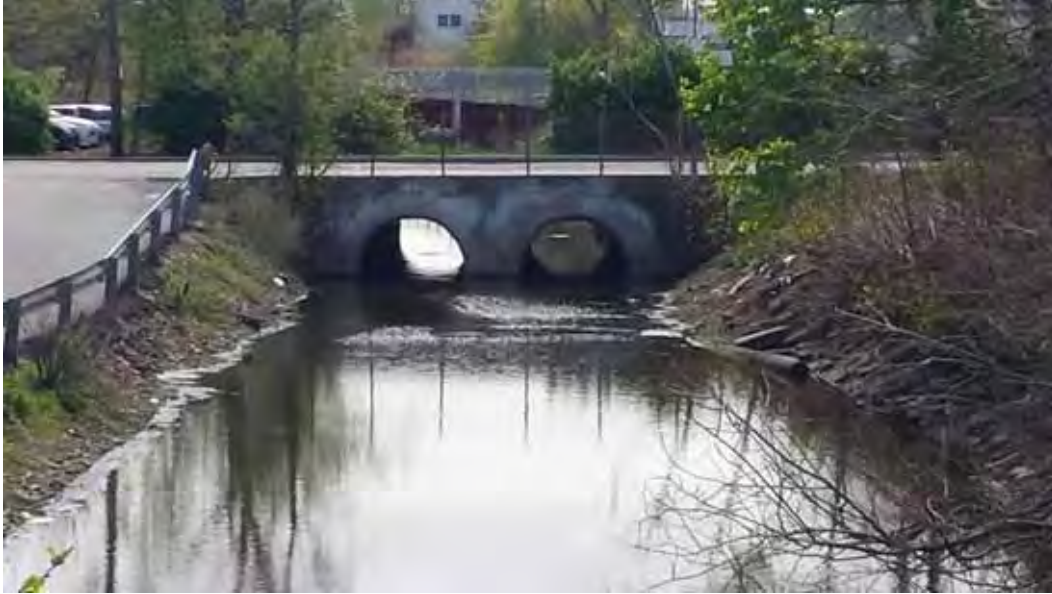
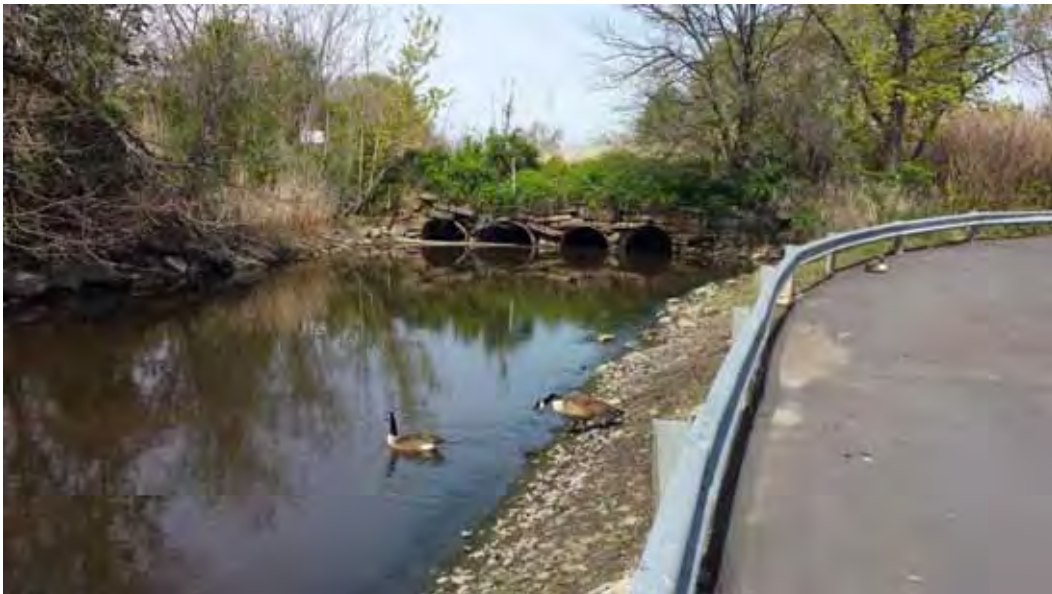
Site ID/Name: Peach Island Creek (Carlstadt) – Location #1

Figure 1: Upstream view of ditch

Figure 2: Downstream view of ditch

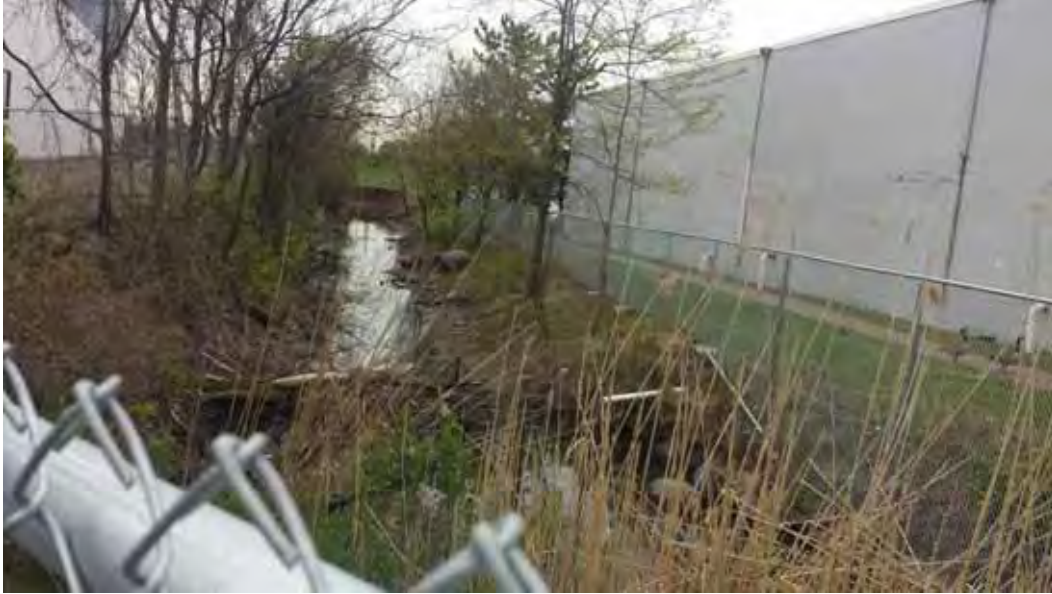
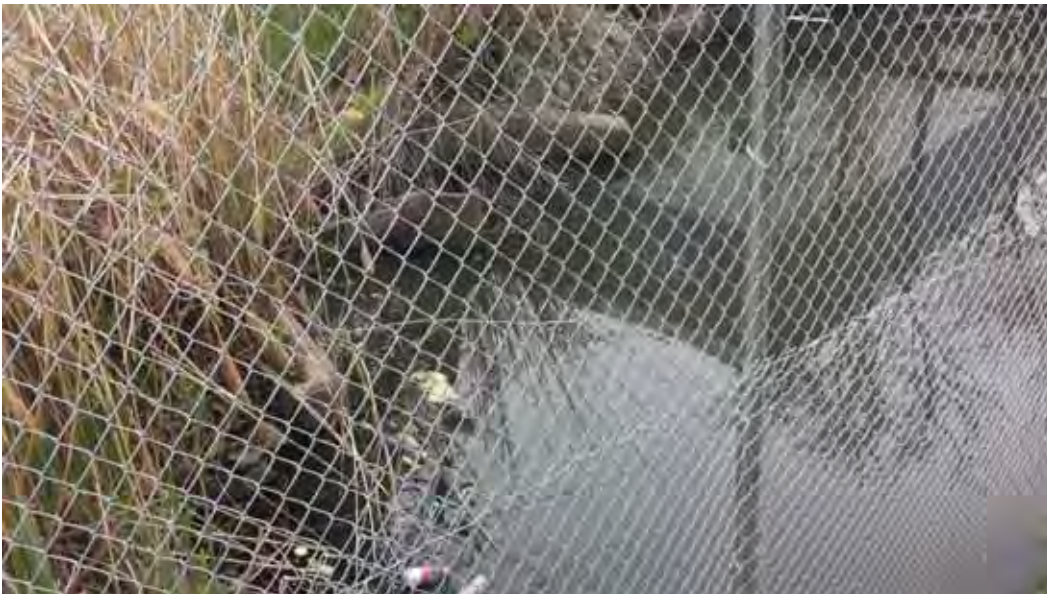
Site ID/Name: Peach Island Creek (Carlstadt) – Location #2

Figure 1: Upstream view of ditch

Figure 2: Downstream view of tide gate

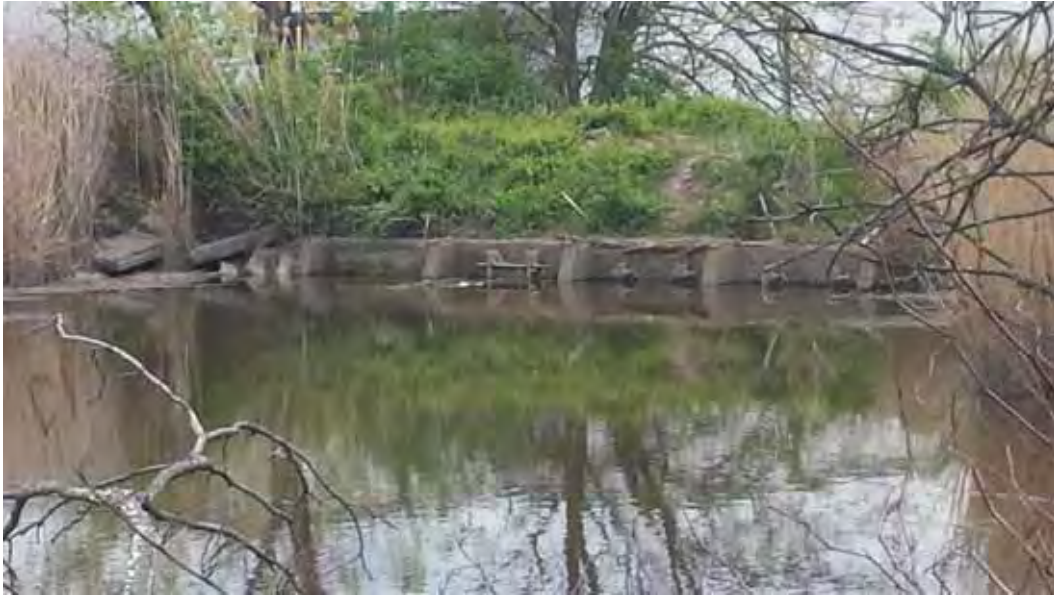
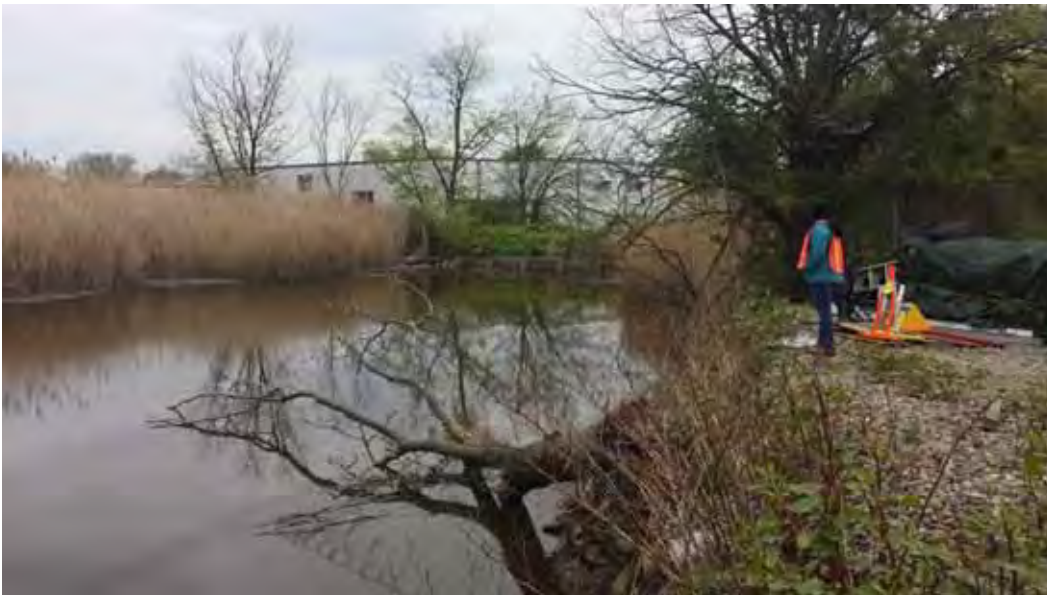
Site ID/Name: Peach Island Creek (Carlstadt) – Location #3

Figure 1: Upstream view of ditch at tide gate

Figure 2: Downstream view of ditch

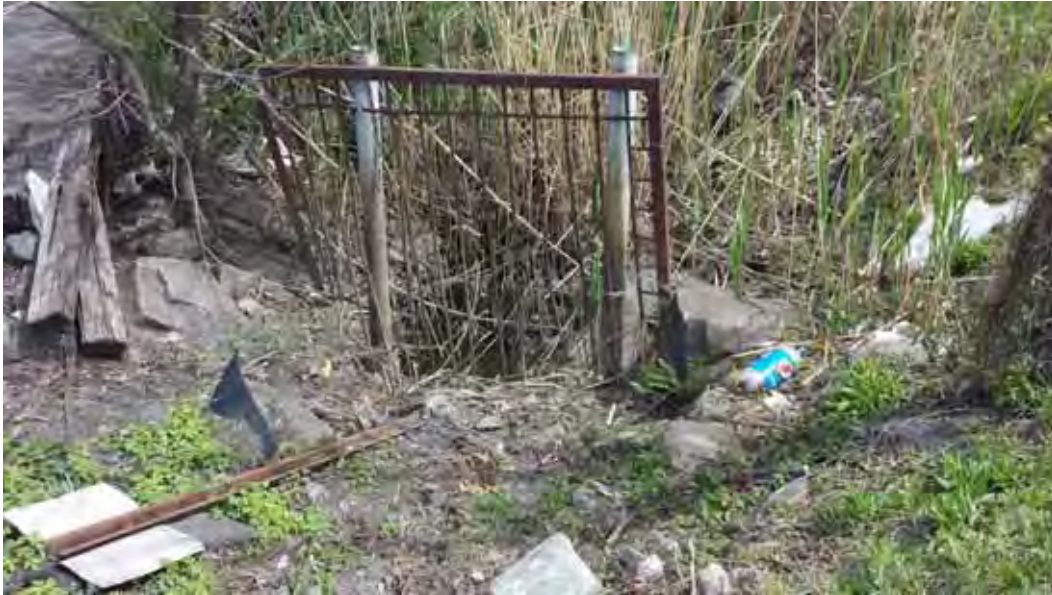
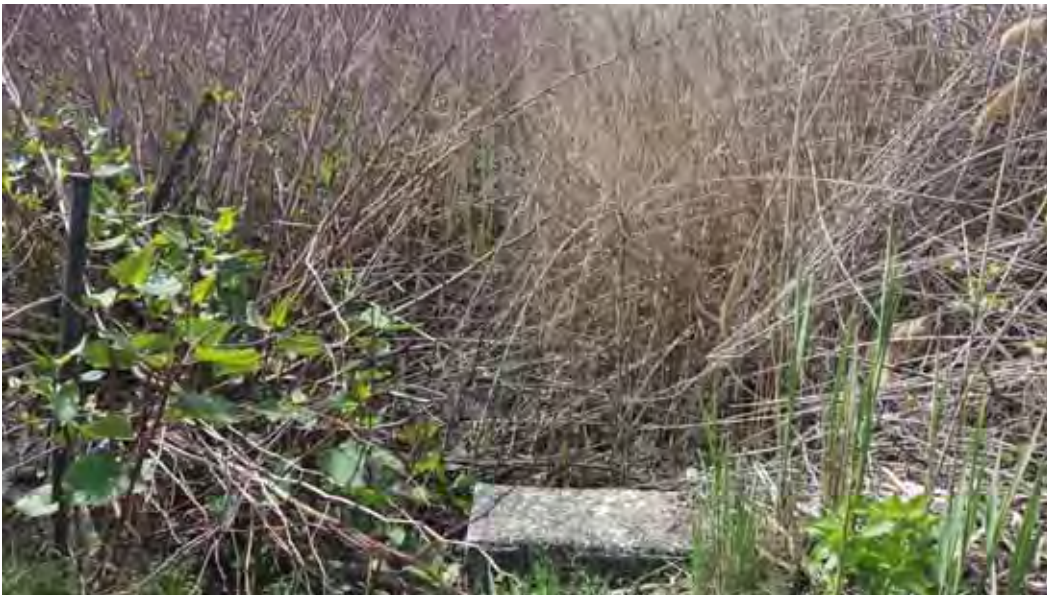
Site ID/Name: Peach Island Creek (Carlstadt) – Location #4

Figure 1: Upstream view of ditch

Figure 2: Downstream view of ditch

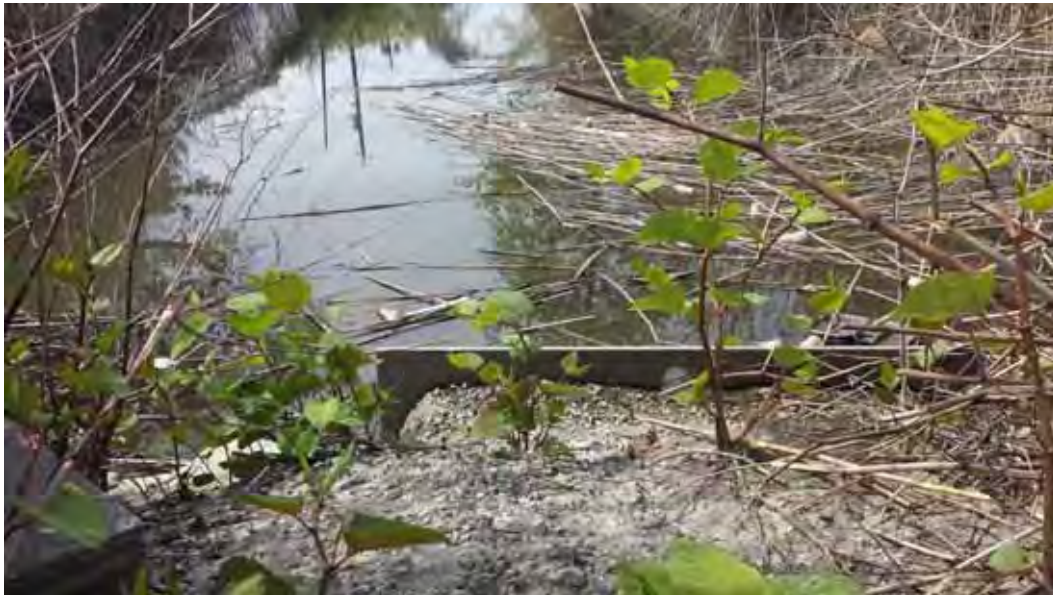
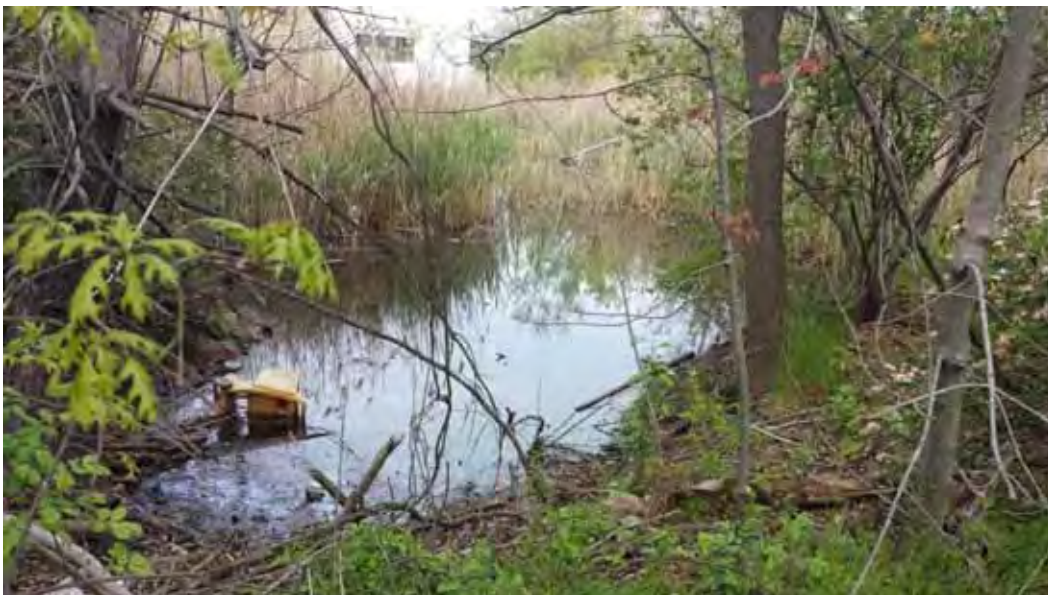
Site ID/Name: Peach Island Creek (Carlstadt) – Location #5

Figure 1: Upstream view of ditch at culvert

Figure 2: Downstream view of ditch

Type of Inspection:		Notes on Condition/Problems:
<input checked="" type="checkbox"/> Yearly	<input checked="" type="checkbox"/> Ditch	Ditch is clear
<input type="checkbox"/> Post-Storm	<input type="checkbox"/> Tide Gate	Natural stream bottom variations
<input type="checkbox"/> Complaint	<input type="checkbox"/> Pump System	Box culvert
System Designation:		
<input checked="" type="checkbox"/> Natural Stream	<input checked="" type="checkbox"/> Culvert	
<input type="checkbox"/> Manmade Channel	<input type="checkbox"/> Outfall	
<input type="checkbox"/> Catch Basin	<input type="checkbox"/> Other: _____	
Overall Functionality:		Notes on Maintenance:
<input checked="" type="checkbox"/> Fully Functional	<input type="checkbox"/> High Tide	
<input type="checkbox"/> Functional with Restrictions	<input type="checkbox"/> Low Tide	
<input type="checkbox"/> Non-Functional		
Maintenance Required:		
<input type="checkbox"/> Immediate		Other Notes:

<input type="checkbox"/> Repair		
<input checked="" type="checkbox"/> Continued Upkeep

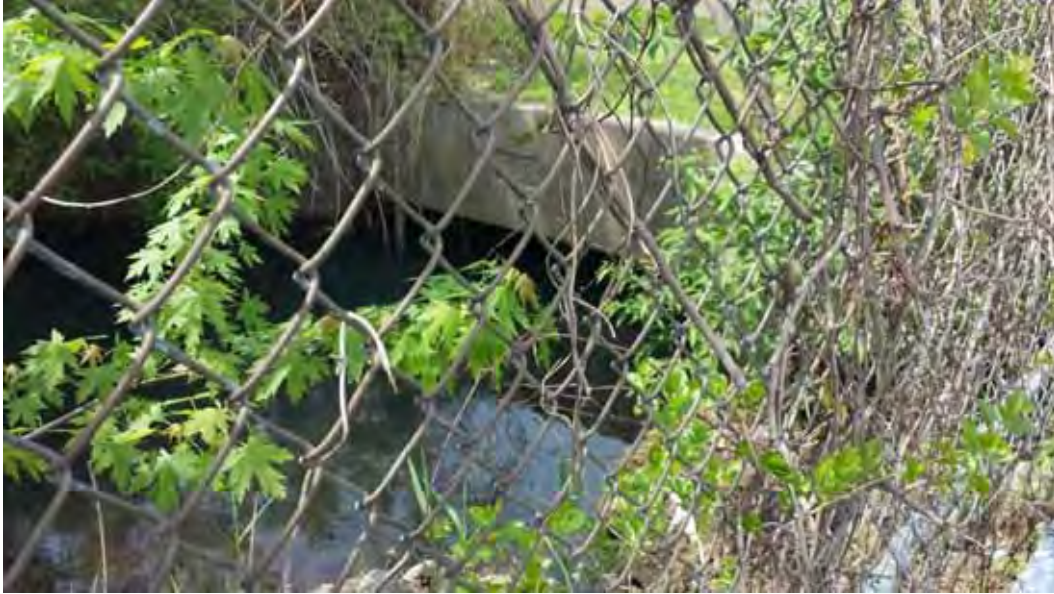
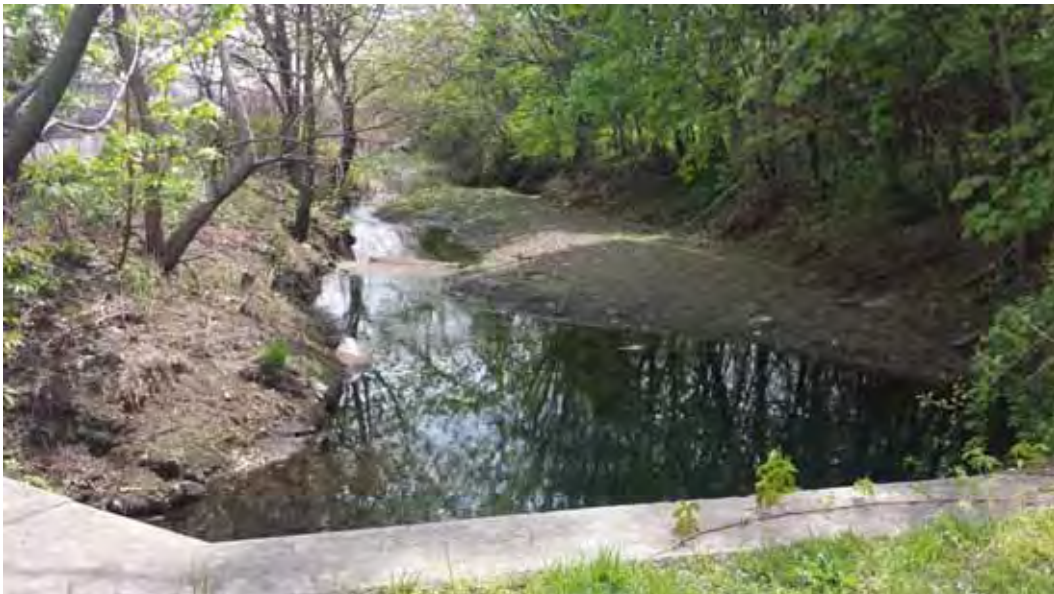
Site ID/Name: East Rutherford Ditch (East Rutherford) – Location #1

Figure 1: Upstream view of ditch at culvert

Figure 2: Downstream view of ditch

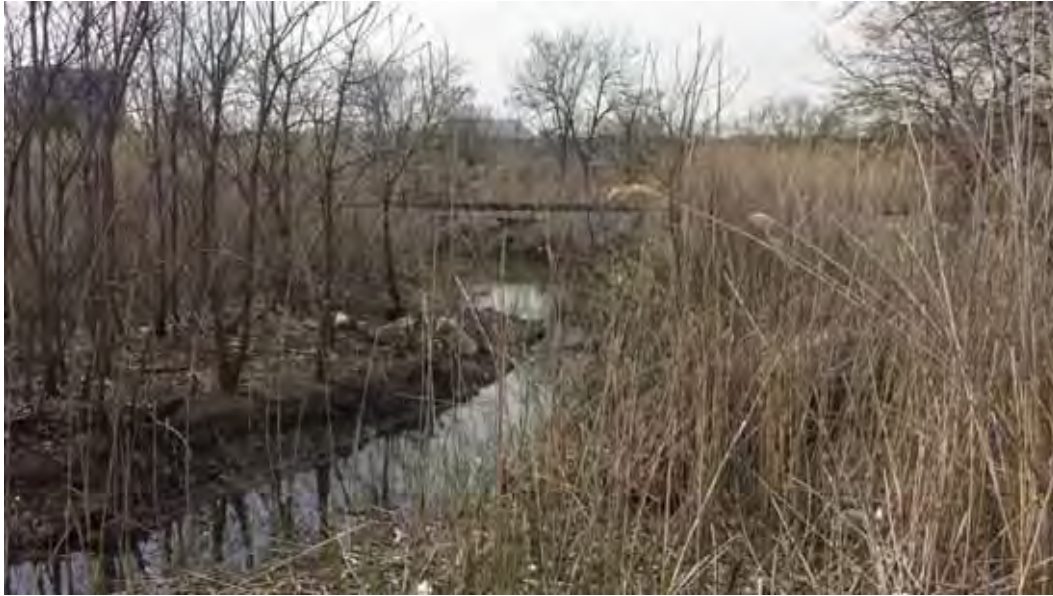
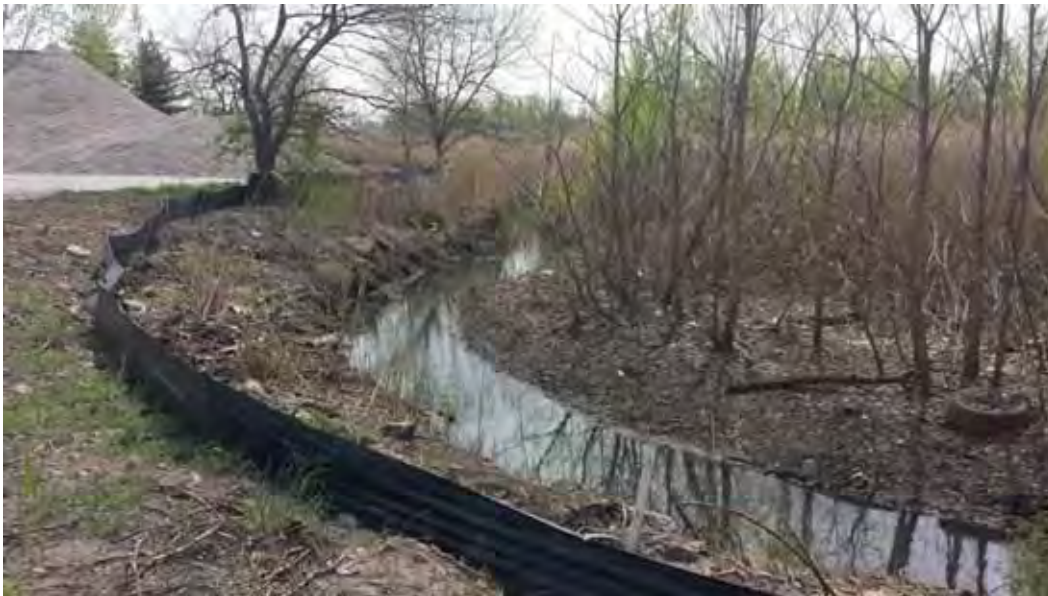
Site ID/Name: East Rutherford Ditch (East Rutherford) – Location #2

Figure 1: Upstream view of ditch

Figure 2: Downstream view of ditch

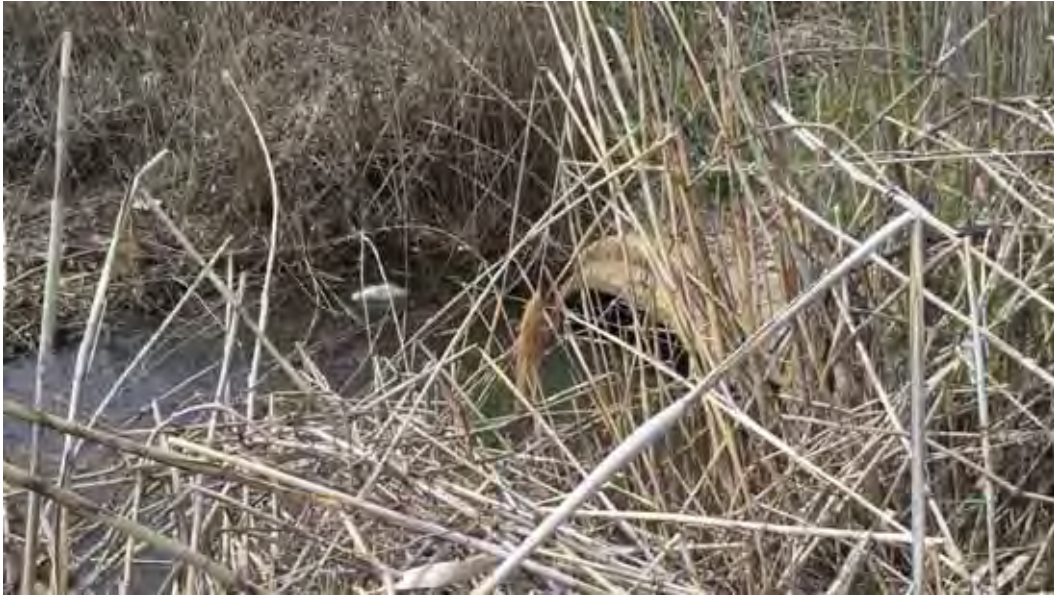
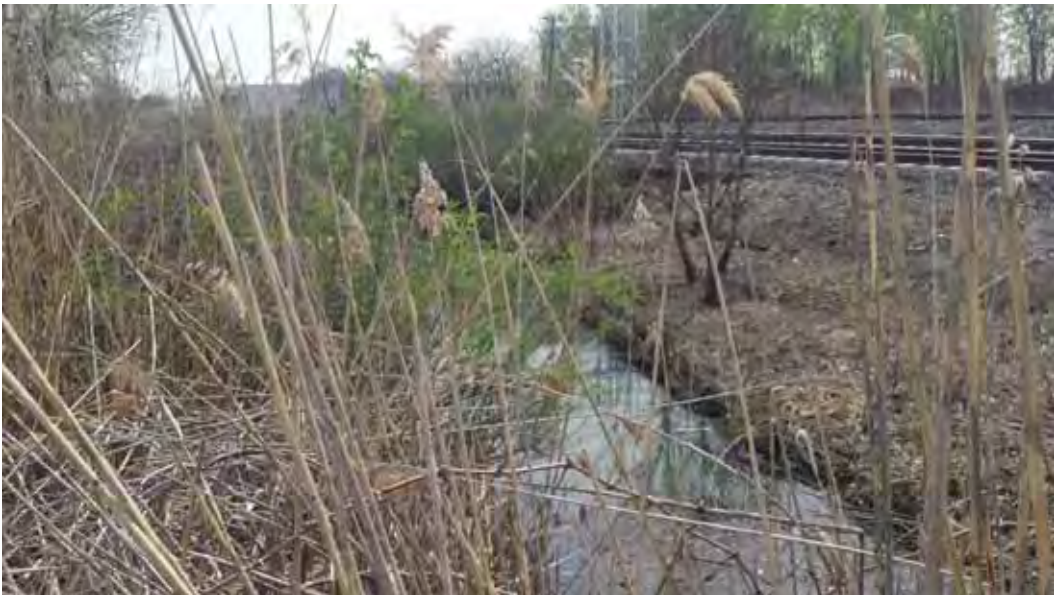
Site ID/Name: East Rutherford Ditch (East Rutherford) – Location #3

Figure 1: Upstream view of culvert

Figure 2: Downstream view of ditch at culvert

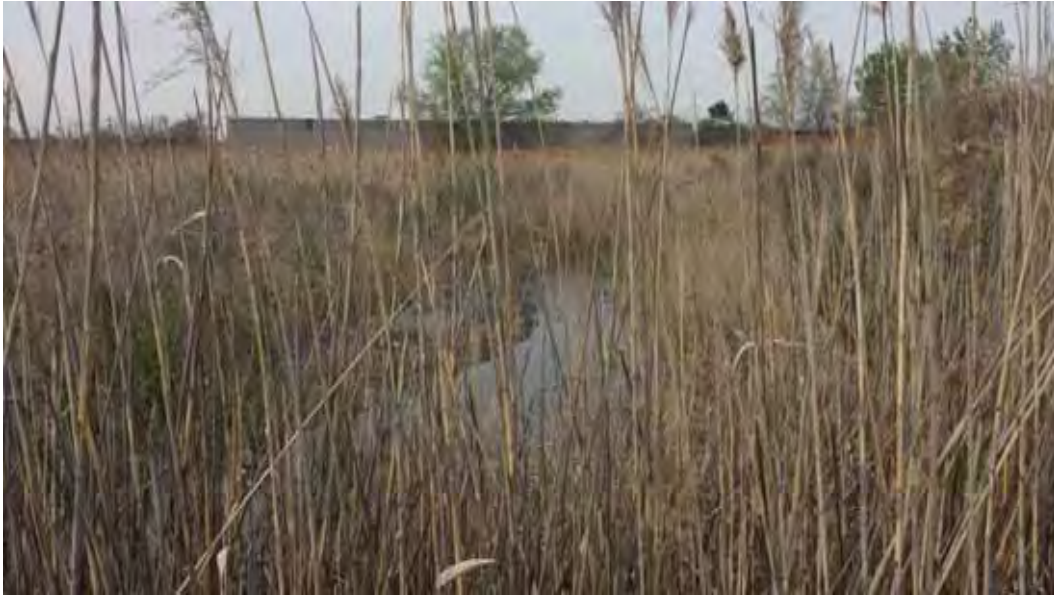
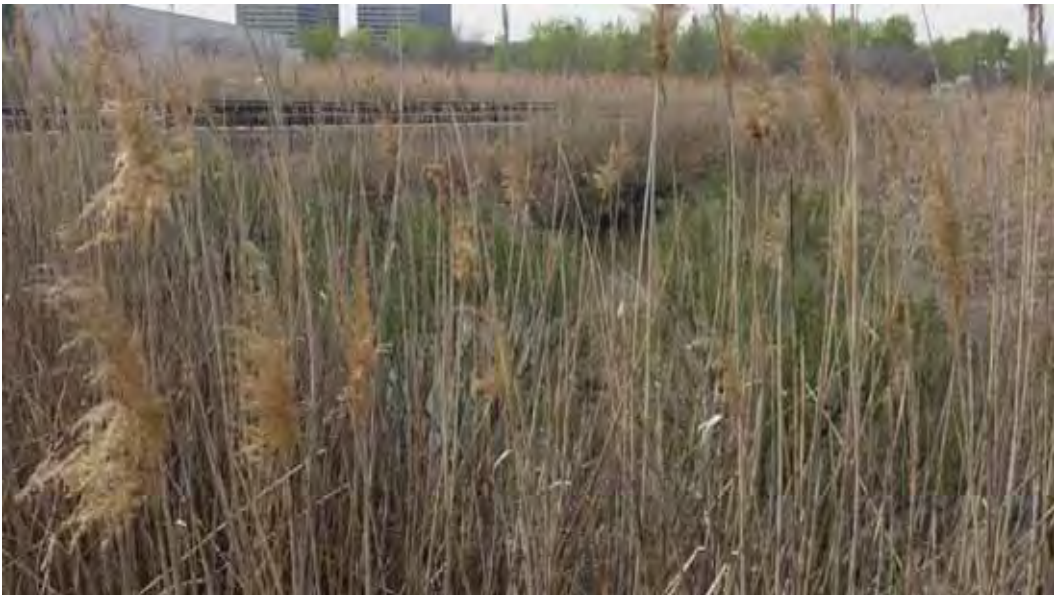
Site ID/Name: East Rutherford Ditch (East Rutherford) – Location #4

Figure 1: Upstream view of ditch

Figure 2: Downstream view of ditch

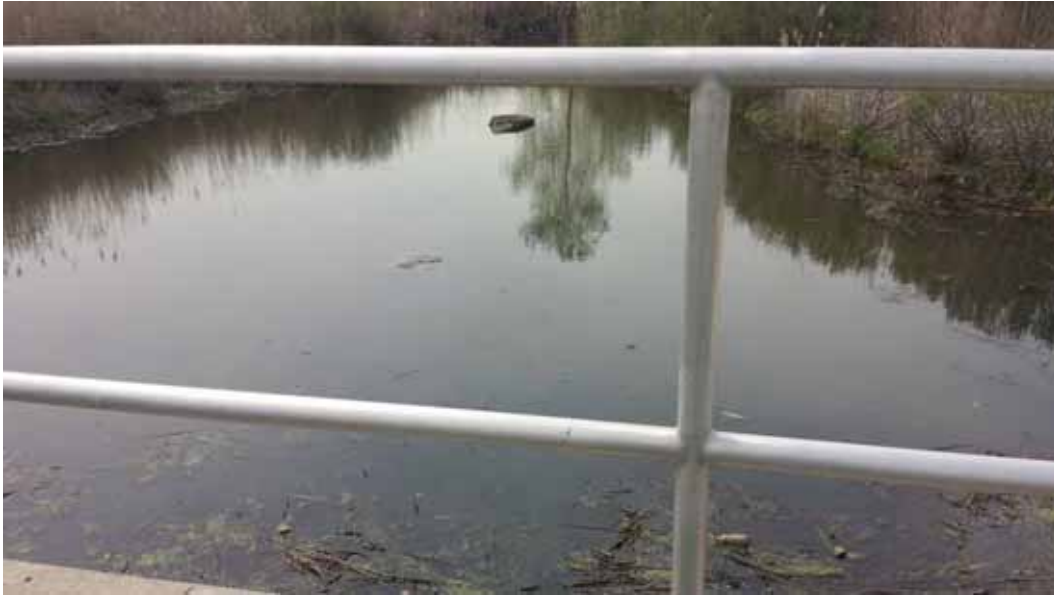
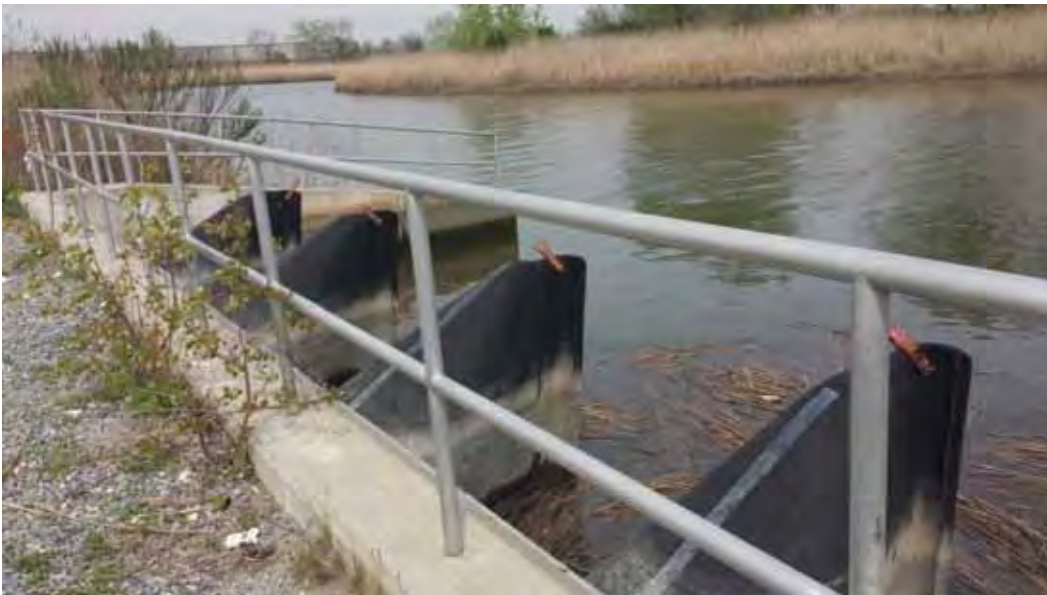
Site ID/Name: East Rutherford Ditch (East Rutherford) – Location #5

Figure 1: Upstream view of ditch at tide gate

Figure 2: Downstream view of tide gate

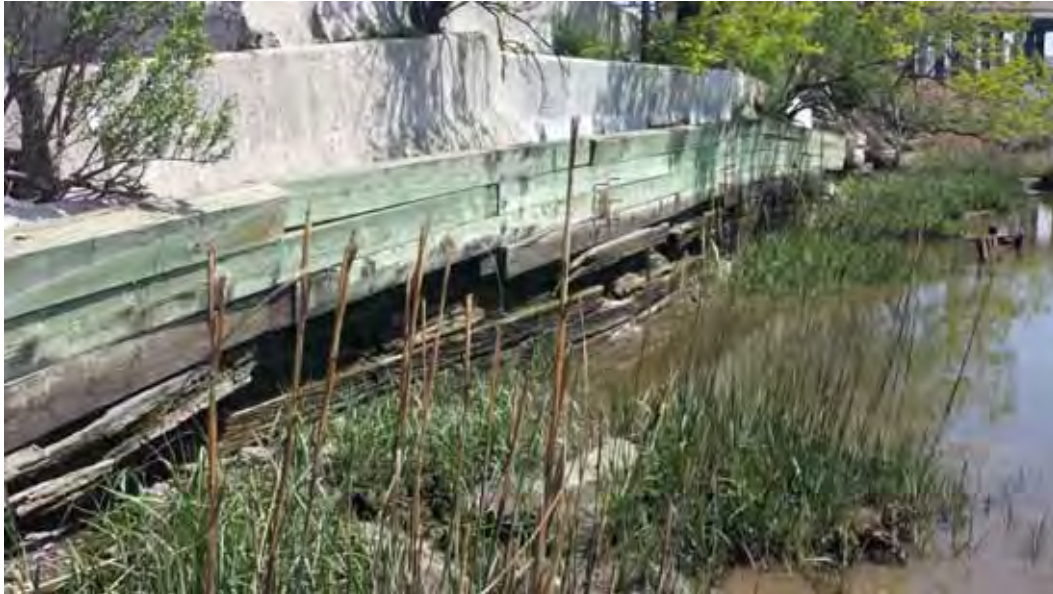
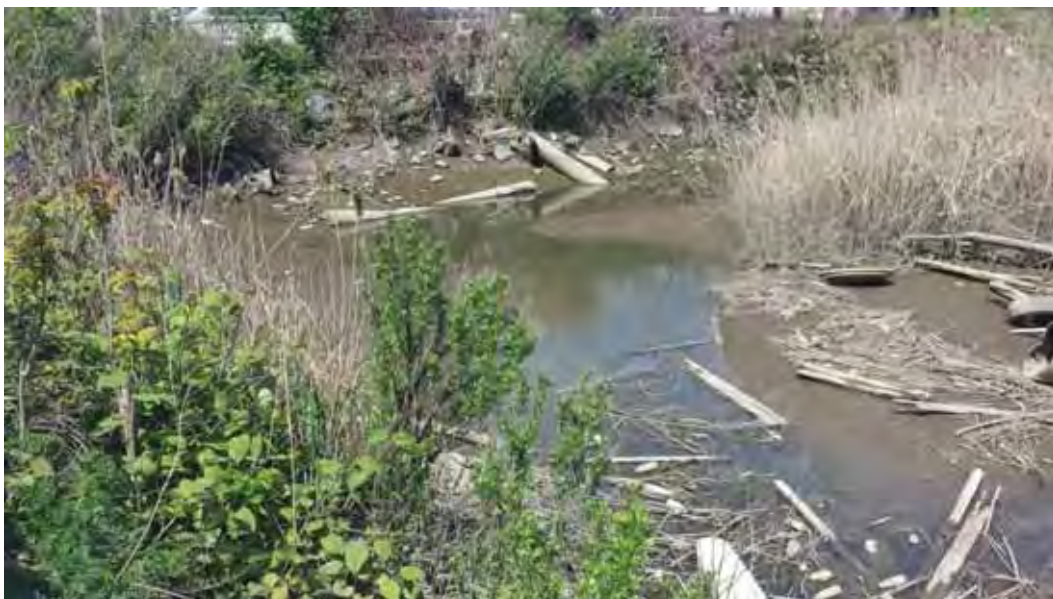
Site ID/Name: Belezza Ditch System (Kearny) – Location #1

Figure 1: Downstream view of tide gate location

Figure 2: Upstream view of ditch

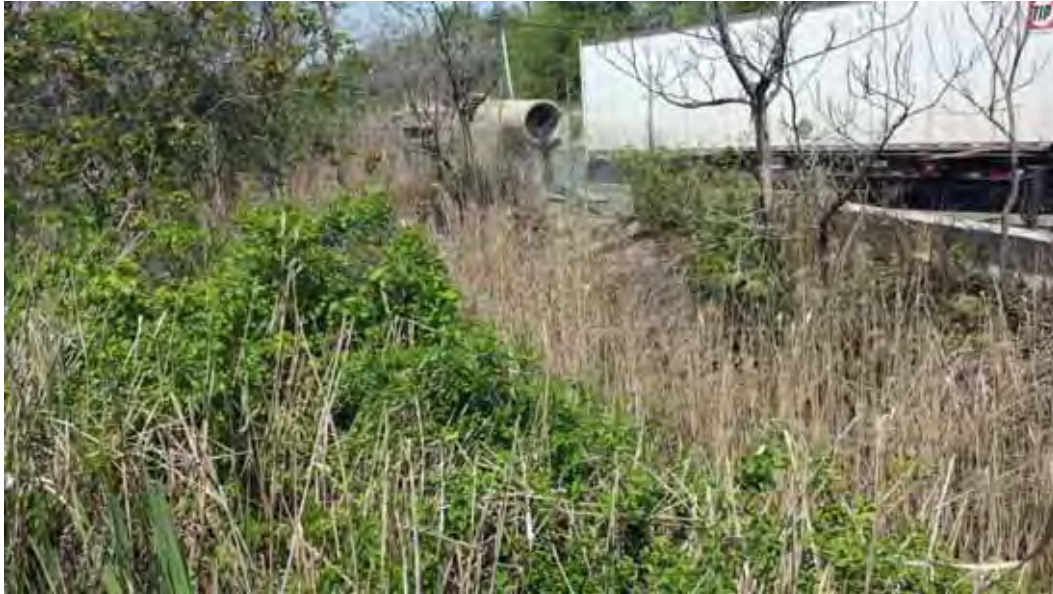
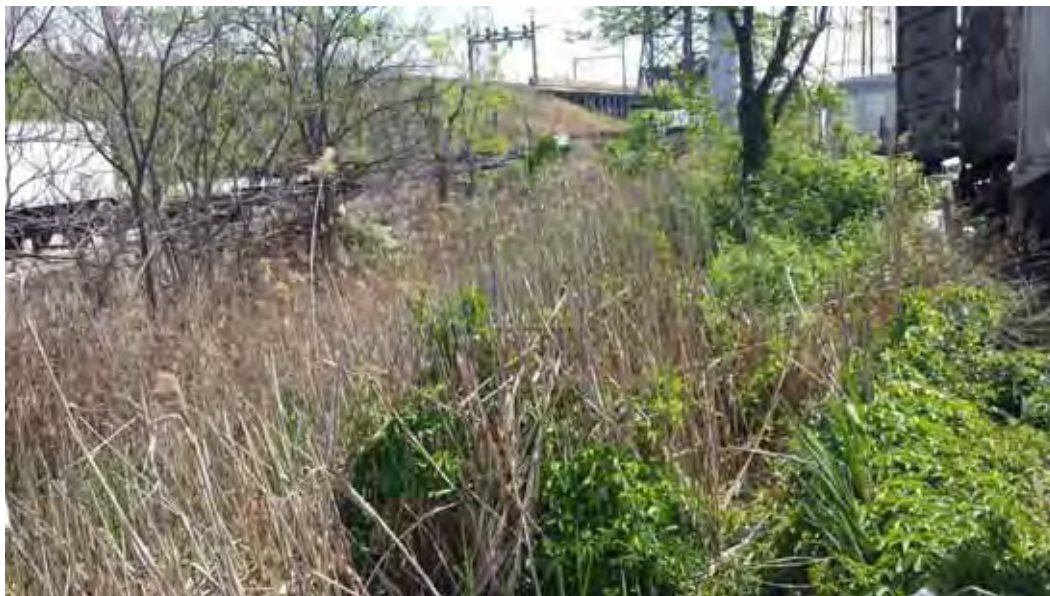
Site ID/Name: Belezza Ditch System (Kearny) – Location #2

Figure 1: Upstream view of ditch

Figure 2: Downstream view of ditch

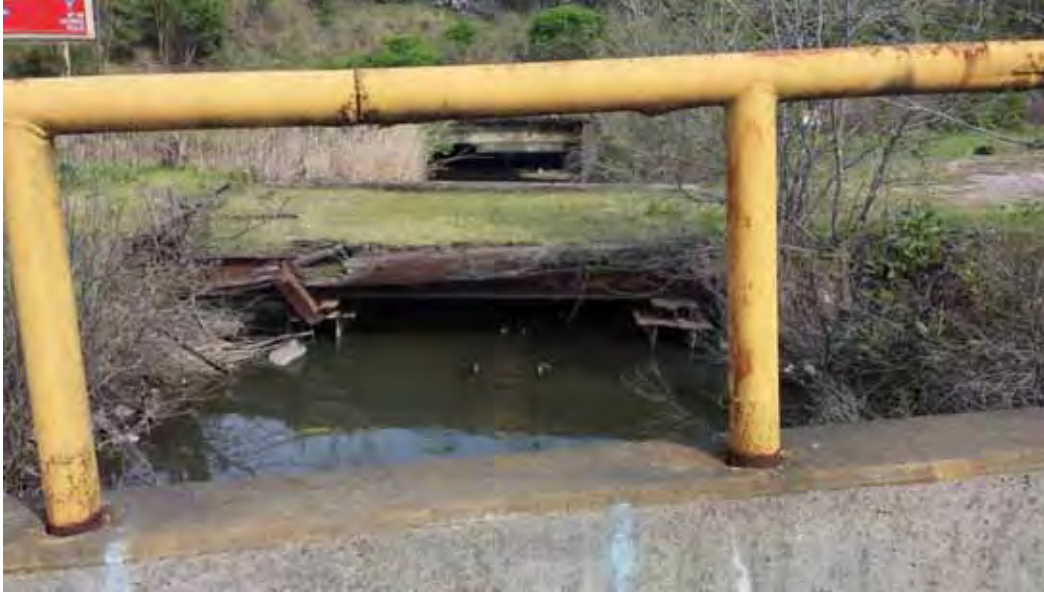
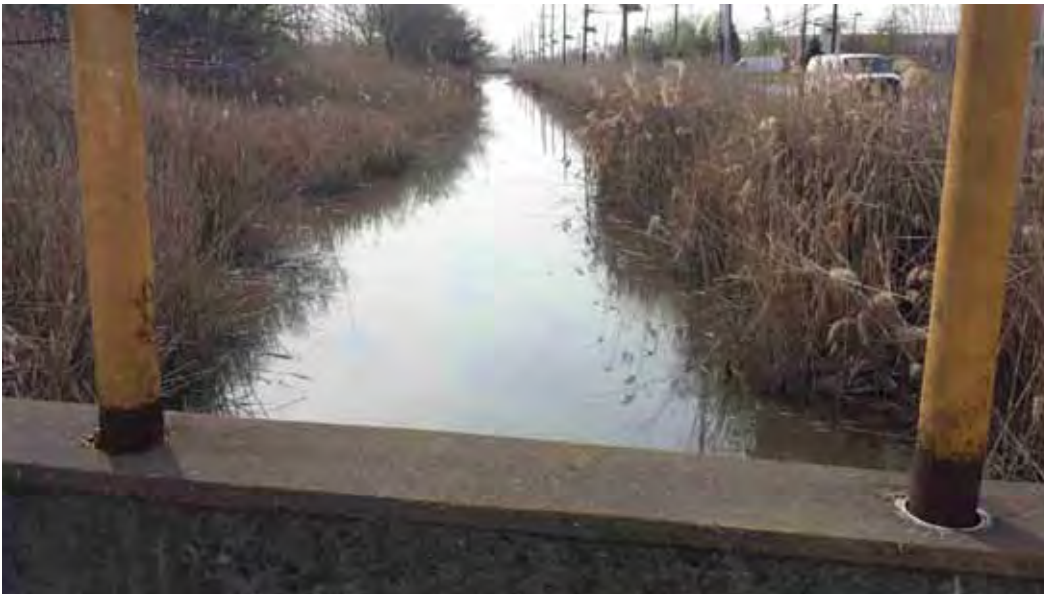
Figure 1: Upstream view of ditch at bridge

Figure 2: Downstream view of ditch at bridge

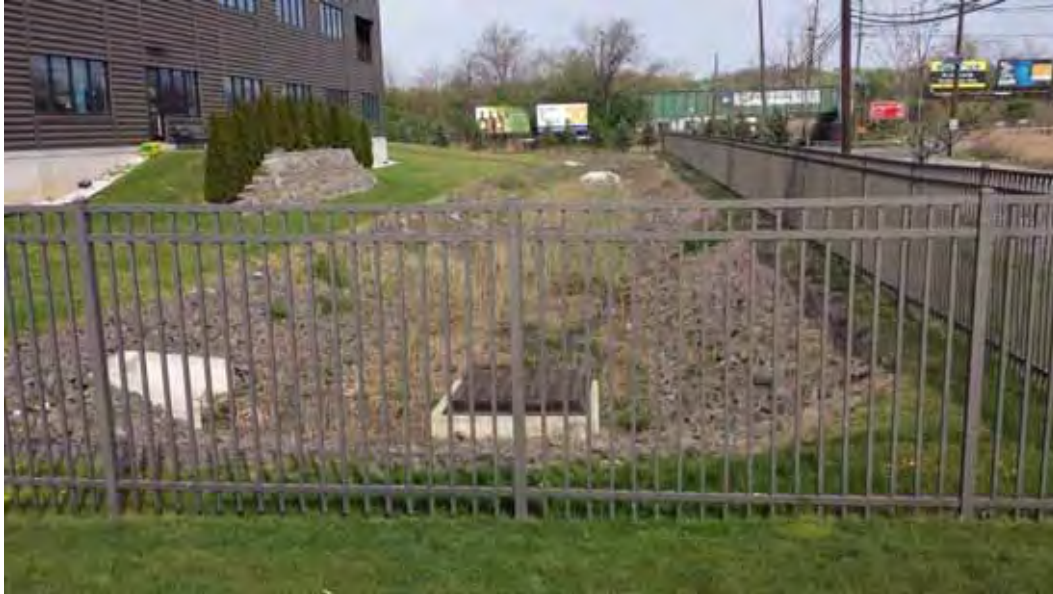
Figure 1: Upstream view of detention basin

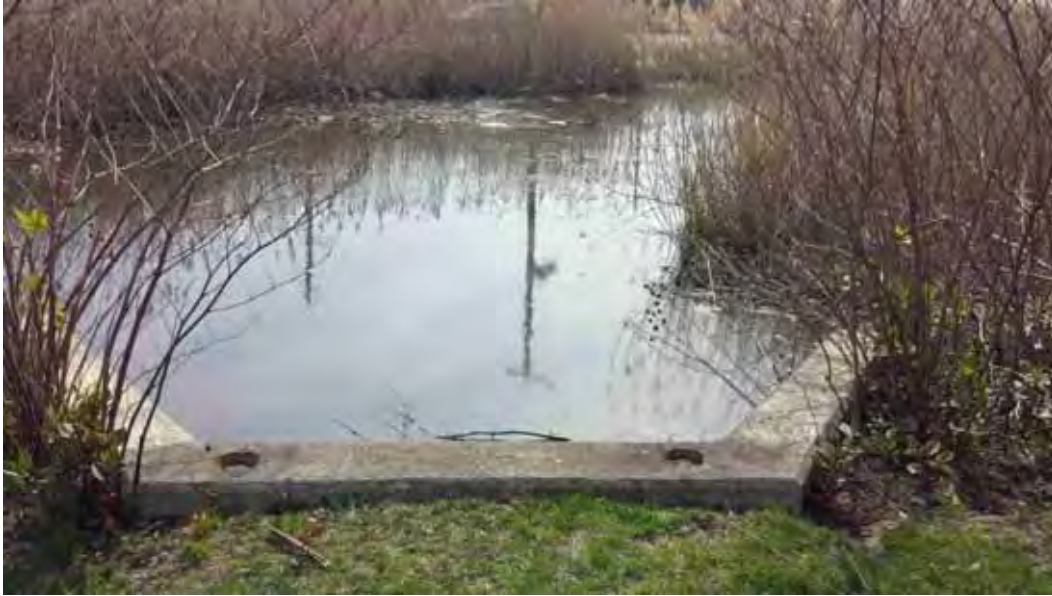
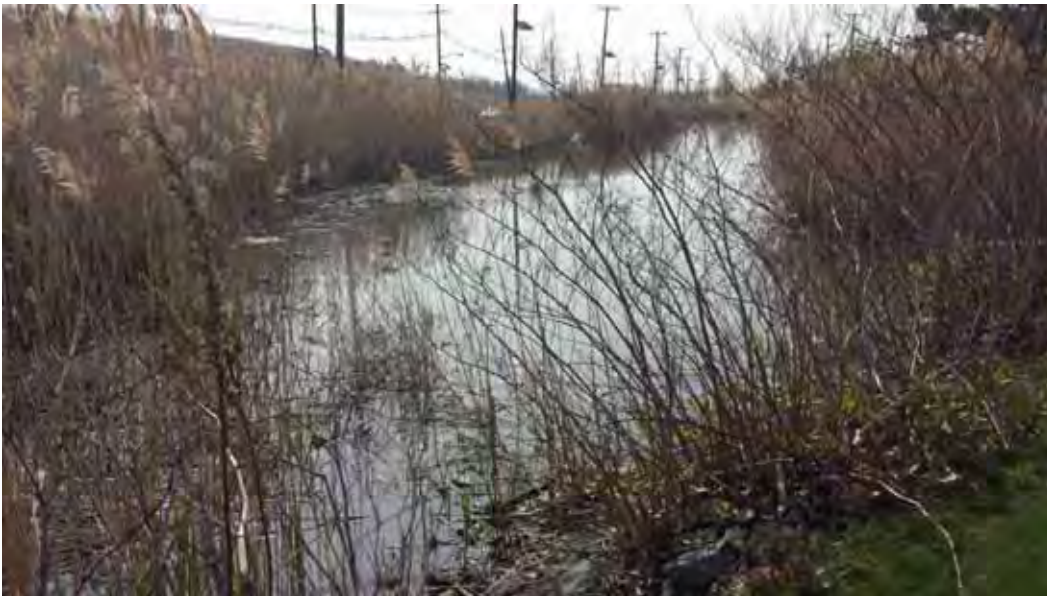
Figure 1: Downstream view of ditch at headwall

Figure 2: Downstream view of ditch

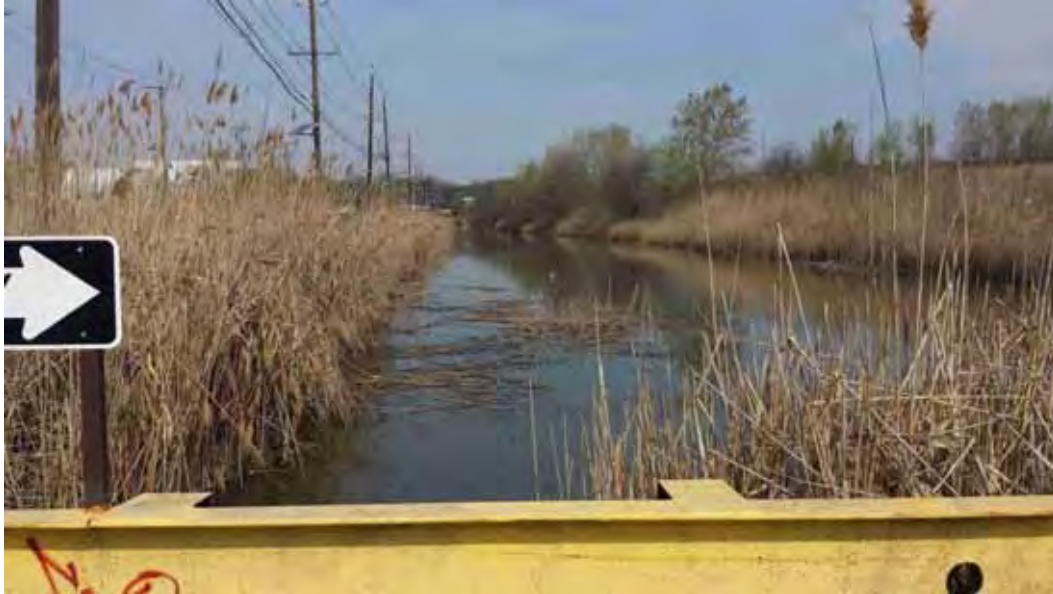
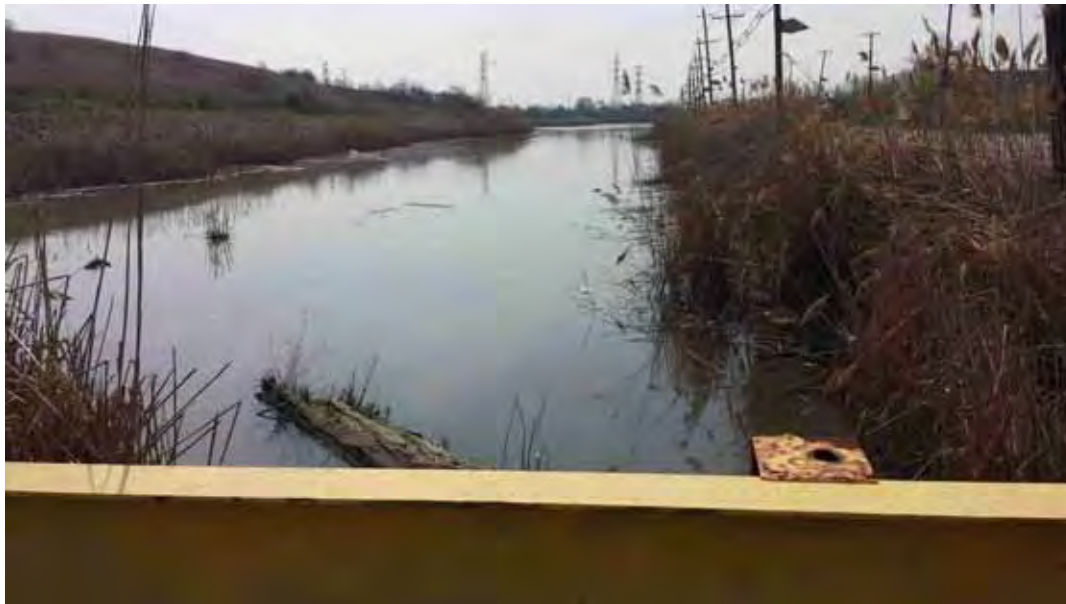
Figure 1: Upstream view of ditch at bridge

Figure 2: Downstream view of ditch at bridge

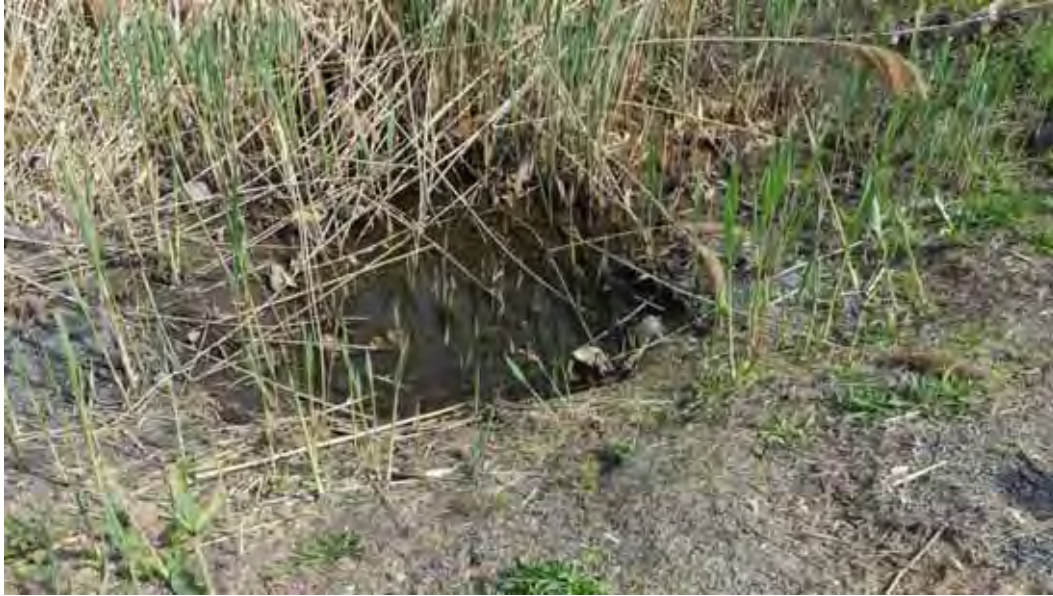
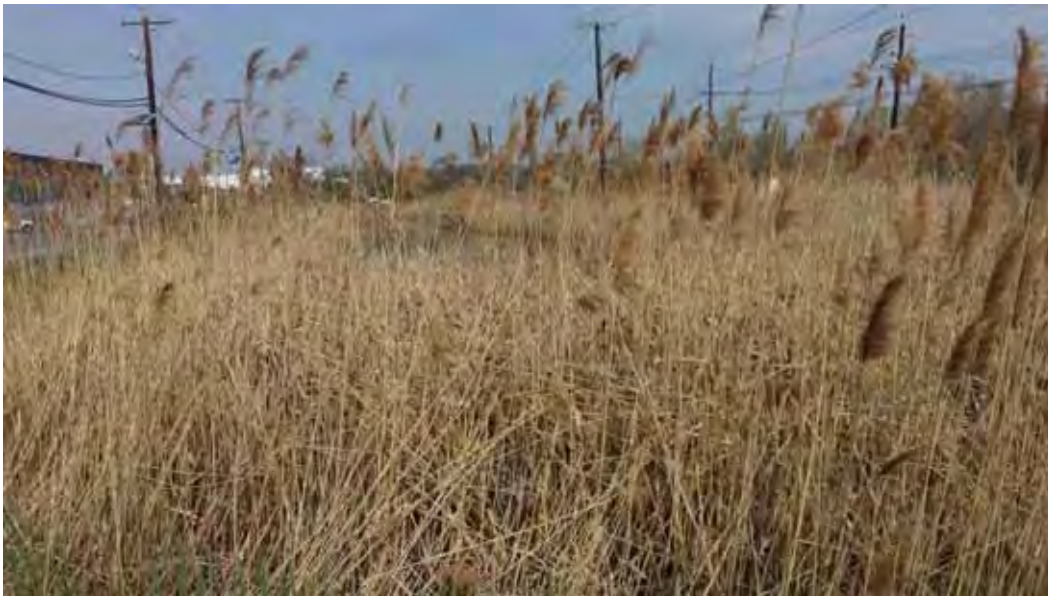
Figure 1: Upstream view of culvert

Figure 2: Upstream view of ditch at culvert

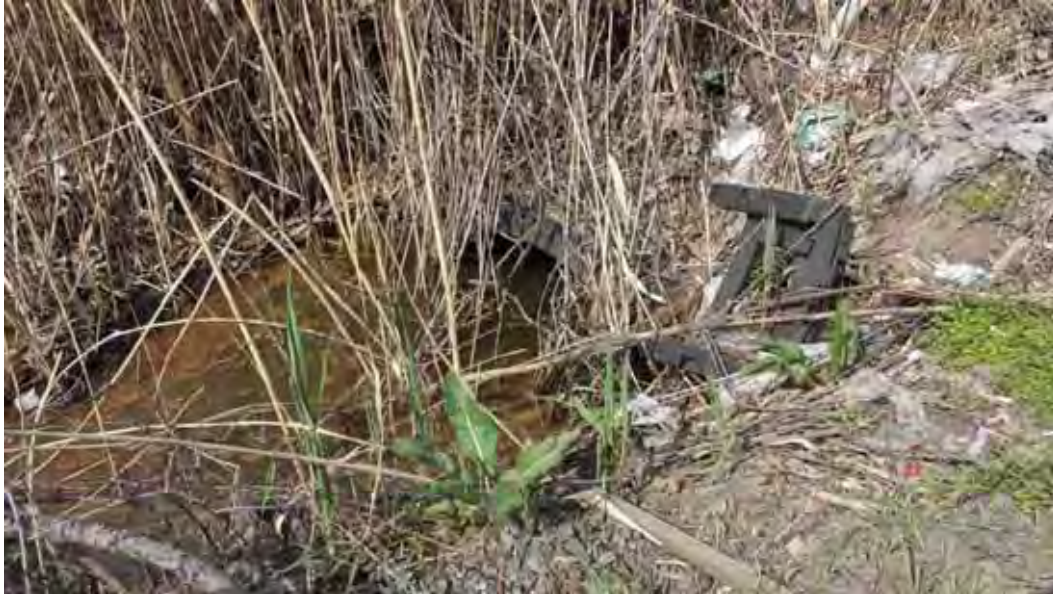
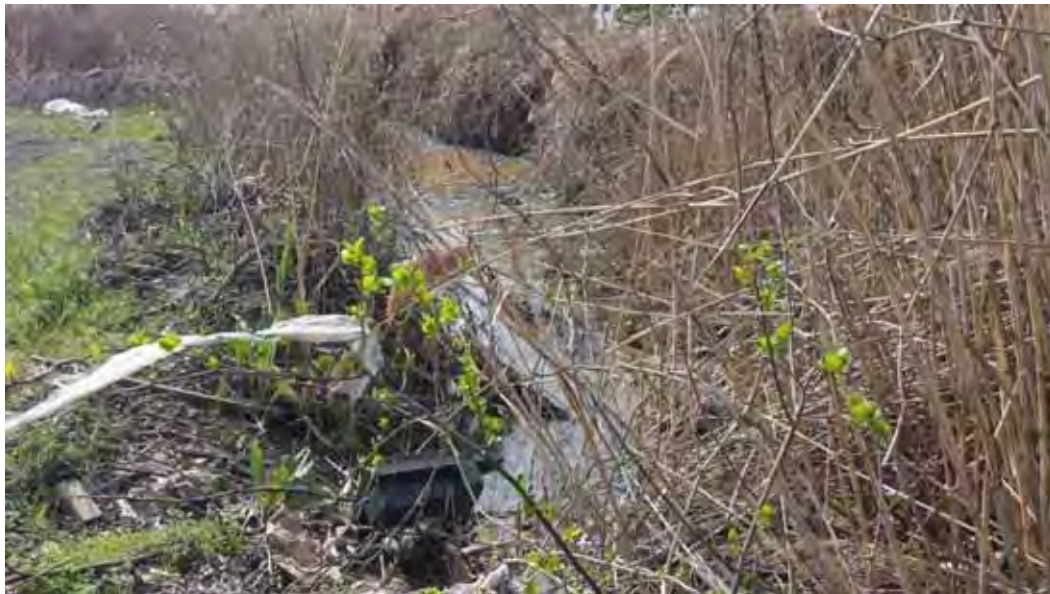
Figure 1: Upstream view of culvert

Figure 2: Downstream view of ditch at culvert
