New Jersey Sports & Exposition Authority Drainage Ditch Inspection Report

**The National Flood Insurance Program
Community Rating System**

The New Jersey Sports and Exposition Authority

December 7, 2016

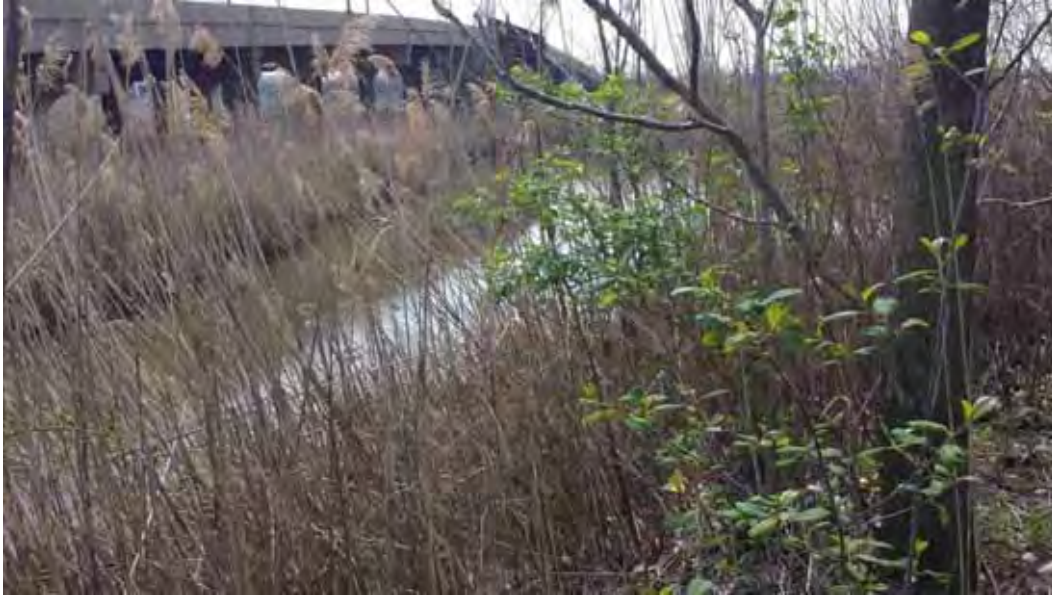
Figure 1: Downstream view of ditch

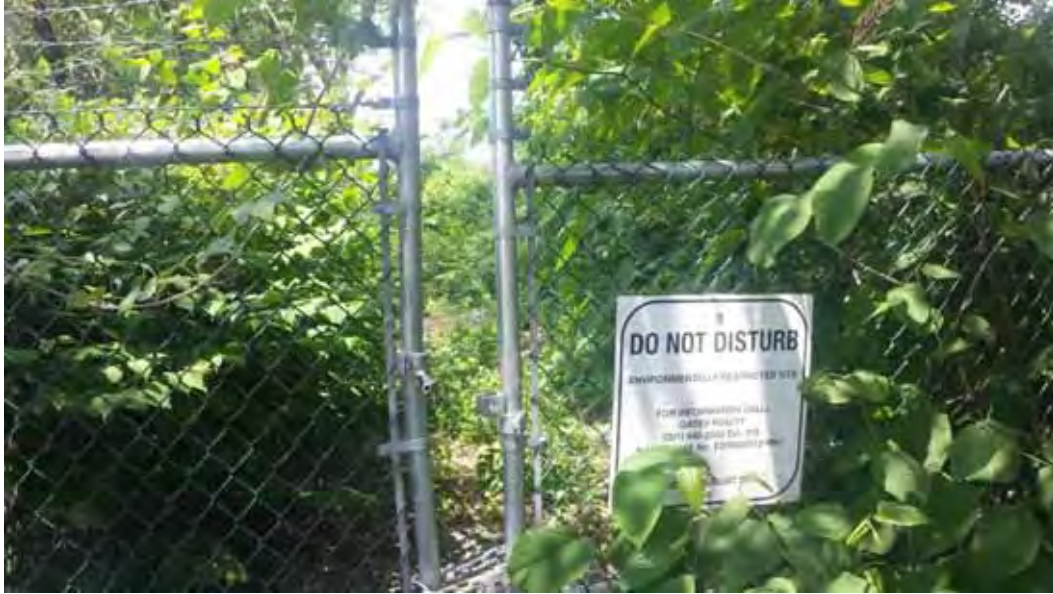
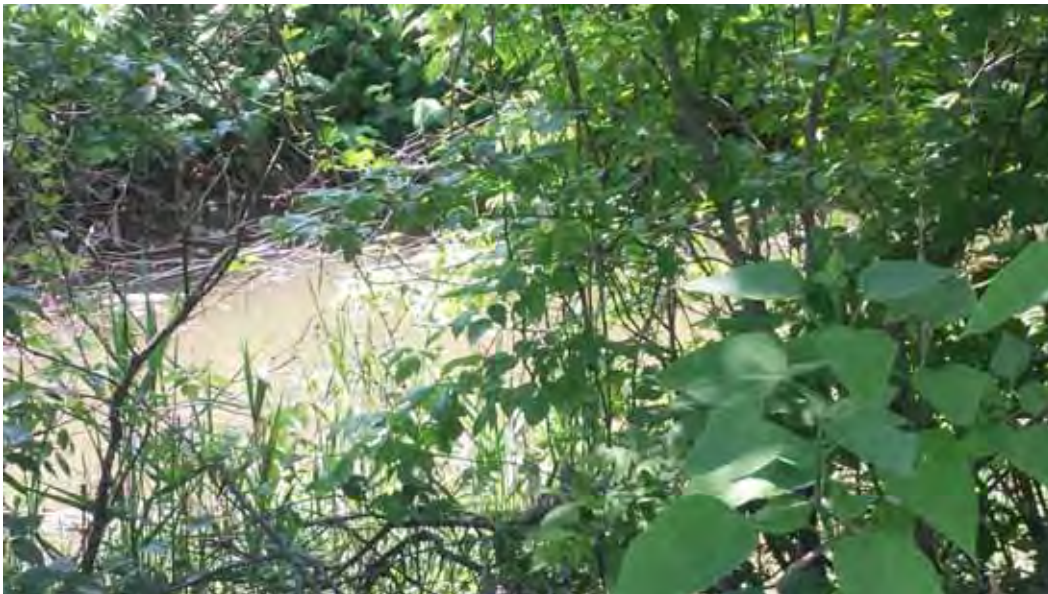
Site ID/Name: Depeyster Creek Ditch System (Secaucus) – Location #2

Figure 1: Upstream view of ditch

Figure 2: Downstream view of ditch

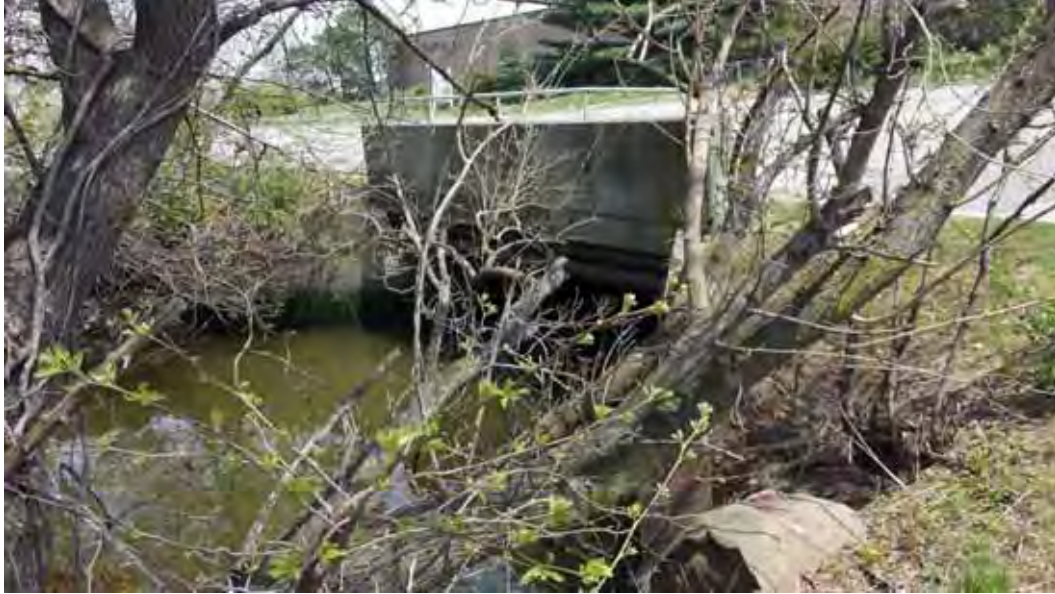
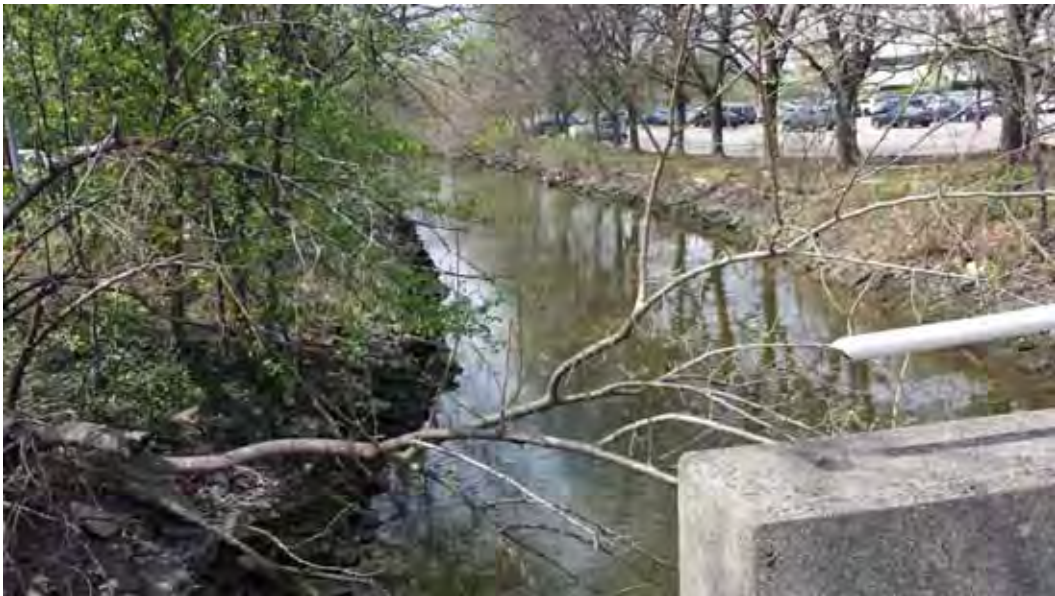
Site ID/Name: Chubb Ave/Wall St W/Polito Ave Ditch System (Lyndhurst) – Location #6

Figure 1: Upstream view of culvert

Figure 2: Downstream view of ditch at culvert

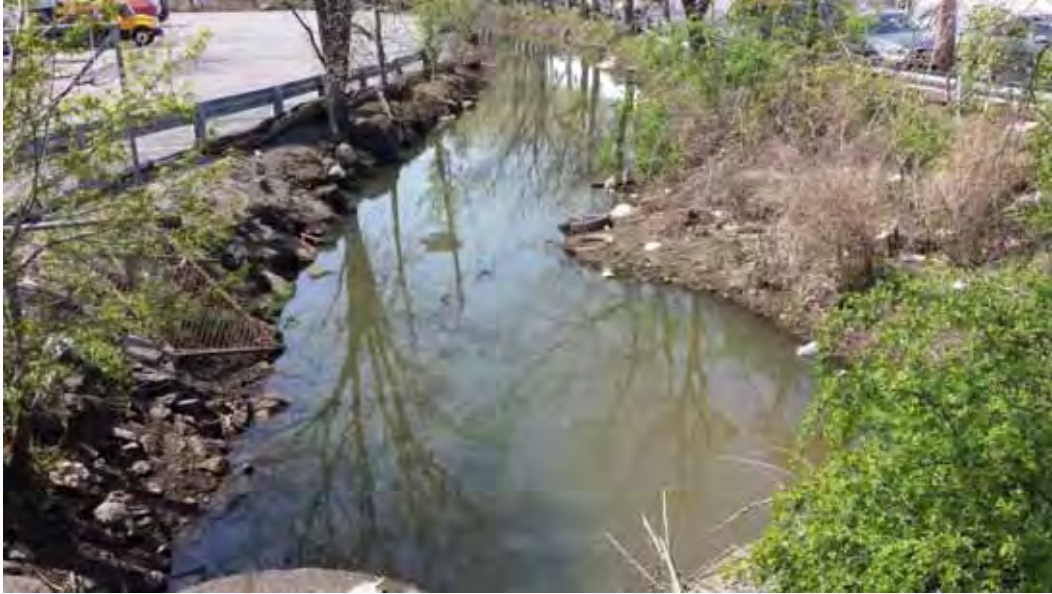
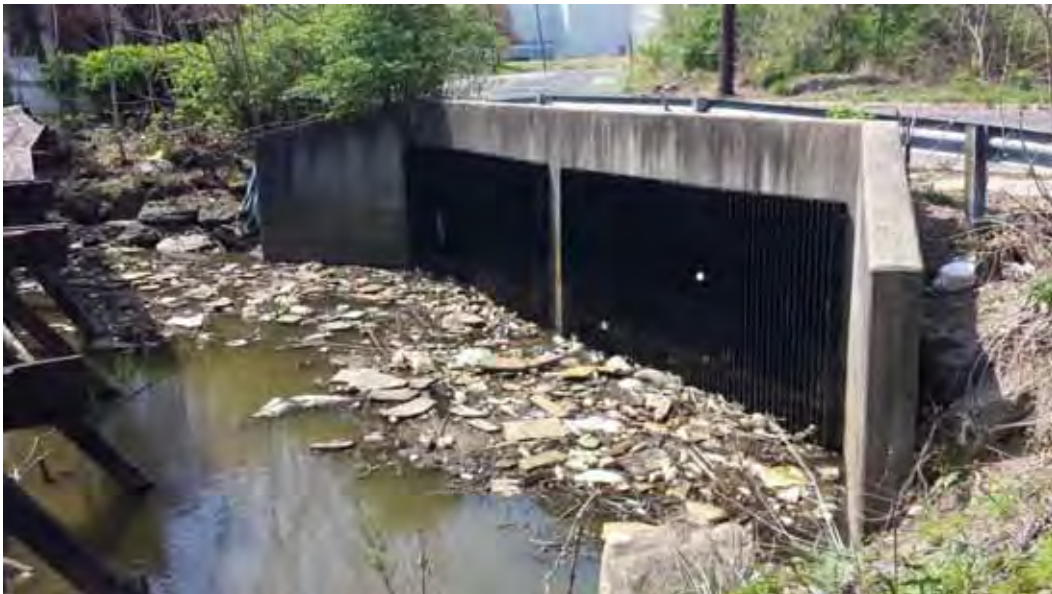
Site ID/Name: East Riser Ditch (Carlstadt) – Location #1

Figure 1: Upstream view of ditch at tide gate

Figure 2: Downstream view of trash rack

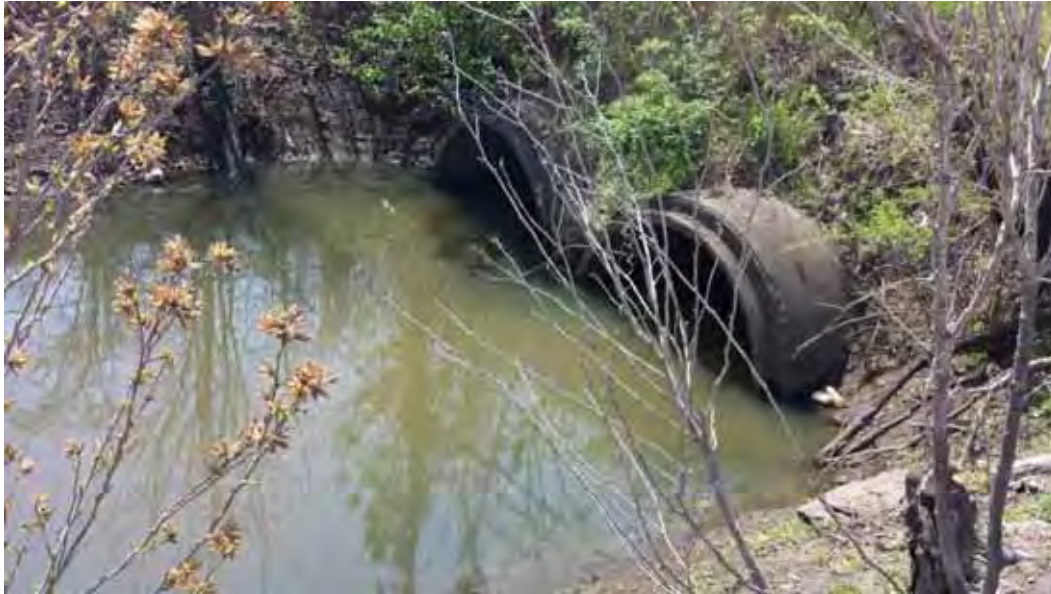
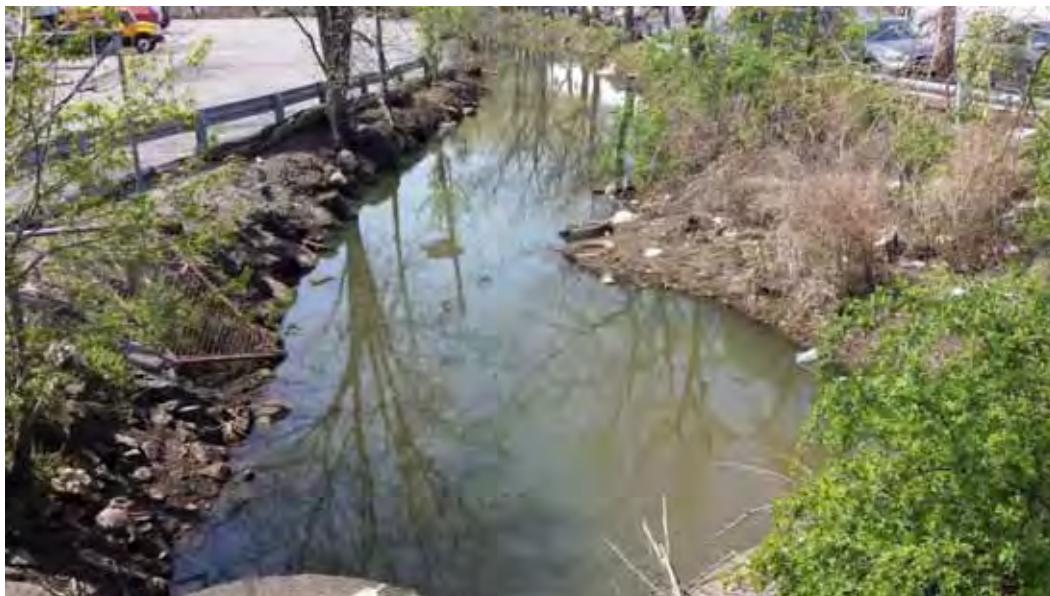
Site ID/Name: East Riser Ditch (Carlstadt) – Location #2

Figure 1: Upstream view of culvert

Figure 2: Downstream view of ditch at culvert

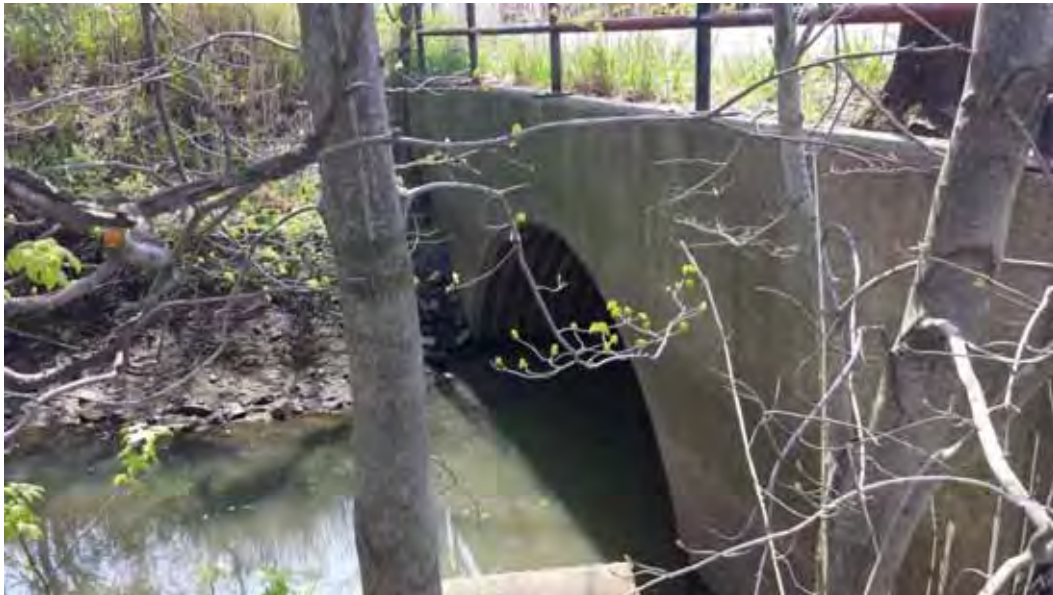
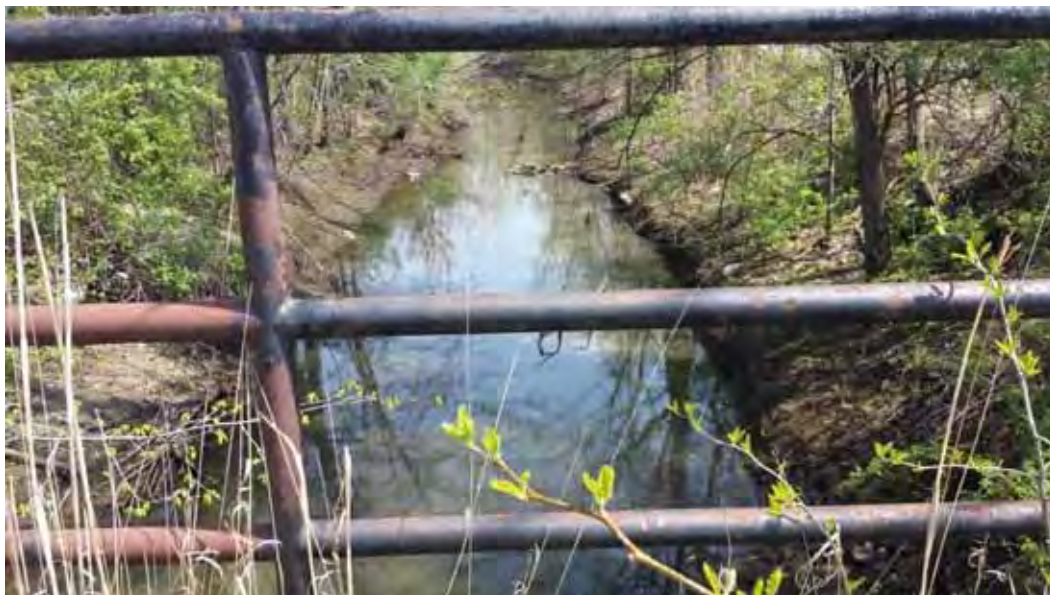
Site ID/Name: East Riser Ditch (Carlstadt) – Location #3

Figure 1: Upstream view of culvert

Figure 2: Downstream view of ditch at culvert

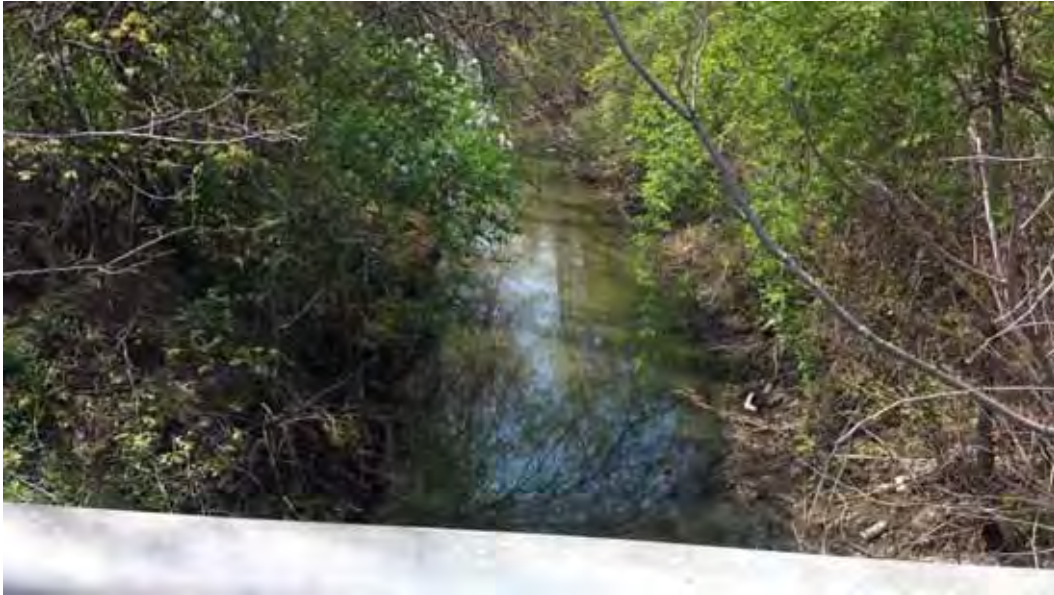
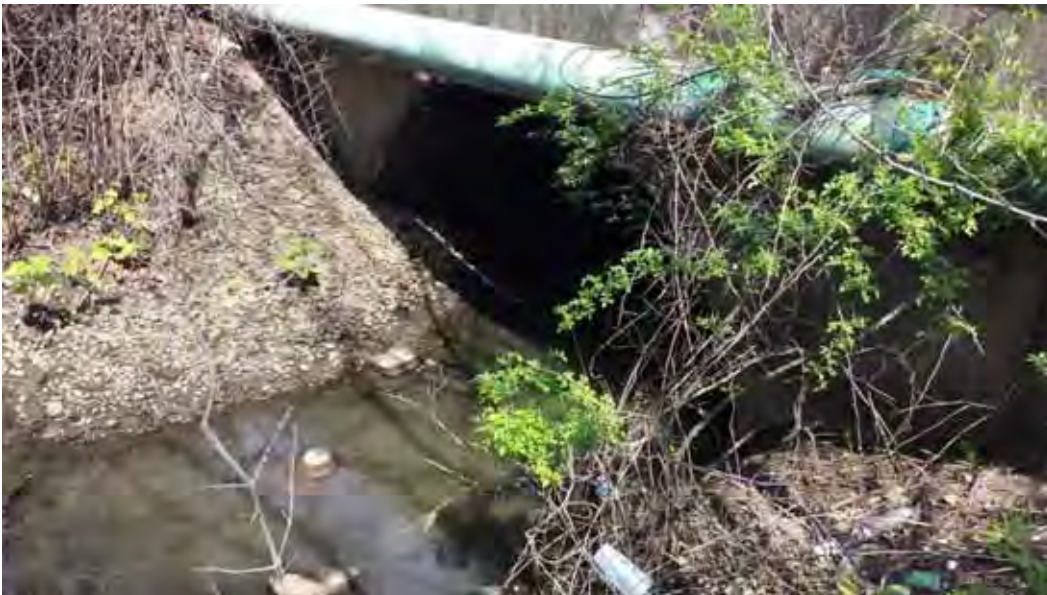
Site ID/Name: East Riser Ditch (Carlstadt) – Location #4

Figure 1: Upstream view of culvert

Figure 2: Downstream view of ditch at culvert

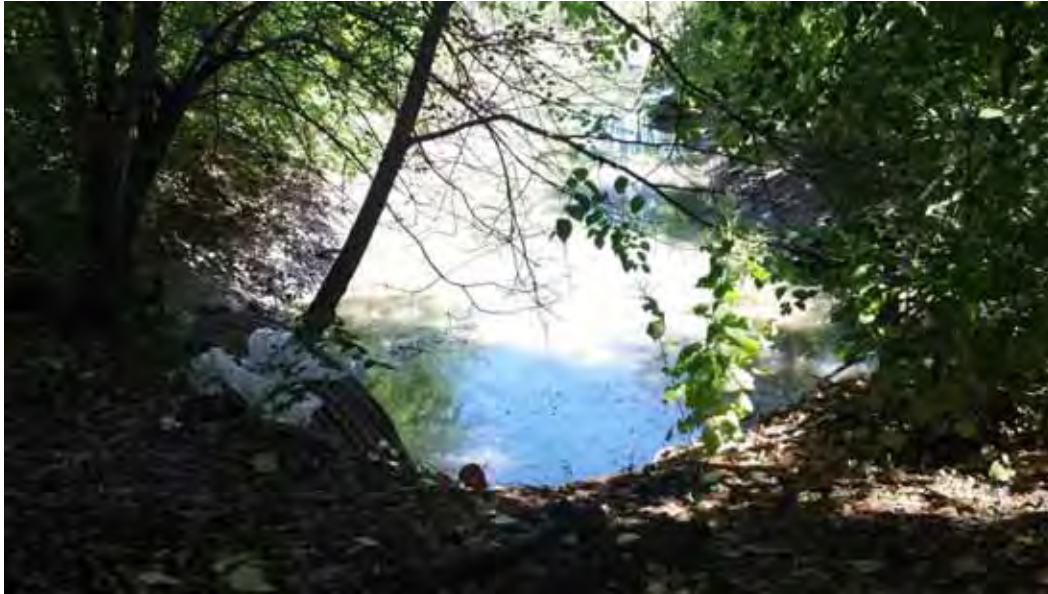
Site ID/Name: Sack's Creek & Golden Ave Ditch System (Secaucus) – Location #4

Figure 1: Downstream view of ditch at culvert

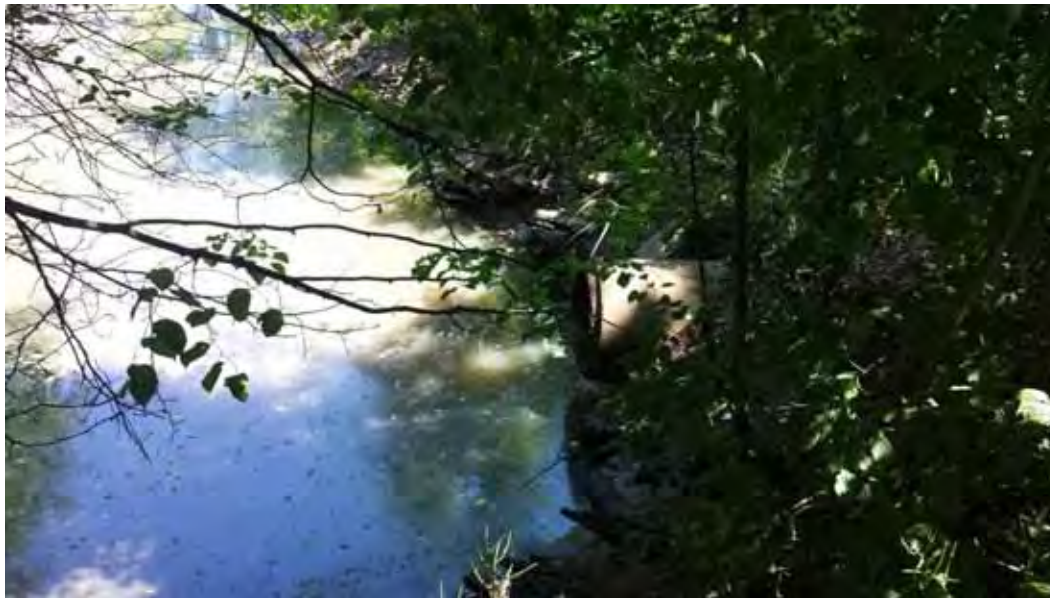
Figure 2: Upstream view of ditch at culvert

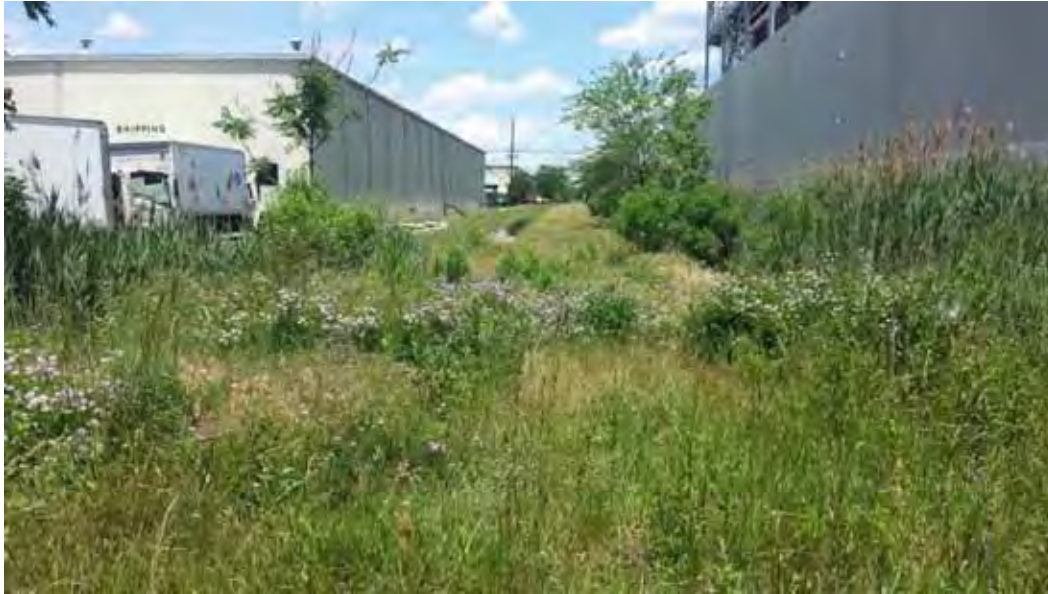
Site ID/Name: Sack's Creek & Golden Ave Ditch System (Secaucus) – Location #5

Figure 1: Upstream view of ditch

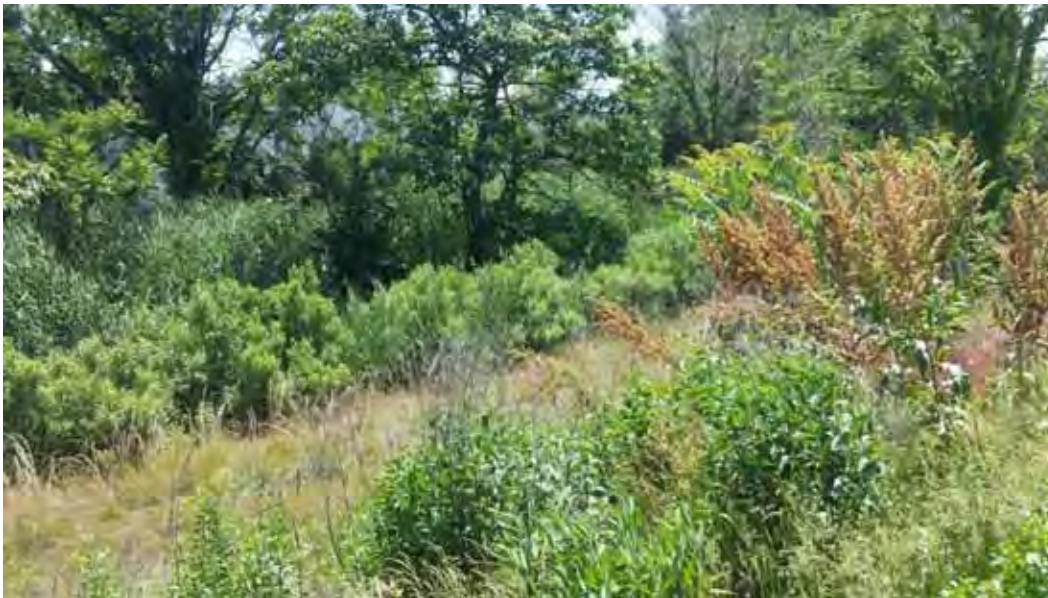
Figure 2: Downstream view of ditch

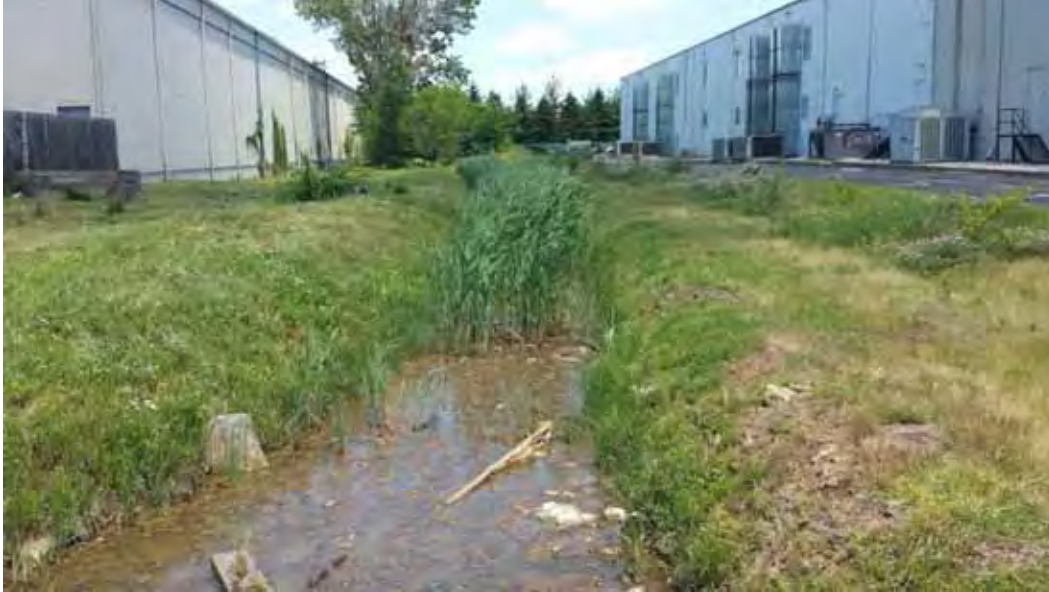
Site ID/Name: Sack's Creek & Golden Ave Ditch System (Secaucus) – Location #6

Figure 1: Downstream view of ditch

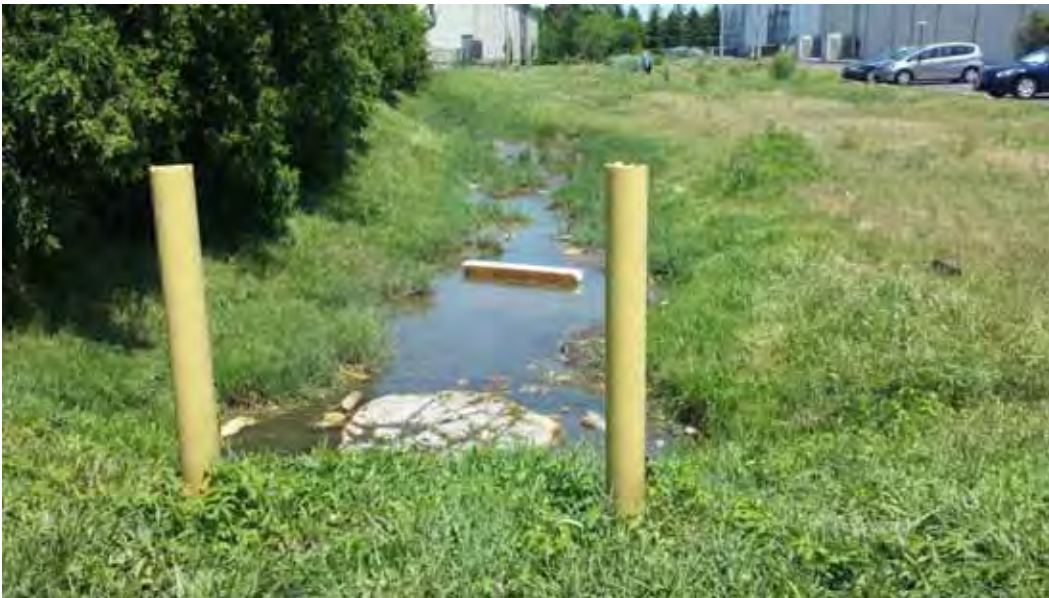
Figure 2: Upstream view of ditch

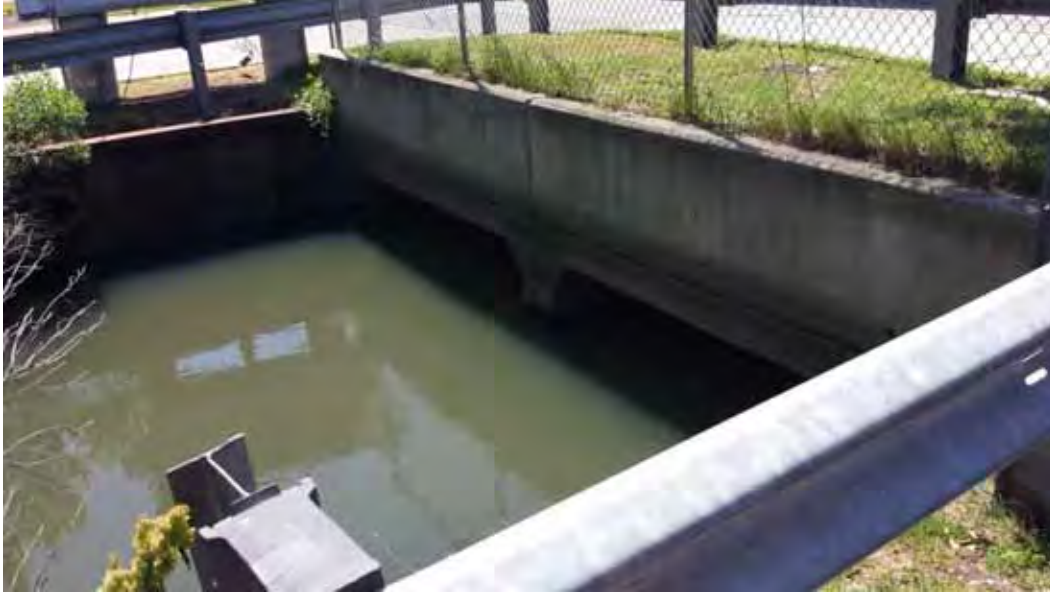
Site ID/Name: Sack's Creek & Golden Ave Ditch System (Secaucus) – Location #7

Figure 1: Upstream view of culvert

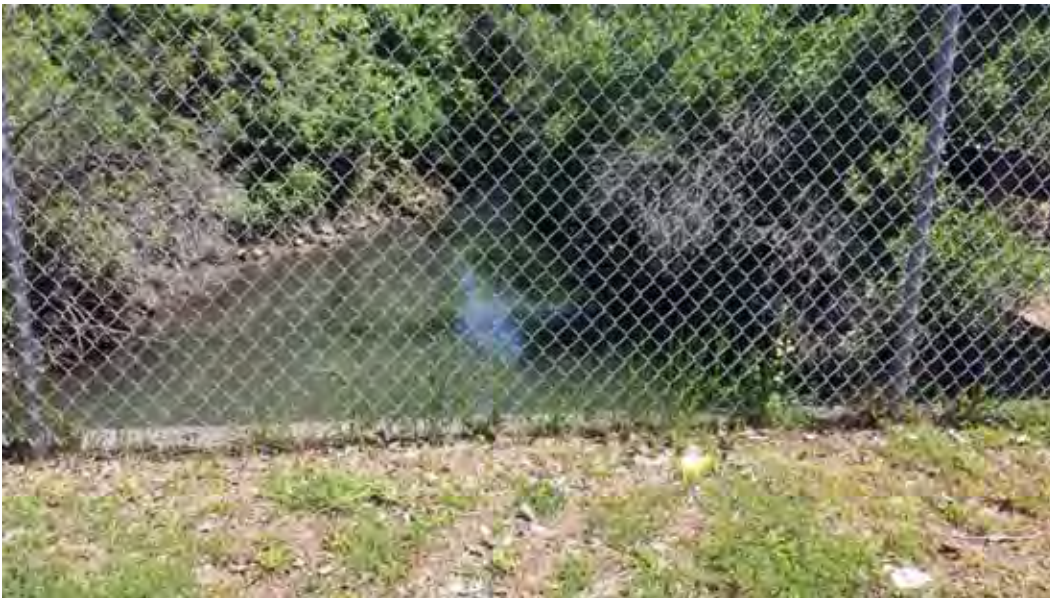
Figure 2: Downstream view of ditch at culvert

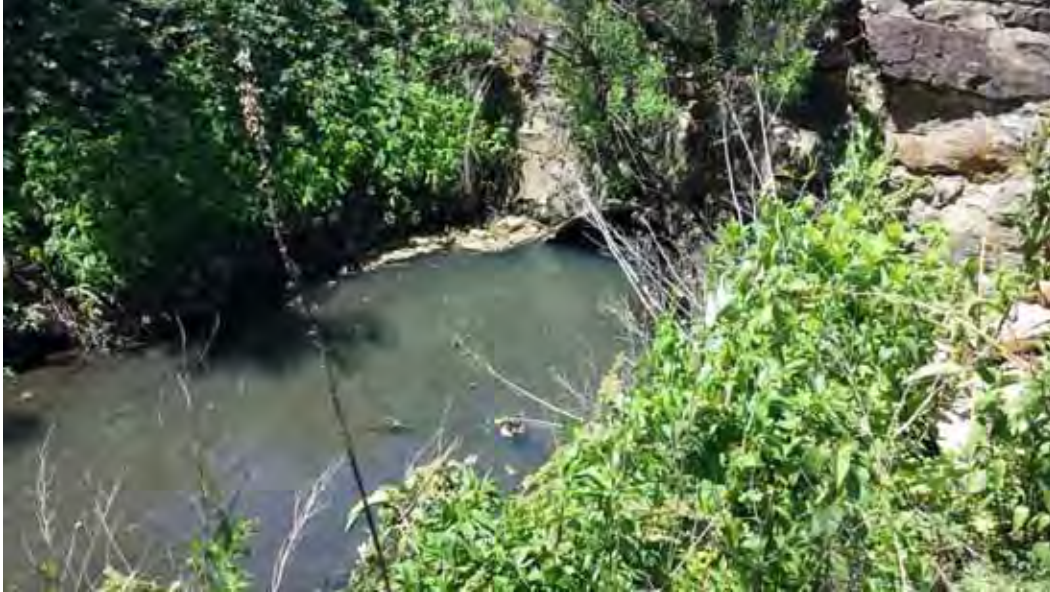
Site ID/Name: Sack's Creek & Golden Ave Ditch System (Secaucus) – Location #8

Figure 1: Upstream view of ditch at culvert

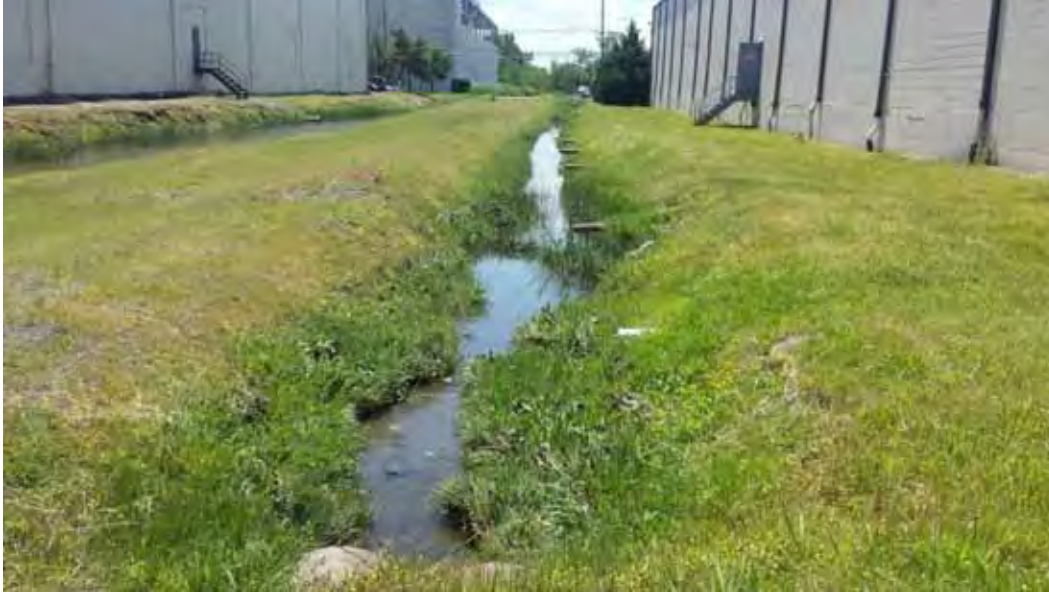
Site ID/Name: Sack's Creek & Golden Ave Ditch System (Secaucus) – Location #9

Figure 1: Downstream view of ditch

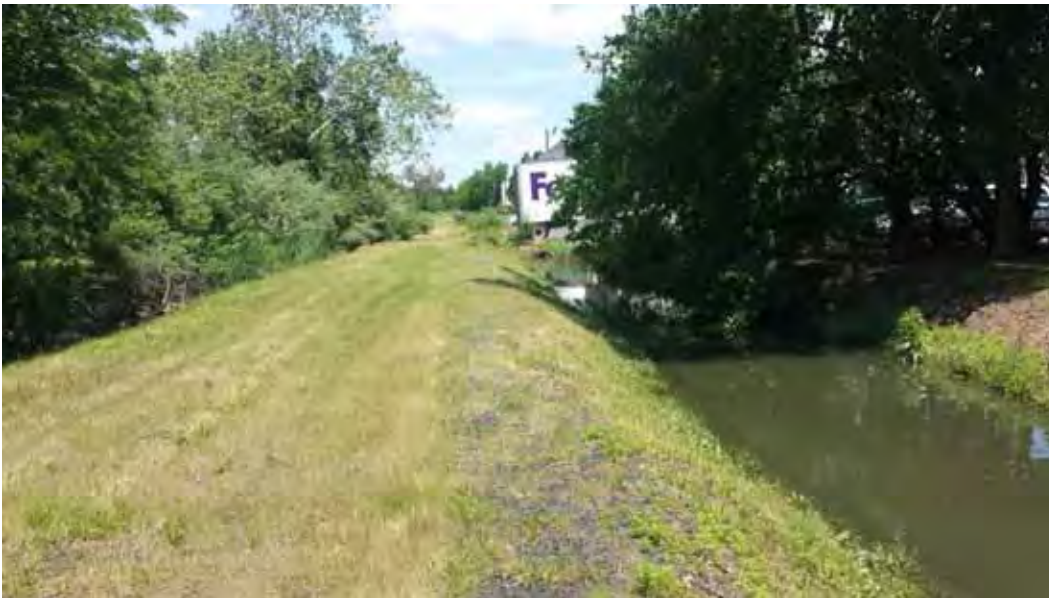
Figure 2: Upstream view of ditch

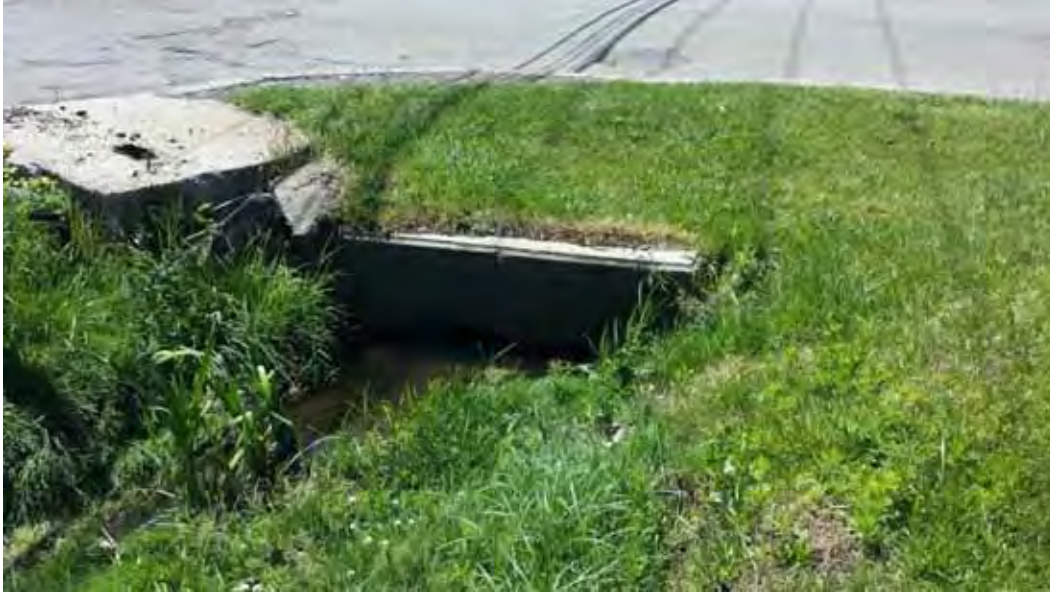
Site ID/Name: Sack's Creek & Golden Ave Ditch System (Secaucus) – Location #10

Figure 1: Downstream view of ditch at culvert

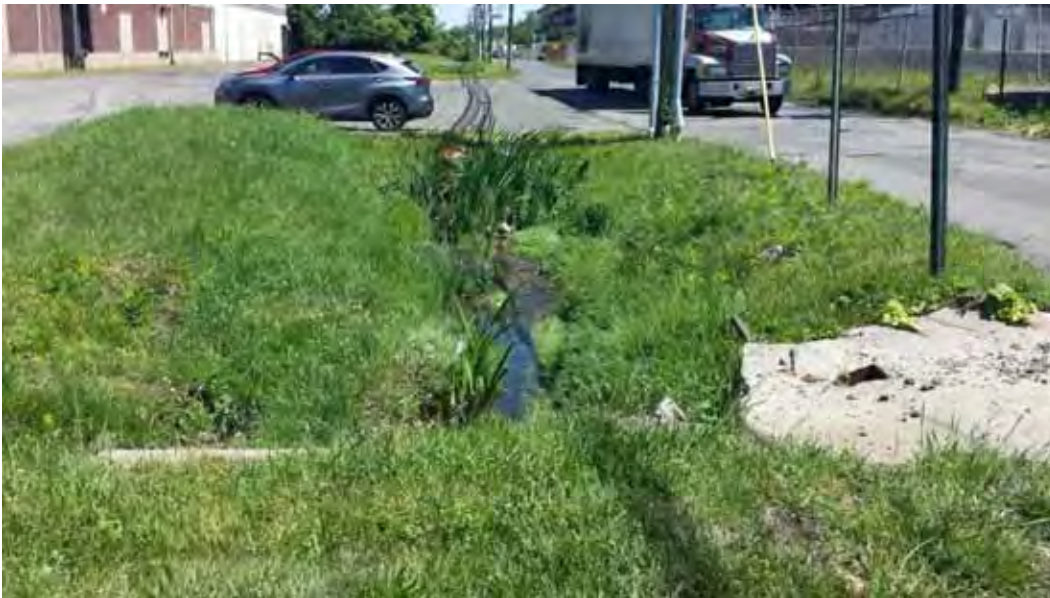
Figure 2: Upstream view of ditch
