### ENERGY AUDIT REPORT

PINE HALL

HOME MENTAL HEALTH CENTER

May 7, 1980

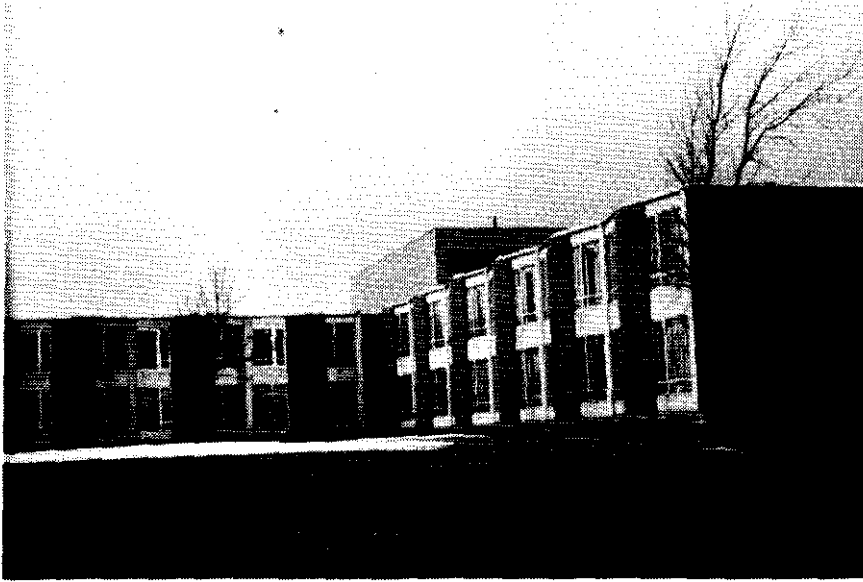
SOUTHEAST EXPOSURE  
SHOWING ZIG-ZAG WINDOW  
CONFIGURATION

At present the building envelope contains approximately 25% glass area in the form of single pane windows, most with operable sections which allow infiltration. It is recommended that panels containing 1 1/2 inches of urethane insulation be installed over selected glass
