**Subject: Root Resistance Testing of Sarnafil® Membranes**

**19-01**

# Sika Sarnafil Waterproofing Green Roof Root Resistance Test Final Report

Prepared by:  
Dr. Robert Berghage  
Center for Green Roof Research

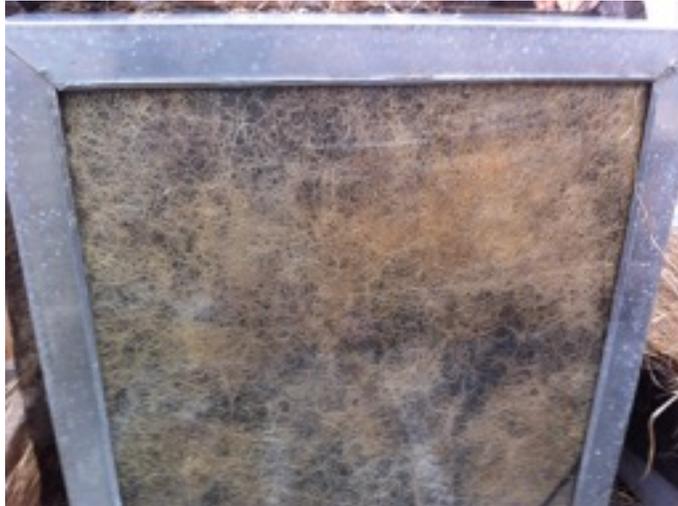
**FIGURE 1. CONTROL BOX AT HARVEST SHOWING ROOTS VISIBLE THROUGH THE PLEXIGLASS**

Test and control boxes were tipped on their sides and the bottom of the test system was closely evaluated for evidence of roots. There were many root traces visible with the control boxes (Figure 1). There were no roots or rhizomes visible through the plexiglass of the test boxes. Plants and media were removed from the test boxes by flipping them over and lifting off the test boxes and the membrane assemblies. In all cases the media and root masses were easily removed from the membrane assemblies. There were large numbers of roots observed on the bottoms of control test boxes (Figure 2). There were no roots or rhizomes evident on the outside of the bottom or sides of any of the test membranes (Figure 3,4). The corners and sidewalls were examined closely and no roots or rhizomes were observed to have penetrated the corners or vertical sides or the membrane assemblies. The membrane assemblies were easily pulled away from the media and root mass suggesting that there was no serious root attachment to the membranes. There were large masses of roots and many rhizomes at the bottom of the media and

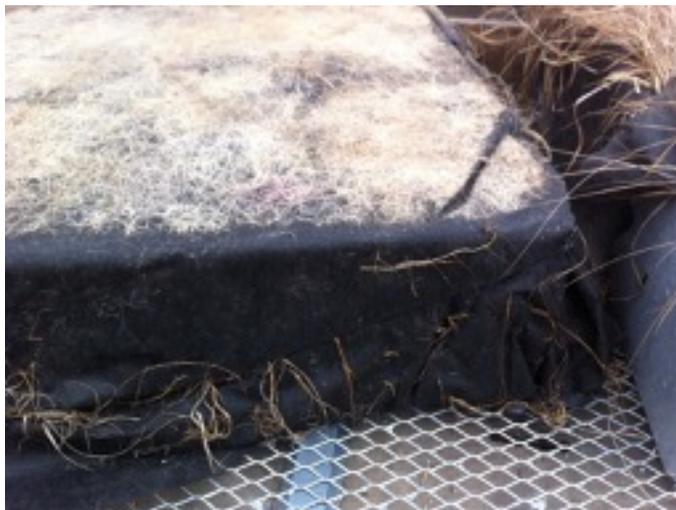
**FIGURE 2. TYPICAL CONTROL ROOT MAT AFTER THE TEST BOX WAS REMOVED WITH THE FABRIC LAYER STILL ATTACHED**

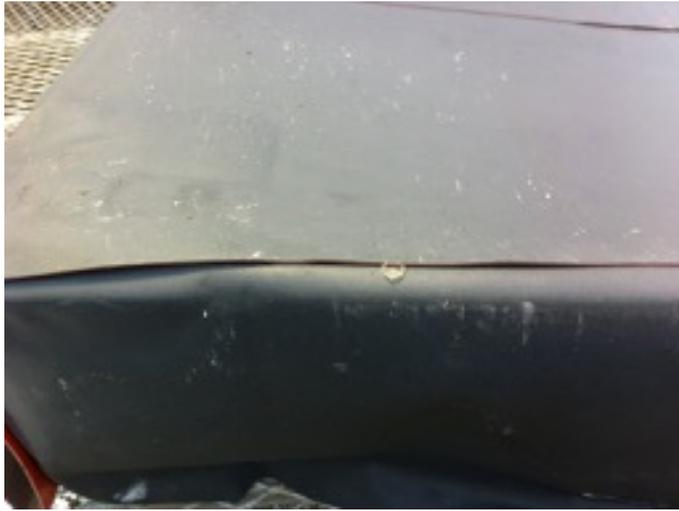
**FIGURE 3. OUTER MEMBRANE SURFACE OF TYPICAL SARNAFIL G 476 MEMBRANE AT HARVEST.**

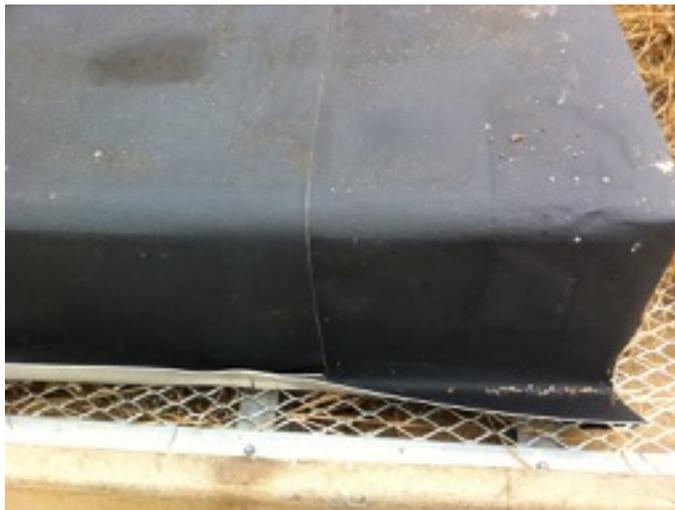
**FIGURE 4. OUTER MEMBRANE SURFACE OF TYPICAL SARNAFIL G 410 MEMBRANE AT HARVEST.**

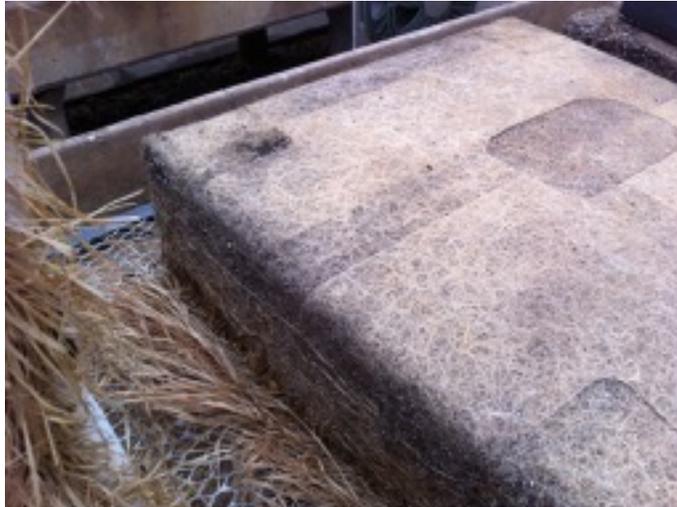
**FIGURE 5. TYPICAL ROOT MAT OBSERVED ON THE BOTTOM OF THE SARNAFIL MEMBRANE TEST BOXES**

along the sides where they had been in contact with the membrane (Figure 5,6). Some media was stuck on the membranes after the primary root mass was removed. Close examination of the surface of the membrane revealed some fine roots stuck to the surface. These fine roots and media were easily removed by washing or rubbing. Close examination of the surface revealed that there was no penetration or obvious damage to the membrane surface. The white surface of the membrane (Sarnafil G 410) was stained brown or grey by roots and media (Figure 7). Some of the brown stains were not easily washed off. There was much less staining of the orange surface of the Sarnafil G 476 membrane and what staining there was, was more easily washed off (Figure 8). Some roots were found to be tightly attached to some of the seams of the membranes. Close examination reviewed that these roots did not penetrate the sealed seams but were attached to the surface of the weld (Figure 9). There was excellent root growth and large root mats on the bottoms of all test containers.

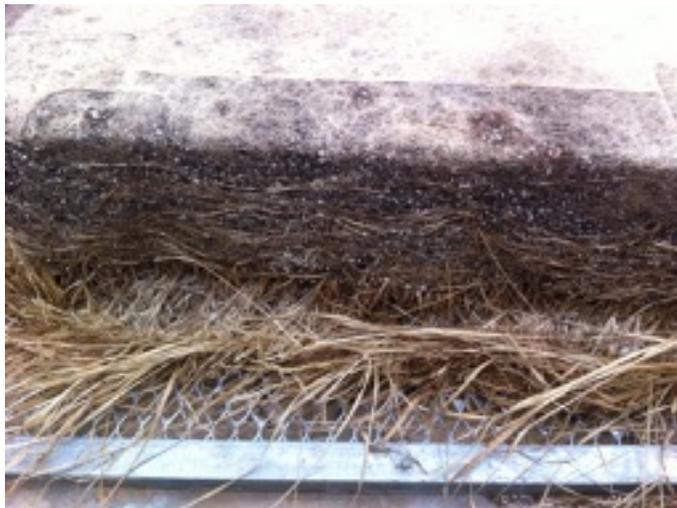
**FIGURE 6. TYPICAL RHIZOME GROWTH ALONG THE SIDES OF SARNAFIL MEMBRANE TEST BOXES**

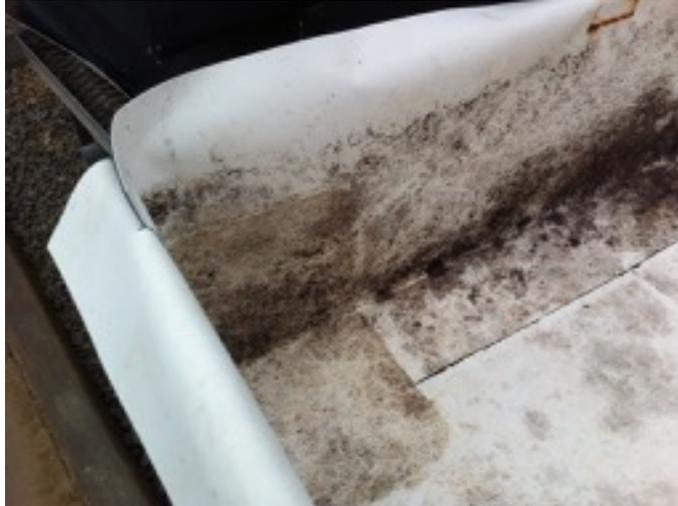
**FIGURE 7. SARNAFIL G 410 MEMBRANE SURFACE AFTER THE MEDIA AND PLANTS WERE REMOVED. SOME MEDIA AND SOME FINE ROOTS STUCK TO THE SURFACE HOWEVER THEY WERE EASILY WASHED OR RUBBED OFF. SOME STAINING WAS OBSERVED.**

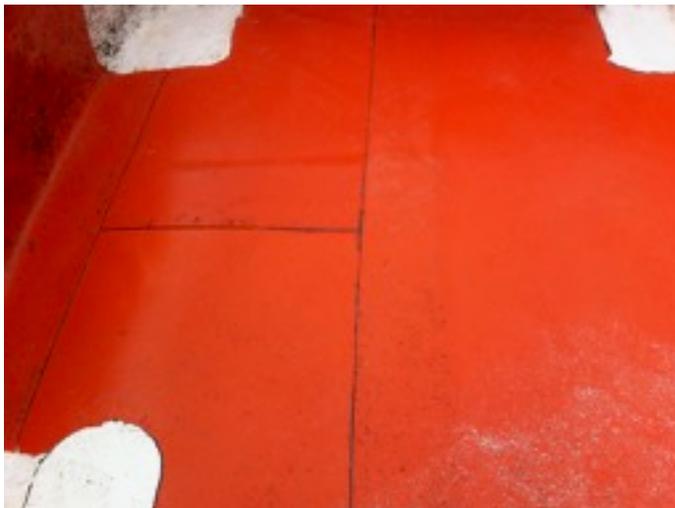
**FIGURE 8. SARNAFIL G 476 MEMBRANE SURFACE AFTER PLANTS AND MEDIA WERE REMOVED. ALTHOUGH THERE WAS SOME STAINING OBSERVED MOST WAS EASILY WASHED OFF.**

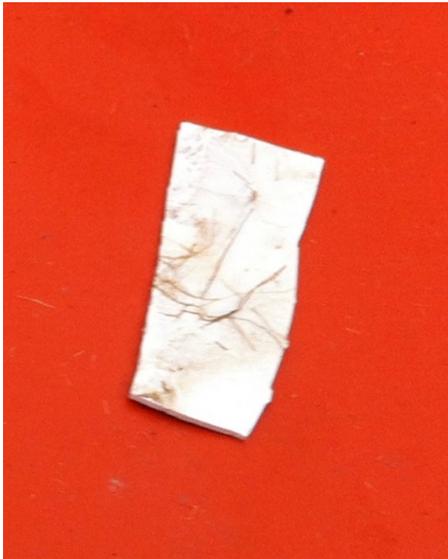
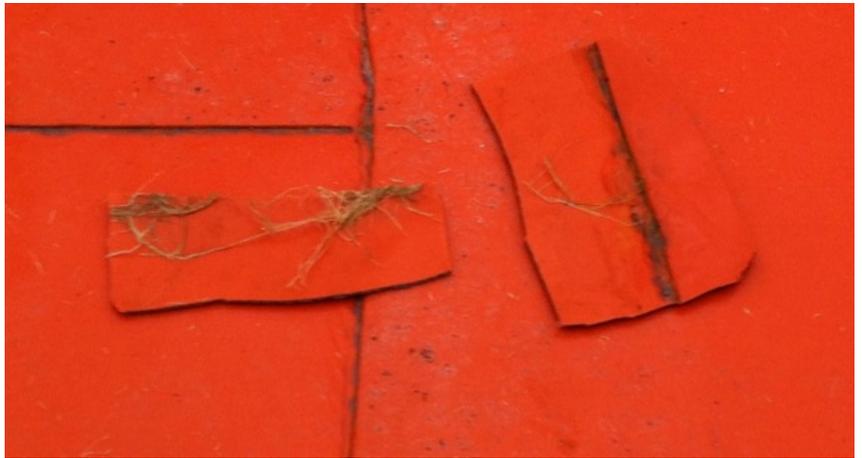
**FIGURE 9. ROOTS ADHERING TO THE SURFACE OF THE MEMBRANES OR THE EDGES OF THE SEAMS. MICROSCOPIC OBSERVATION INDICATED THAT NONE OF THESE PENETRATED THE SURFACE OF SEAMS.**
