Bill Recycler

NE77-BR

Installation Guide

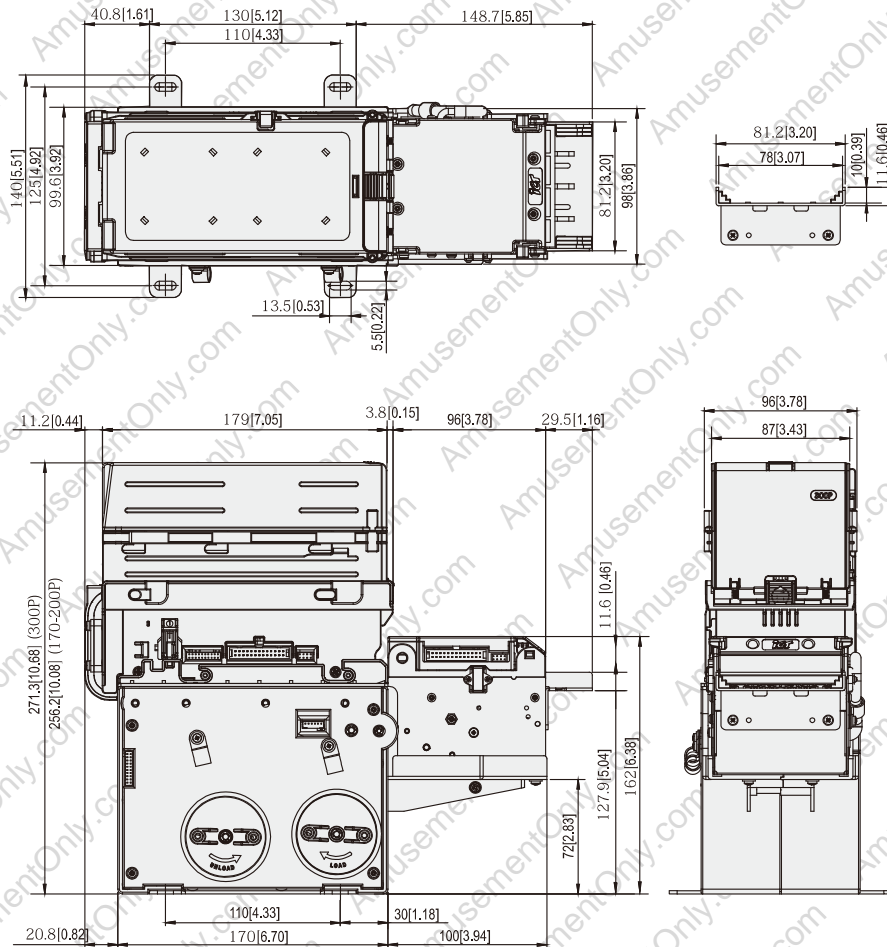
Unit : mm [inch]
4 FIG.01

4. Dimension

Outline Dimension Refer to page. 4

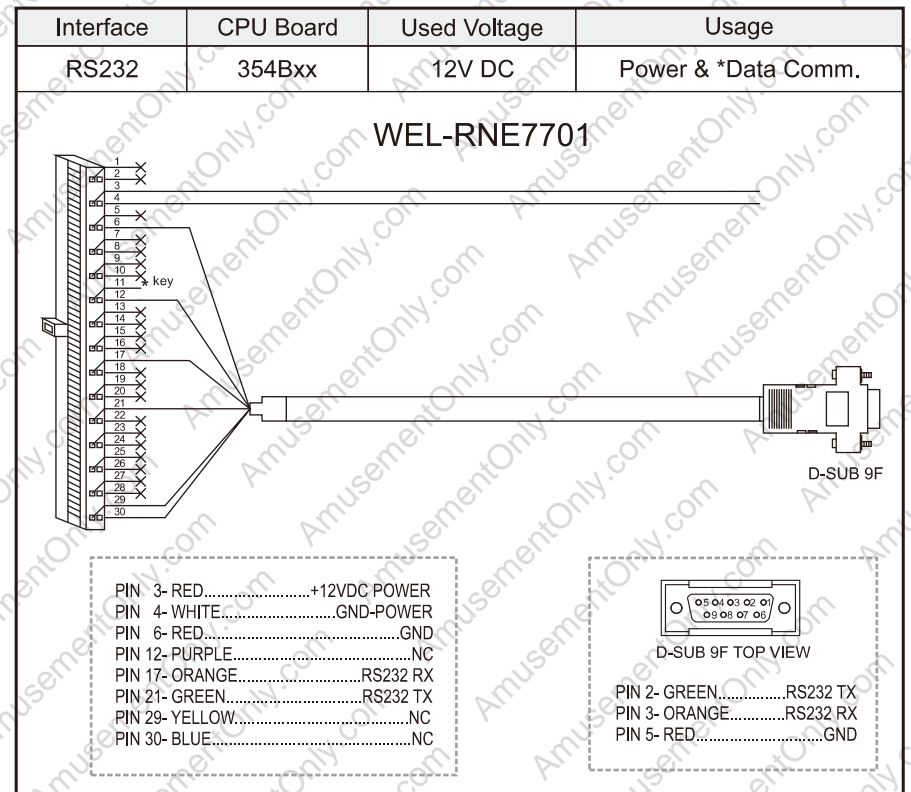
5-1 FIG.02

Interface	CPU Board	Used Voltage	Usage	Harness	Page
RS232	354Bxx	12V DC	Power & *Data Comm.	WEL-RNE7701	5
RS232	354Qxx	12V DC		WEL-RNE7711	6
ccTalk	354Bxx	12V DC		WEL-RE7732	7
MDB	354Qxx	34V DC		WEL-RNE7707	8

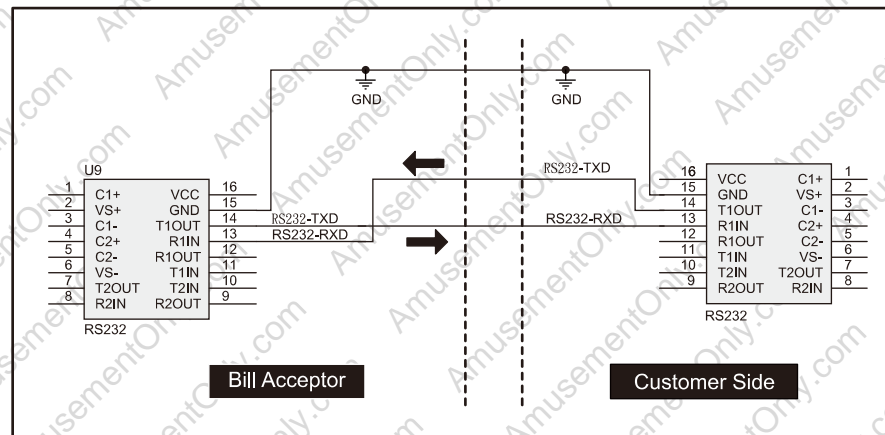
5-1-1 FIG.01

5-1-1. I/O Circuit
RS232 Interface.

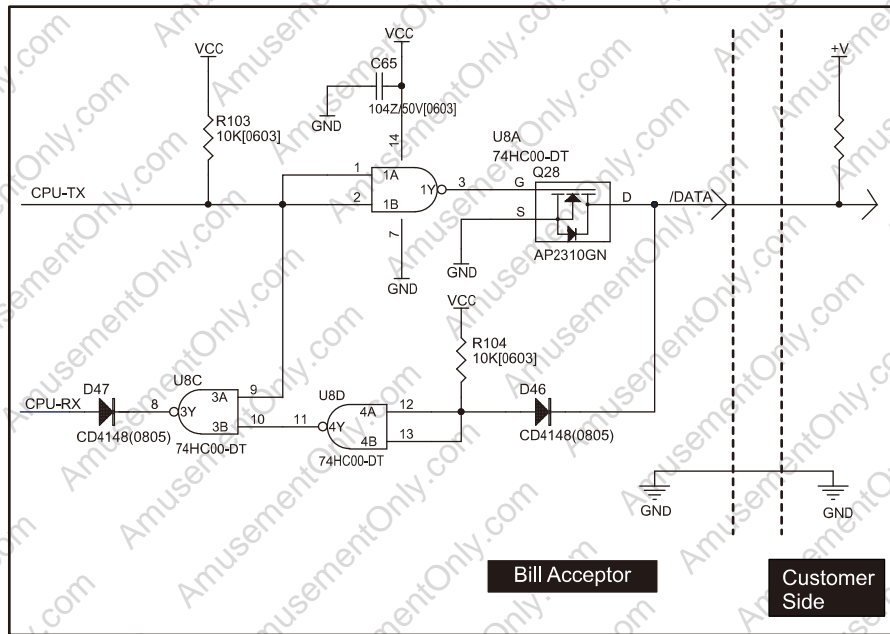
ccTalk Interface.

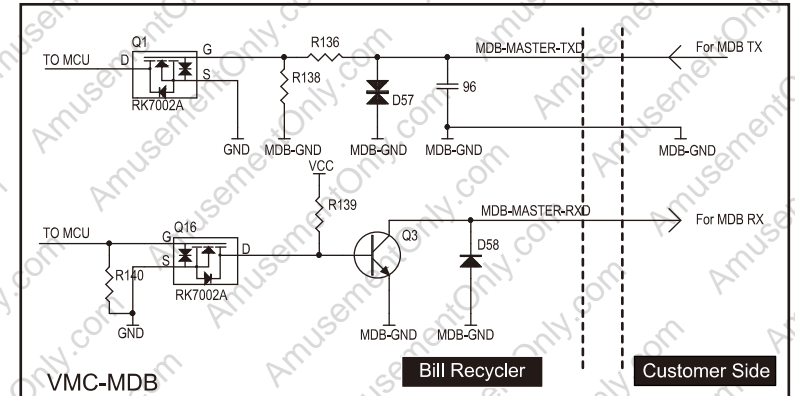
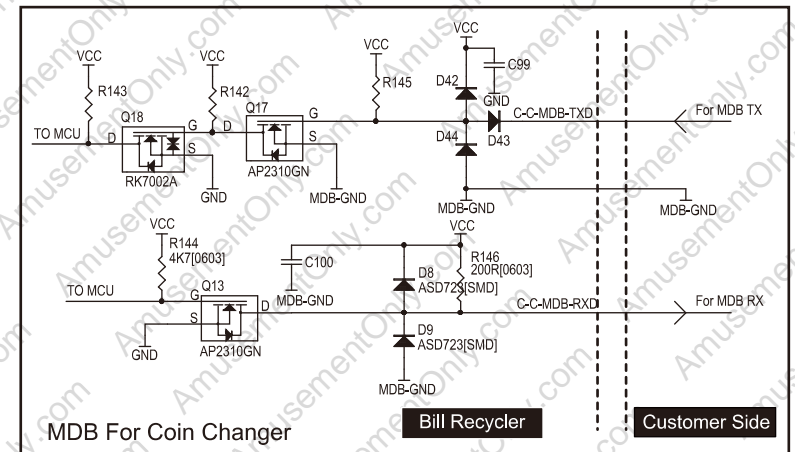
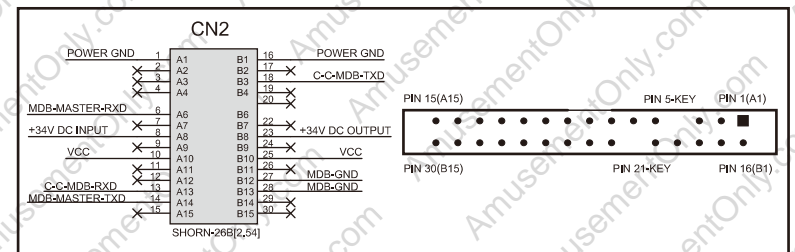
5-1-1 FIG.03

MDB Interface.

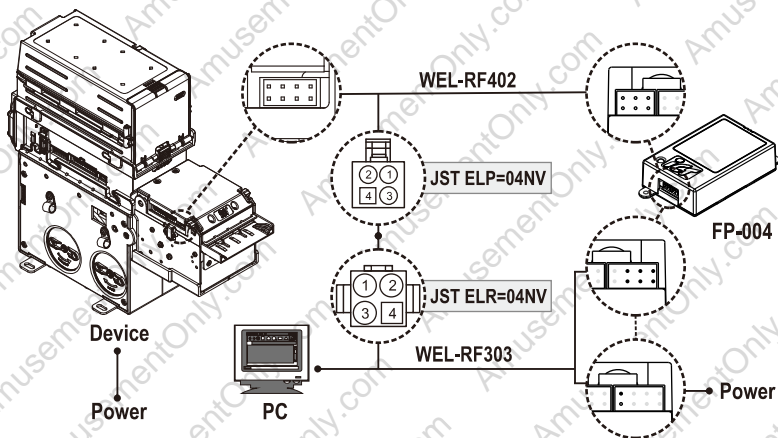
< NE77-BR Validator > 5-2 FIG.01

To download and upgrade the software to NE77-BR, the programmer FP-004 is needed. Please contact ICT to purchase FP-004 and refer to FP-004 user guide for software download and upgrade information.

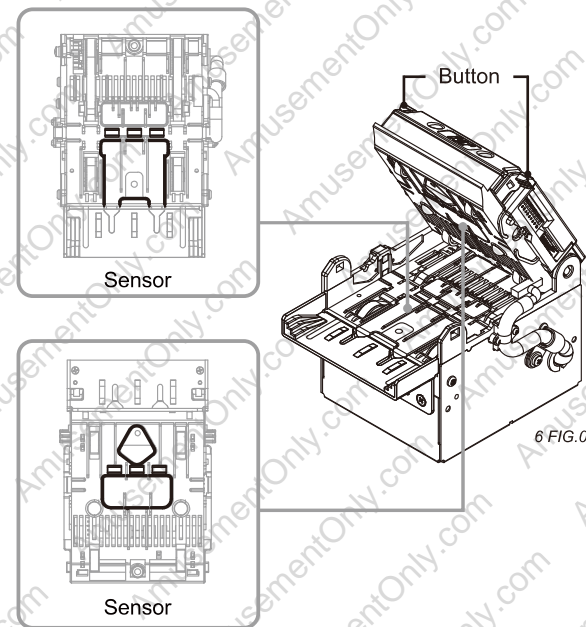
1. Turn Bill Acceptor off.
2. Press the buttons on the side of NE77-BR cover and lift the unit .
3. Use a soft, dry cloth, or towel to clean the bill path and sensors.

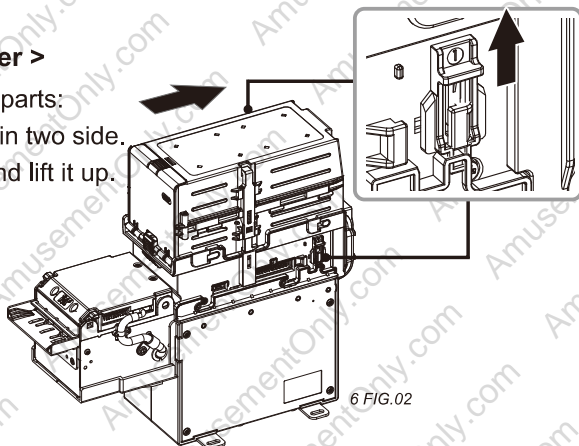
1. Push up the lever in two side.
2. Move backward and lift it up.

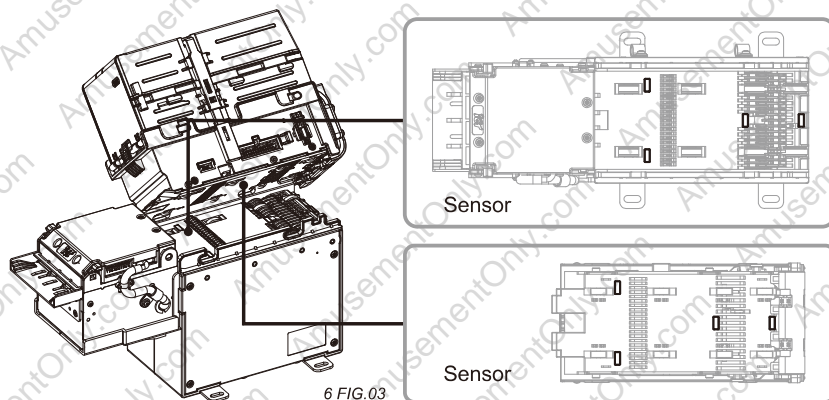
3. Use a soft, dry cloth, or towel to clean the bill path and sensors.

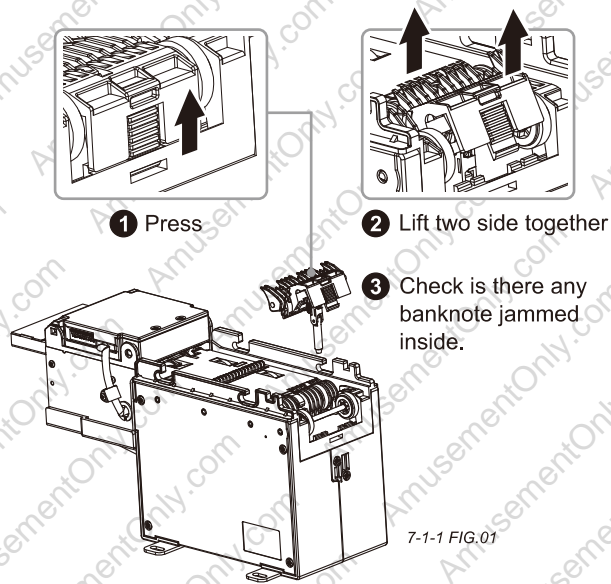
7-1-1. Removing recycler jammed banknote.

LED Flashes		Status	Corrective Actions
Red	Green		
1	1	Bill Jam	Remove the jammed bill. (Refer to page 13 &14)
2	1	BA Disable	Inspect for right DIP switch setting, Harness connections, and communication.
3	1	IR LED/Sensor Error	Inspect for foreign objects on sensors or bill path and clean.
3		Sensor Error	
3	4	Output Error	
4	1	Fish	1. A stringing attempt has detected. 2. Inspect for foreign objects on sensors or bill path and clean.
5	2	Stacker Open	Return bill box back to position.
		Recycle Error	Inspect for any banknote or object jammed in recycler and clean. (Refer to page 16).
		Stacker Error	Check the bill box, Sent the product to service point to maintain.
		Stacker Full	Empty the bill box.
		Recycle Comm_Error	Check all the cable on NE77-BR Validator, recycler connected well.
7	1	Motor Error	Inspect for foreign objects on sensors or bill path and clean.

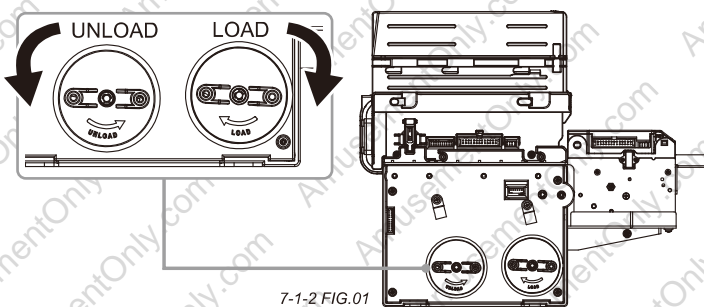
7-1-2. Rotate the wheel to remove the jammed banknote.
