HAZARDOUS / REGULATED MATERIALS SURVEY REPORT

13992 Alma
Detroit, Michigan

April 26, 2019

Hazardous/Regulated Materials Survey Executive Summary¹

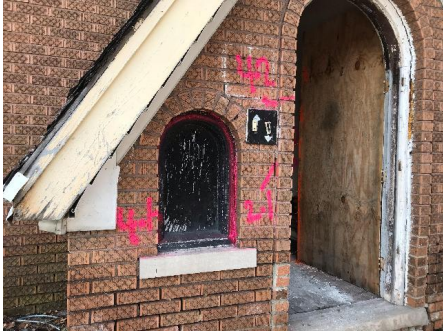
Sample ID: AS 4-1
Notes: Exterior Caulk

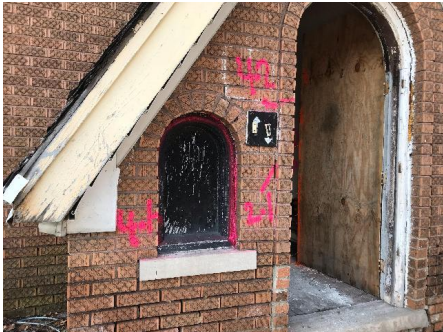
Sample ID: AS 4-2
Notes: Exterior Caulk

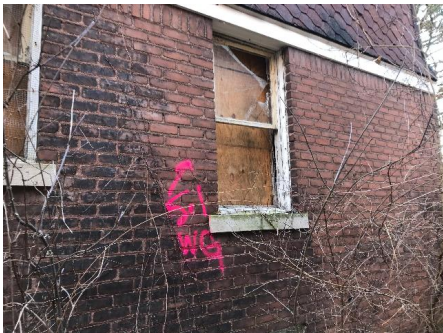
Sample ID: AS 5-1
Notes: House Window Glaze

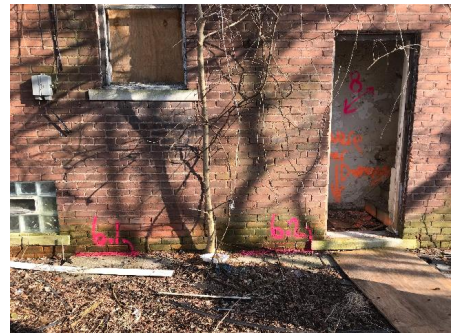
Sample ID: AS 6-2
Notes: Expansion Joint

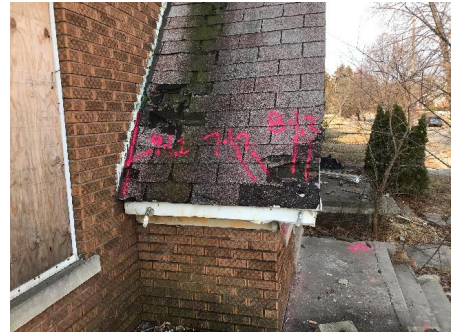
Sample ID: AS 9-1
Notes: Roof Tar

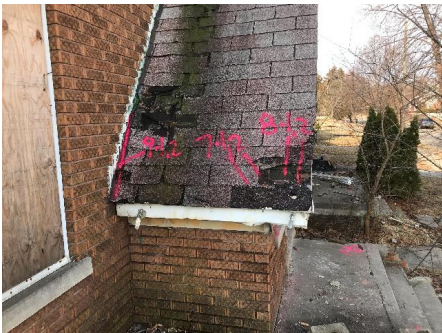
Sample ID: AS 8-1
Notes: Green Roof Shingle

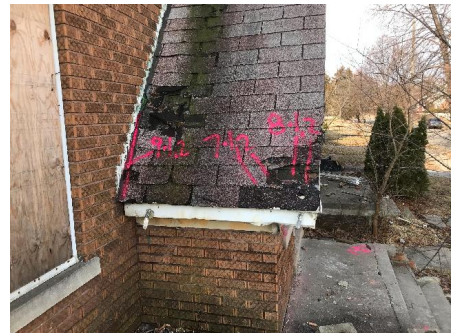
Sample ID: AS 9-2
Notes: Roof Tar

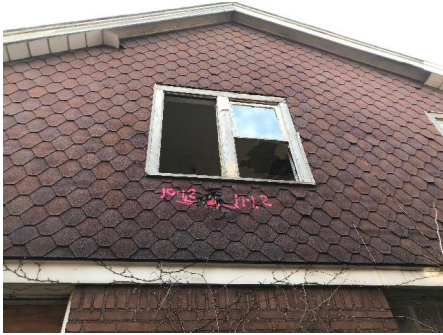
Sample ID: AS 10-1
Notes: Red Octagonal Asphalt Siding

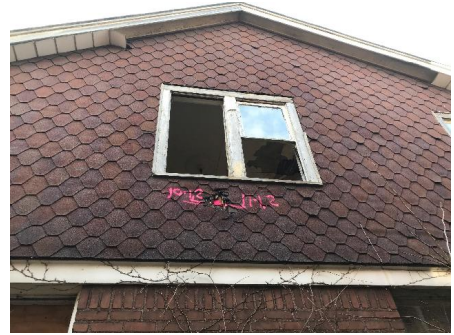
Sample ID: AS 11-2
Notes: Black Siding Underlayment

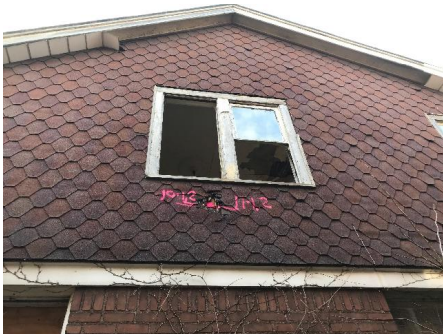
Sample ID: AS 10-2
Notes: Red Octagonal Asphalt Siding

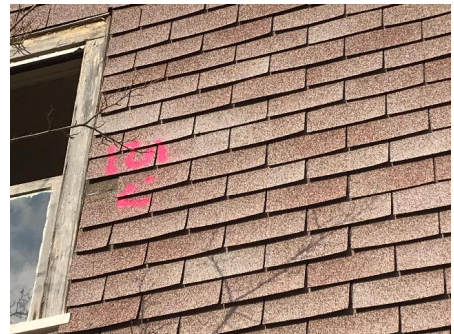
Sample ID: AS 12-1
Notes: Red Square Asphalt Siding

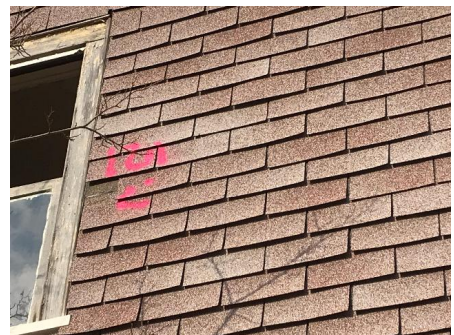
Sample ID: AS 12-2
Notes: Red Square Asphalt Siding

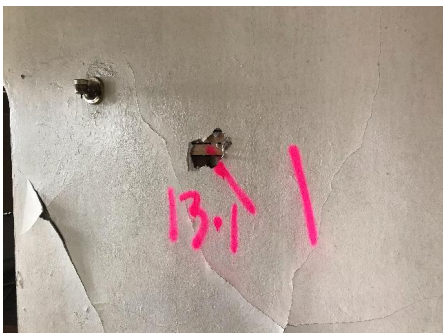
Sample ID: AS 13-1

Notes: Plaster

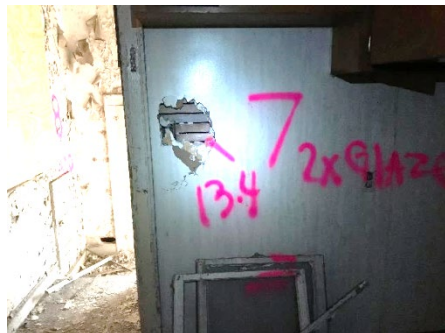
Sample ID: AS 13-4

Notes: Plaster

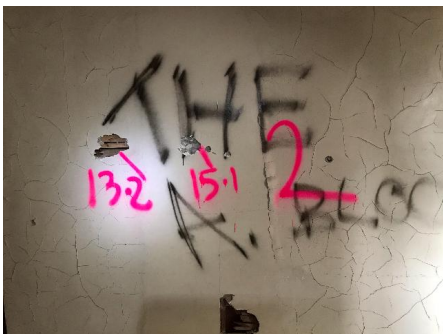
Sample ID: AS 13-2

Notes: Plaster

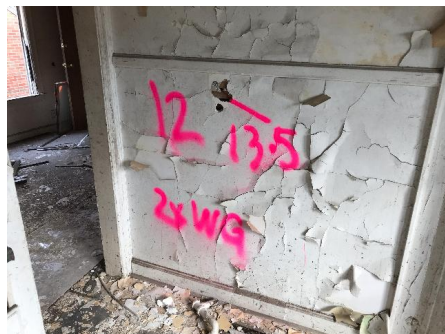
Sample ID: AS 13-5

Notes: Plaster

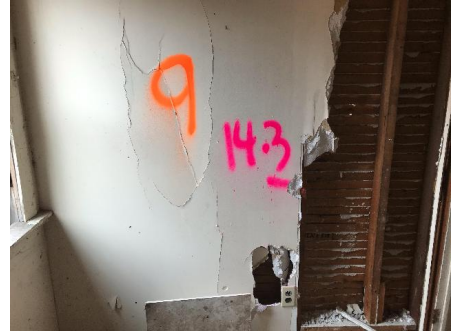
Sample ID: AS 14-3

Notes: Drywall with Joint Compound

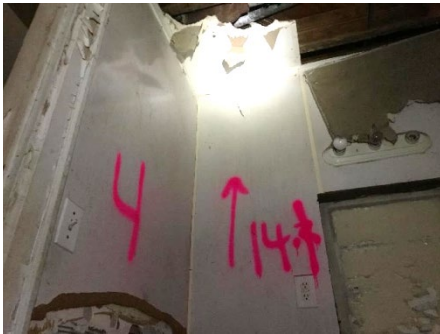
Sample ID: AS 14-1

Notes: Drywall with Joint Compound

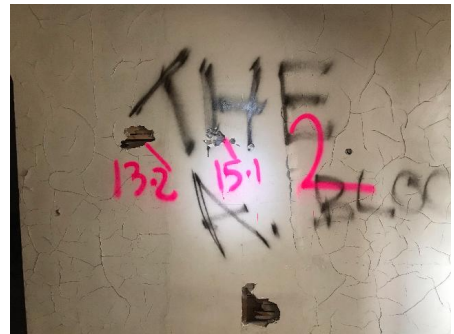
Sample ID: AS 15-1

Notes: Plaster on Backerboard

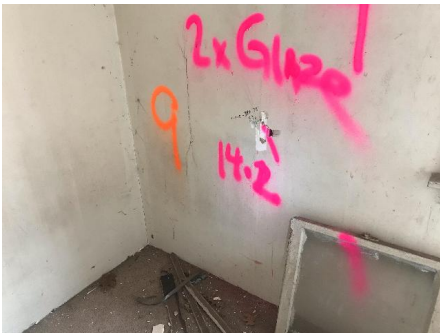
Sample ID: AS 14-2

Notes: Drywall with Joint Compound

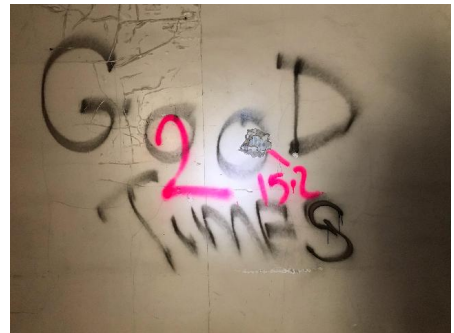
Sample ID: AS 15-2

Notes: Plaster on Backerboard

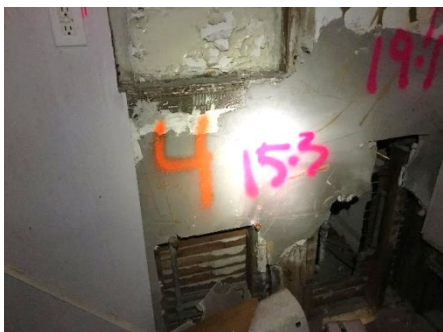
Sample ID: AS 15-3

Notes: Plaster on Backerboard

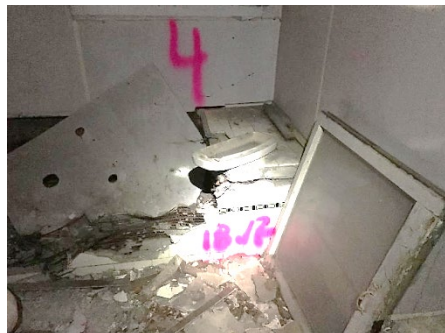
Sample ID: AS 18-1

Notes: Ceramic Tile Wall Mortar

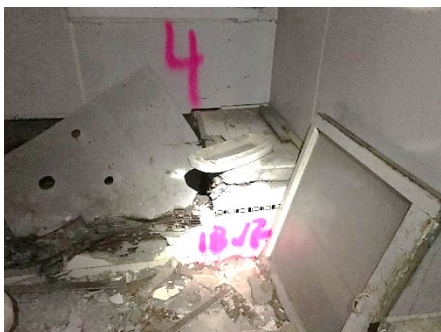
Sample ID: AS 18-2

Notes: Ceramic Tile Wall Mortar

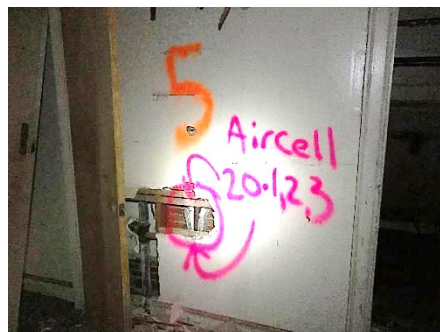
Sample ID: AS 20-1

Notes: Aircell

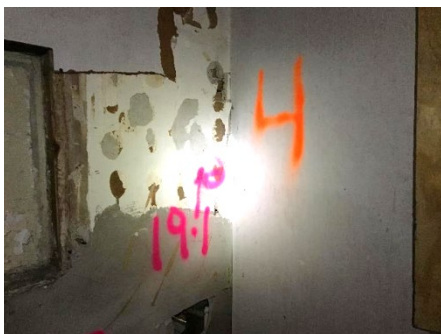
Sample ID: AS 19-1

Notes: Brown Glue

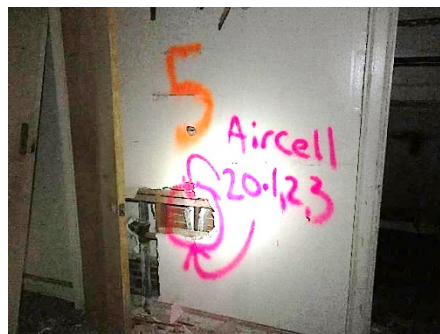
Sample ID: AS 20-2

Notes: Aircell

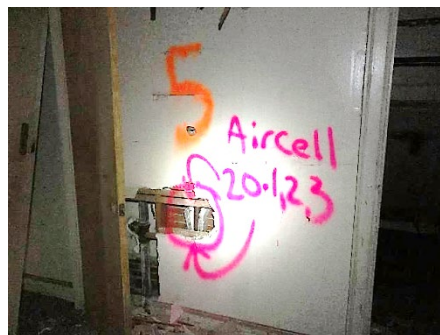
Sample ID: AS 20-3

Notes: Aircell

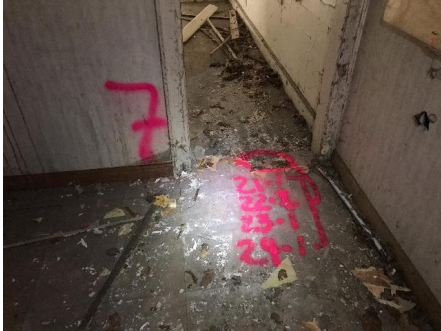
Sample ID: AS 21-1
Notes: Stone 12" Floor Tile

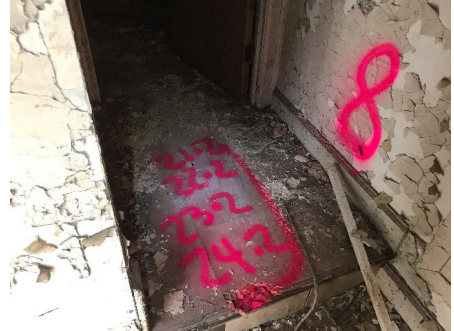
Sample ID: AS 22-2
Notes: Yellow 12" Floor Tile

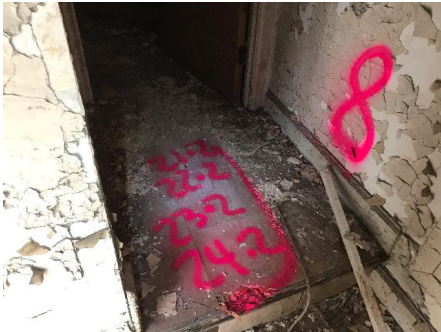
Sample ID: AS 21-2
Notes: Stone 12" Floor Tile

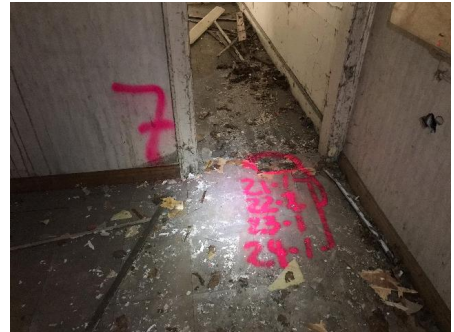
Sample ID: AS 23-1
Notes: Yellow Linoleum

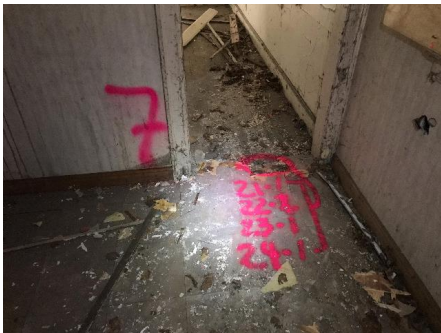
Sample ID: AS 22-1
Notes: Yellow 12" Floor Tile

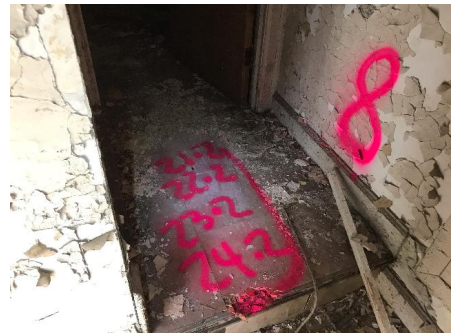
Sample ID: AS 23-2
Notes: Yellow Linoleum

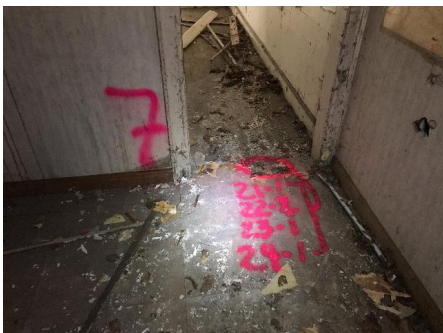
Sample ID: AS 24-1
Notes: Swirl Linoleum

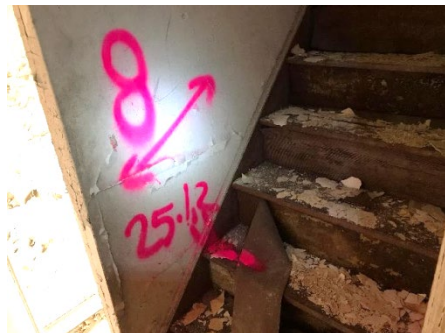
Sample ID: AS 25-2
Notes: Stair Tread

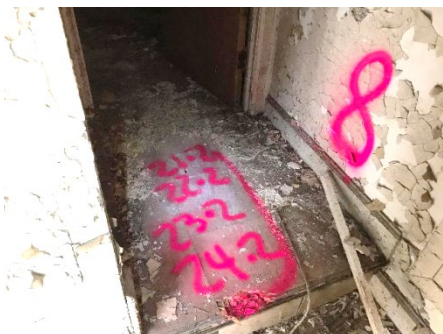
Sample ID: AS 24-2
Notes: Swirl Linoleum

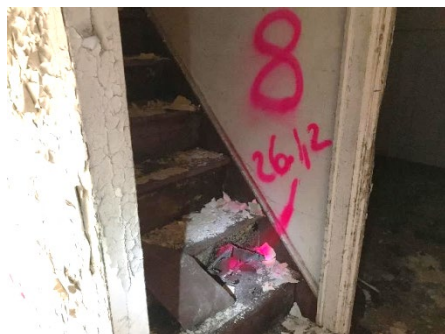
Sample ID: AS 26-1
Notes: Brown Linoleum

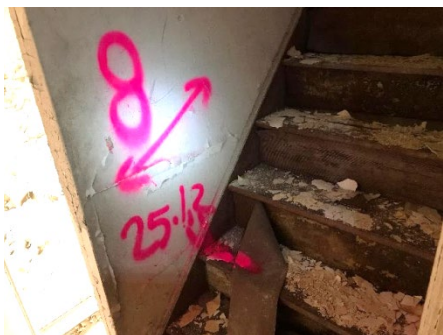
Sample ID: AS 25-1
Notes: Stair Tread

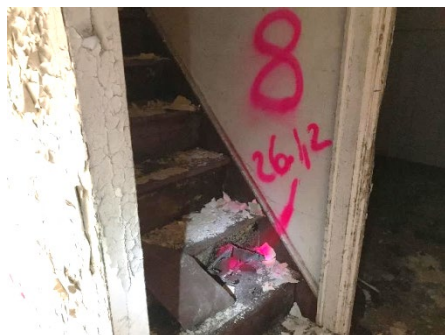
Sample ID: AS 26-2
Notes: Brown Linoleum

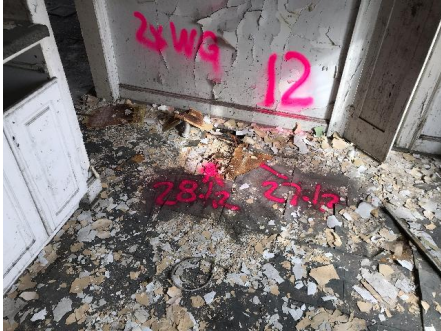
Sample ID: AS 27-1
Notes: Black 12" Floor Tile

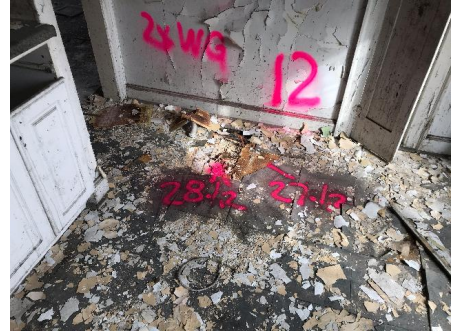
Sample ID: AS 28-2
Notes: Mud Board

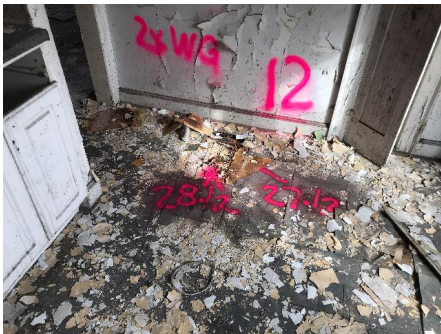
Sample ID: AS 27-2
Notes: Black 12" Floor Tile

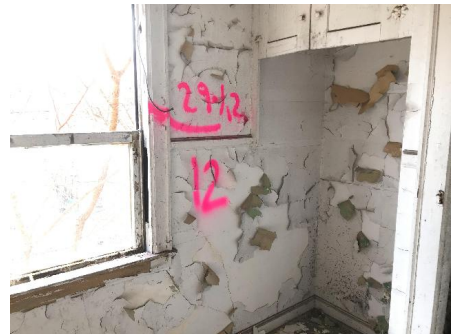
Sample ID: AS 29-1
Notes: Window Rope

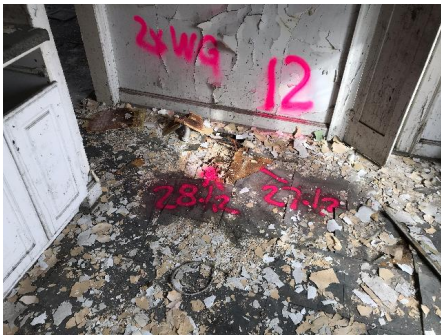
Sample ID: AS 28-1
Notes: Mud Board

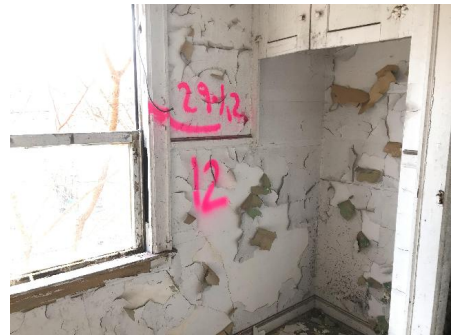
Sample ID: AS 29-2
Notes: Window Rope

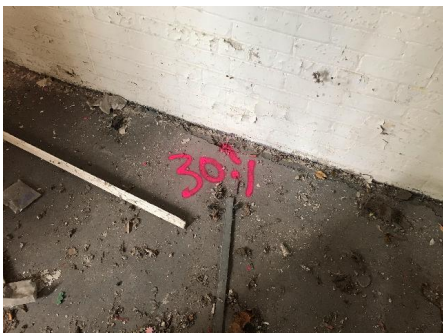
Sample ID: AS 30-1
Notes: Foundation Concrete

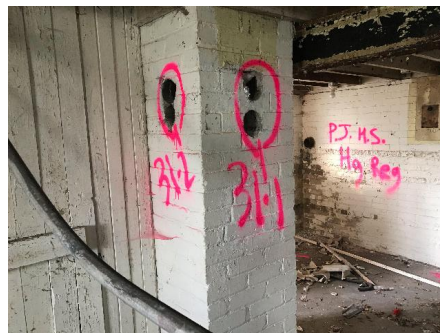
Sample ID: AS 31-2
Notes: Stack Cement

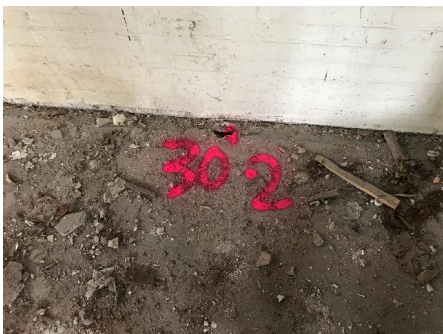
Sample ID: AS 30-2
Notes: Foundation Concrete

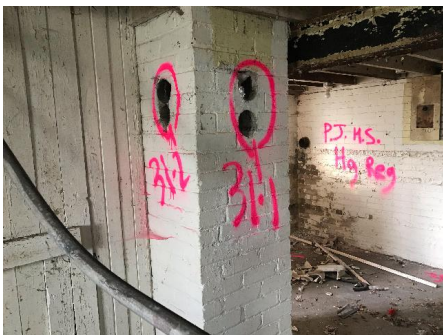
Sample ID: AS 31-1
Notes: Stack Cement

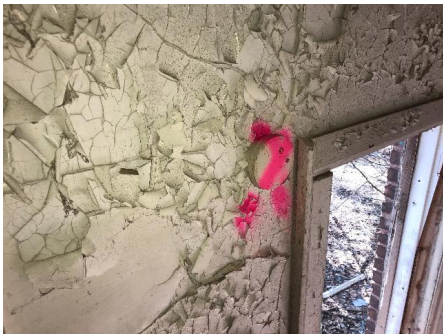
1
Smoke Detector
RM-8

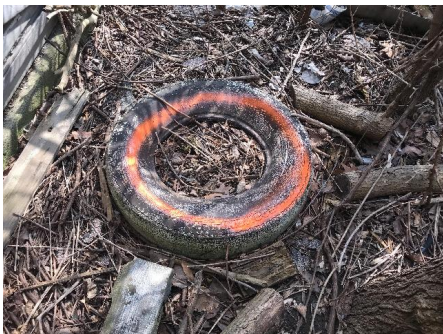
2
Car Tires
Exterior

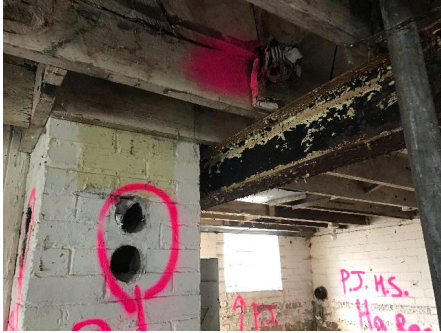
Aircell in Basement Running Up to RM-5
