New Jersey Sports & Exposition Authority Tide Gate Inspection Report

**The National Flood Insurance Program
Community Rating System**

The New Jersey Sports and Exposition Authority

December 7, 2016

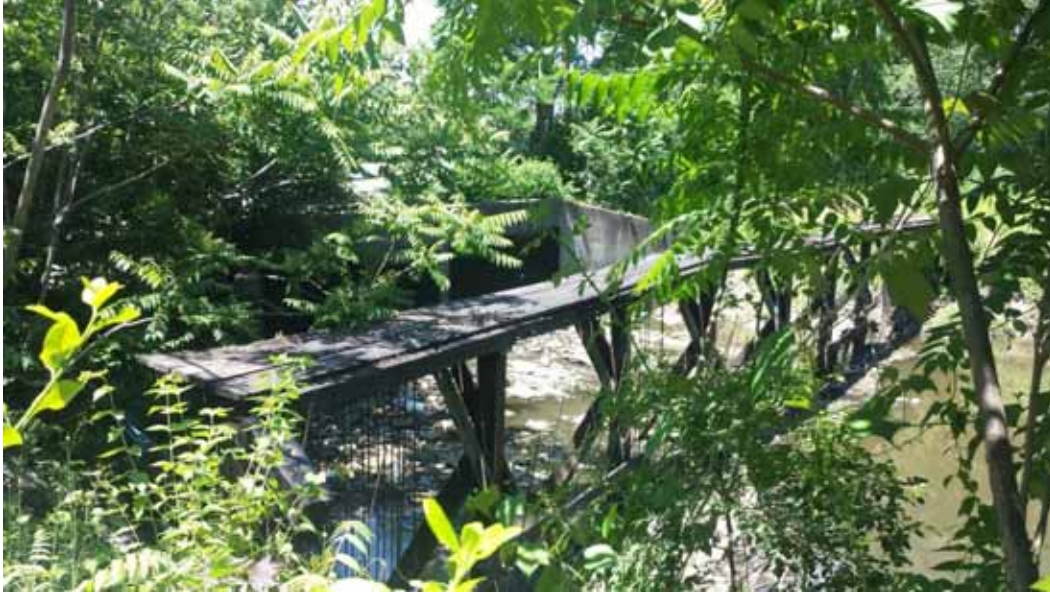
Type of Inspection:		Notes on Condition/Problems:
<input type="checkbox"/> Yearly	<input checked="" type="checkbox"/> Ditch	Debris on upstream side at trash rack.
<input type="checkbox"/> Post-Storm	<input checked="" type="checkbox"/> Tide Gate	
<input type="checkbox"/> Complaint	<input type="checkbox"/> Pump System	
System Designation:		
<input checked="" type="checkbox"/> Natural Stream	<input checked="" type="checkbox"/> Culvert	Notes on Maintenance:
<input type="checkbox"/> Manmade Channel	<input type="checkbox"/> Outfall	Bergen County Mosquito Commission to clear debris
<input type="checkbox"/> Catch Basin	<input type="checkbox"/> Other:	
Overall Functionality:		
<input checked="" type="checkbox"/> Fully Functional	<input type="checkbox"/> High Tide	
<input type="checkbox"/> Functional with Restrictions	<input type="checkbox"/> Low Tide	
<input type="checkbox"/> Non-Functional		
Maintenance Required:		Other Notes:

Figure 1: Upstream view of ditch at tide gate

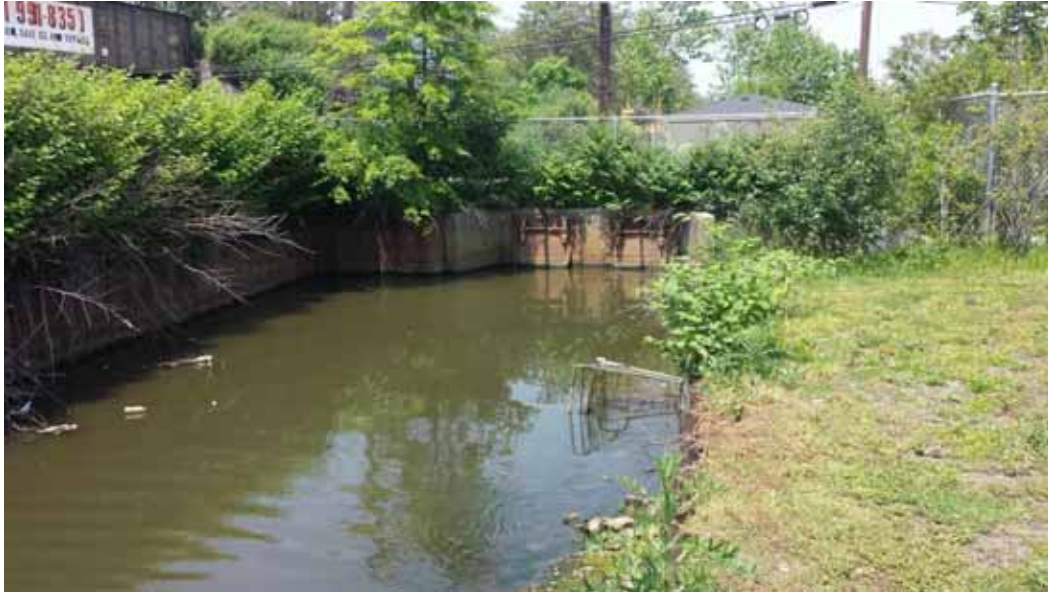
Figure 1: Upstream view of tide gate

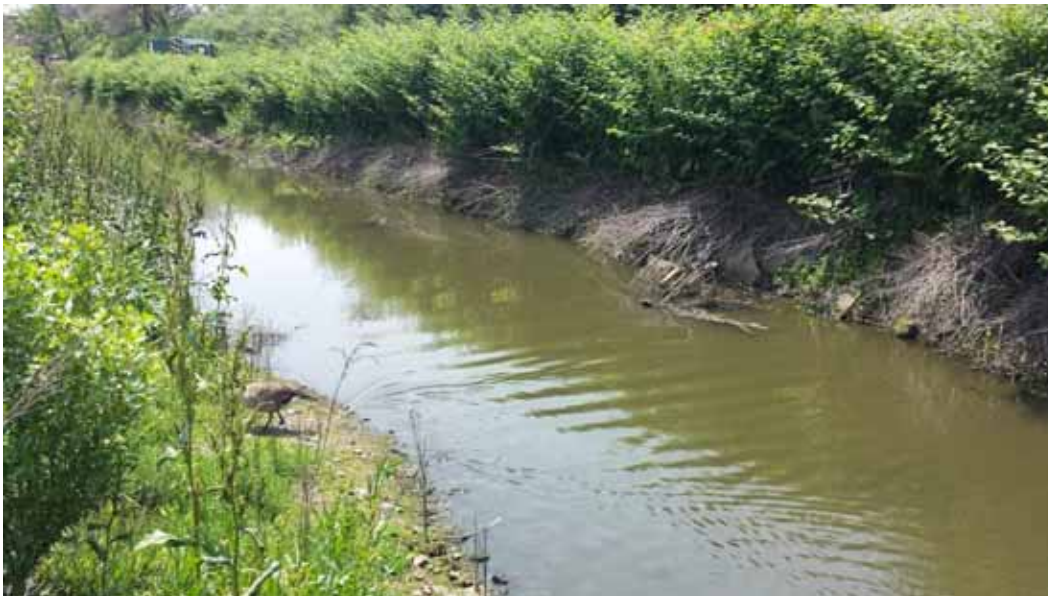
Figure 2: Downstream view from tide gate

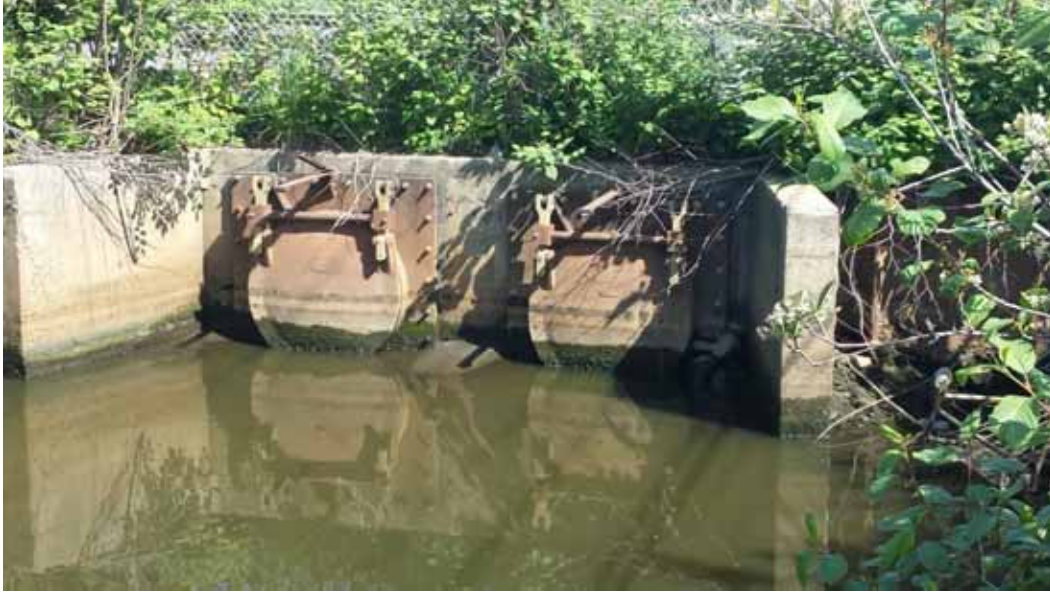
Figure 1: Upstream view of tide gate

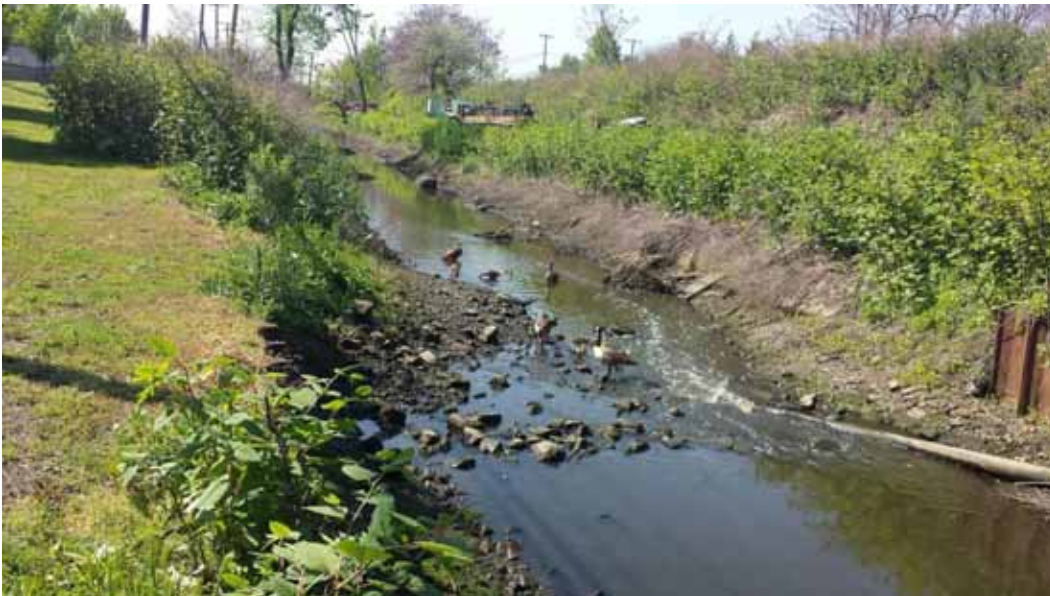
Figure 2: Downstream view from tide gate

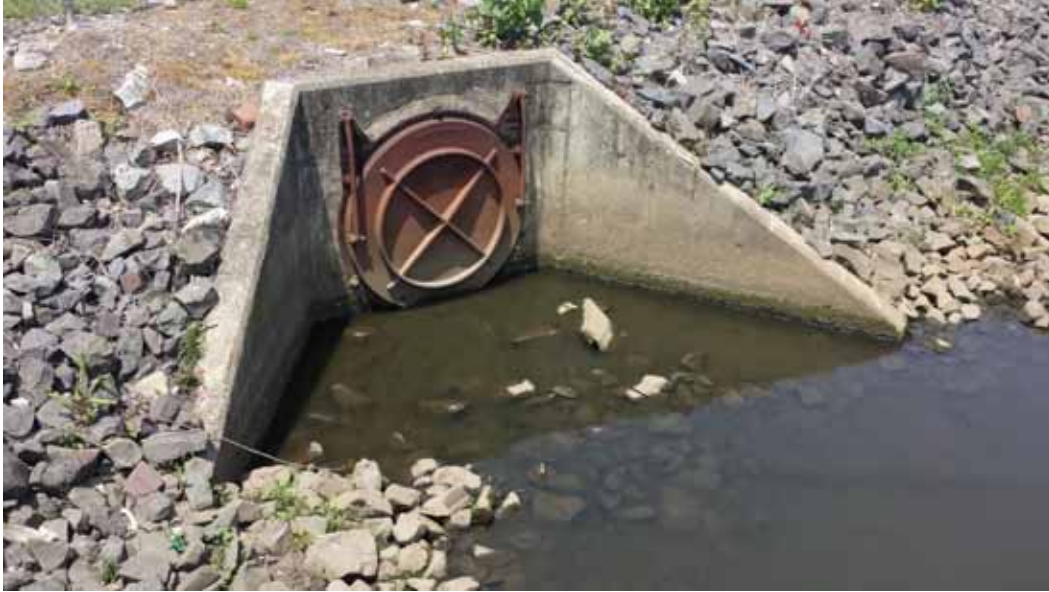
Figure 1: Upstream view of tide gate

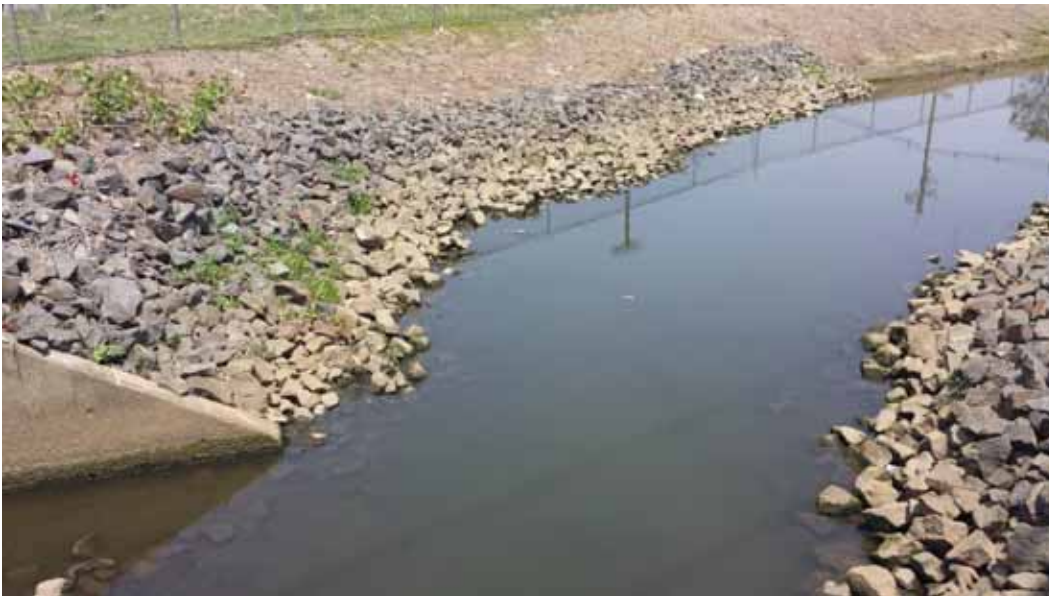
Figure 2: Upstream view from tide gate

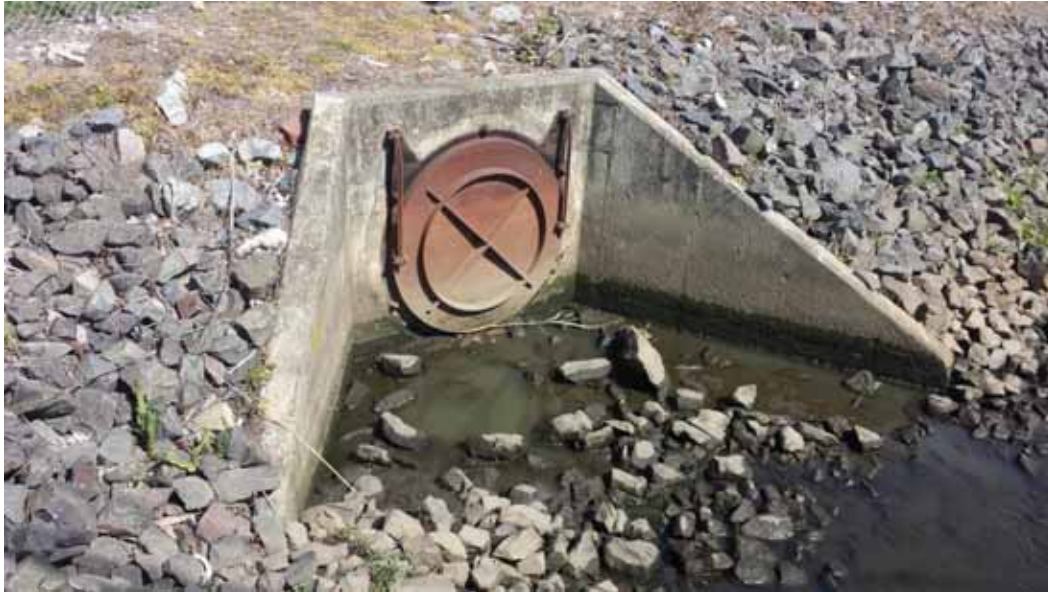
Figure 1: Upstream view of tide gate

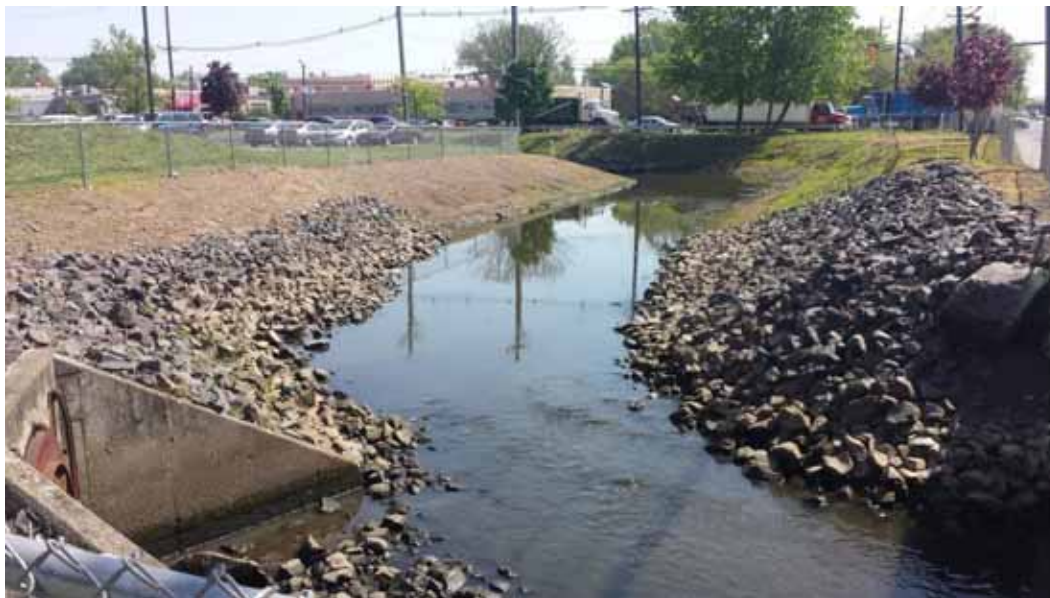
Figure 2: Upstream view from tide gate

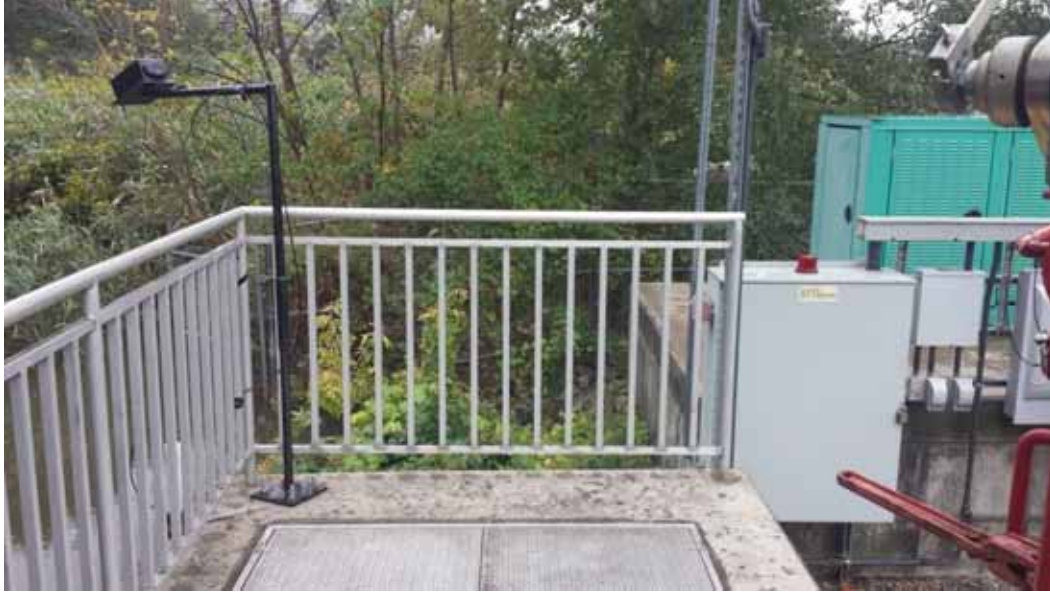
Figure 1: View of ditch adjacent to pump station

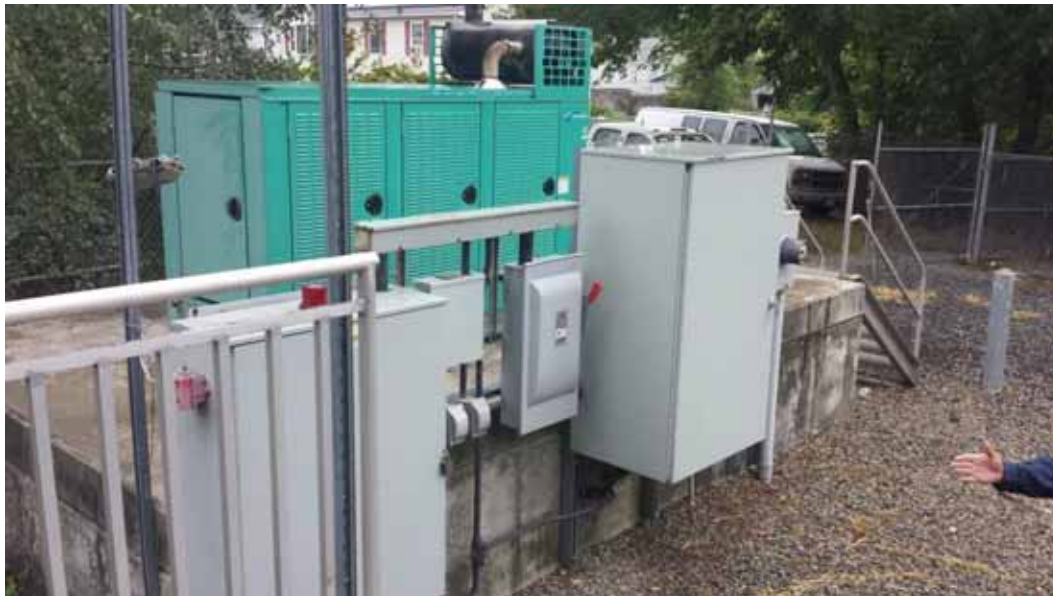
Figure 2: View of pump station and controls

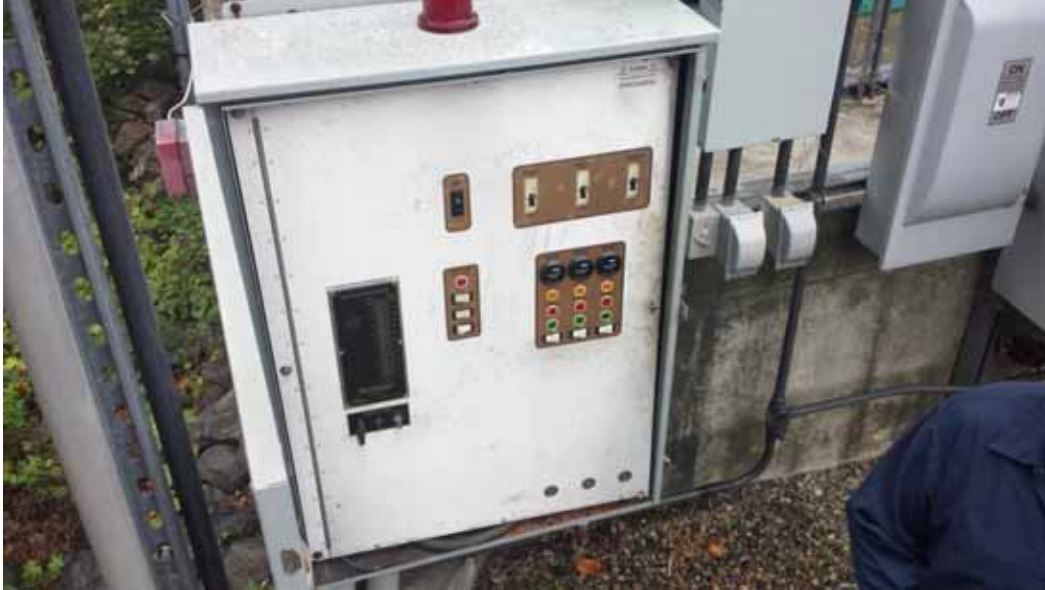
Figure 3: View of pump station controls

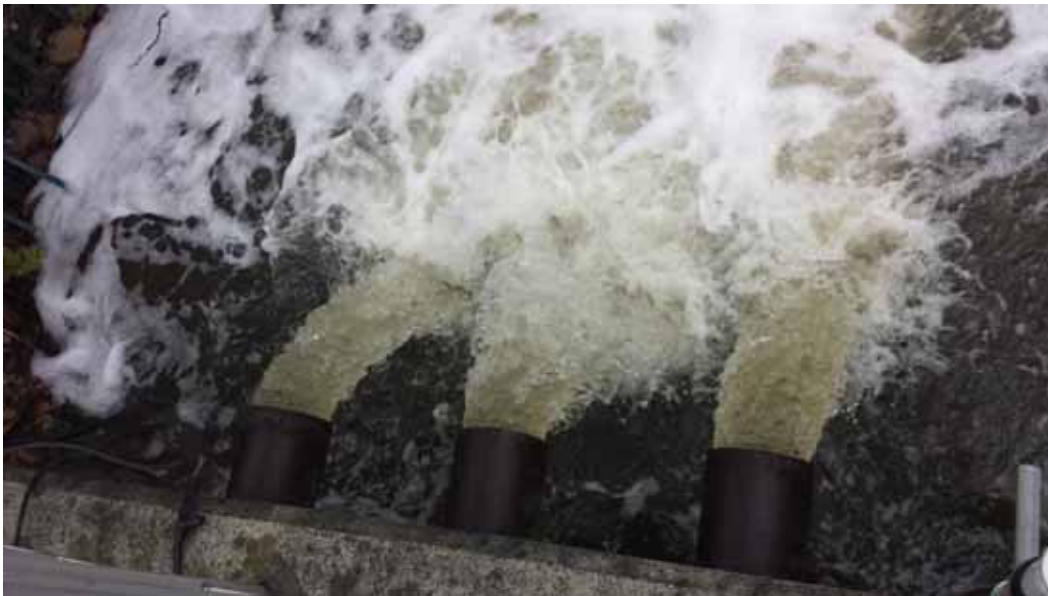
Figure 4: View of pump station in operation

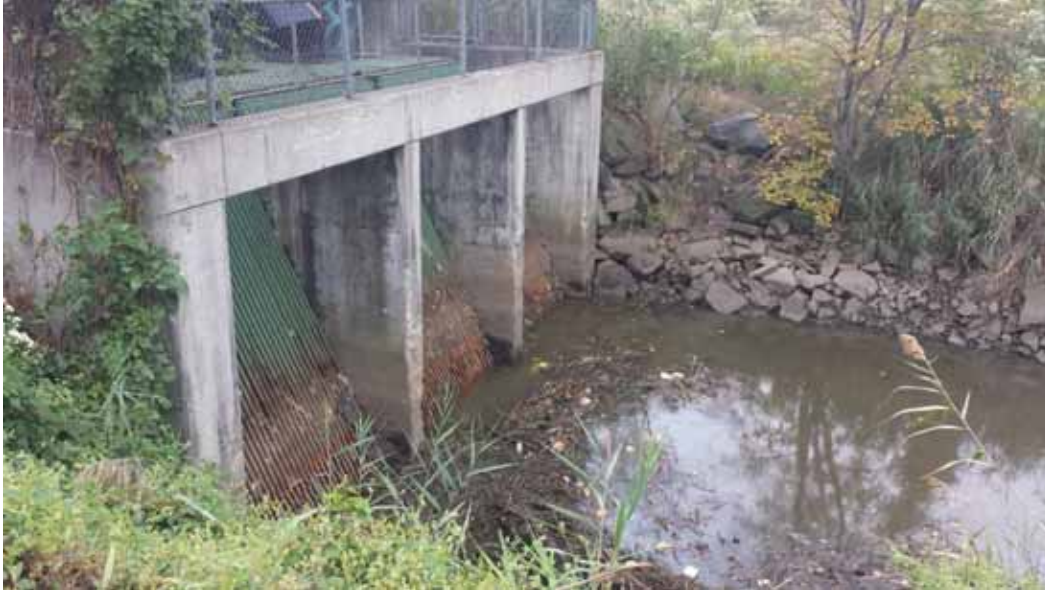
Figure 1: View of trash racks

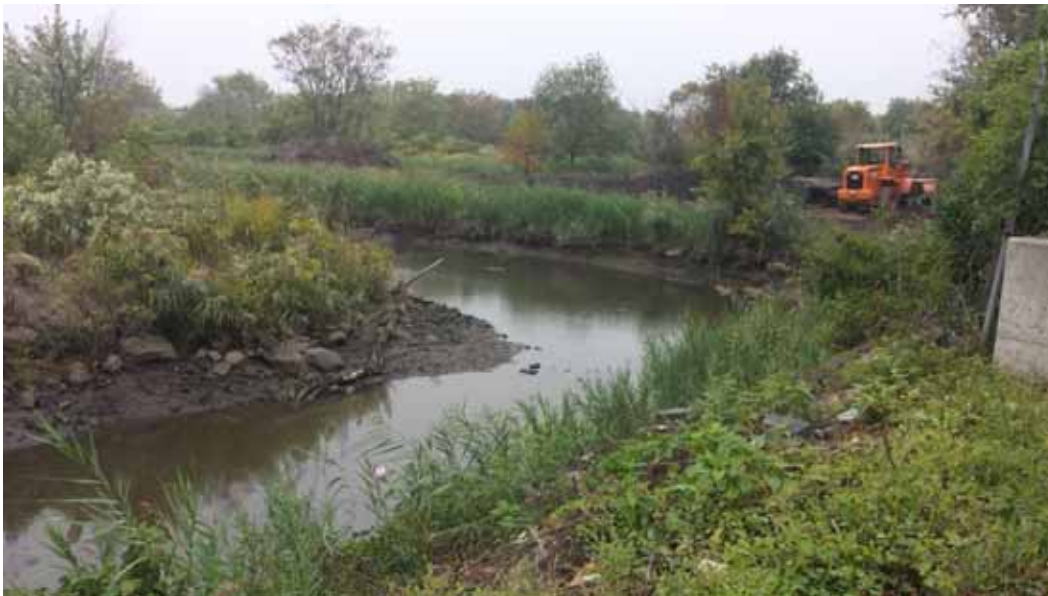
Figure 2: Upstream view of ditch from pump station

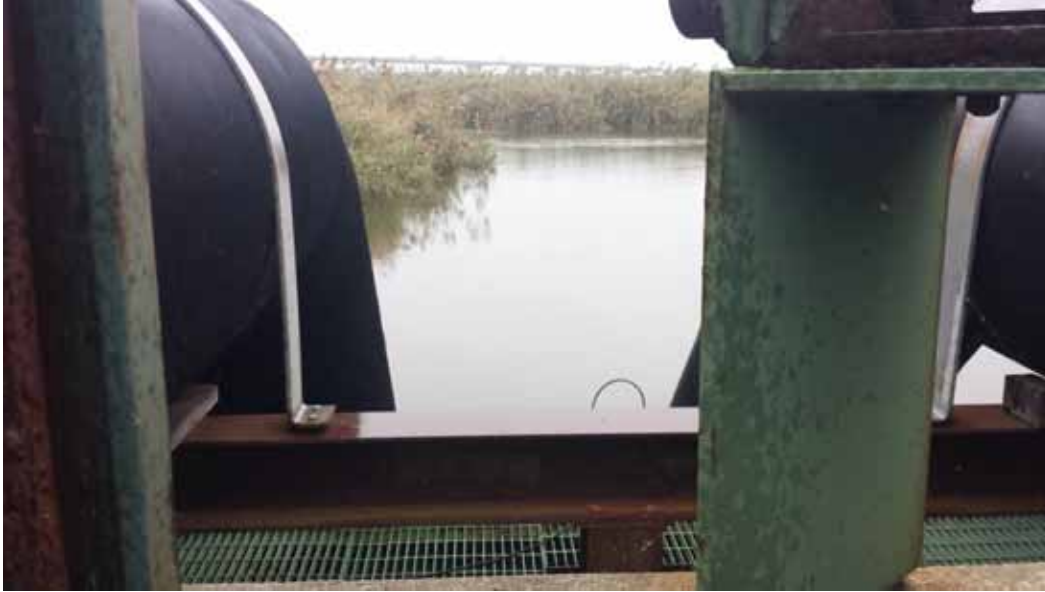
Figure 3: Downstream view from pump station

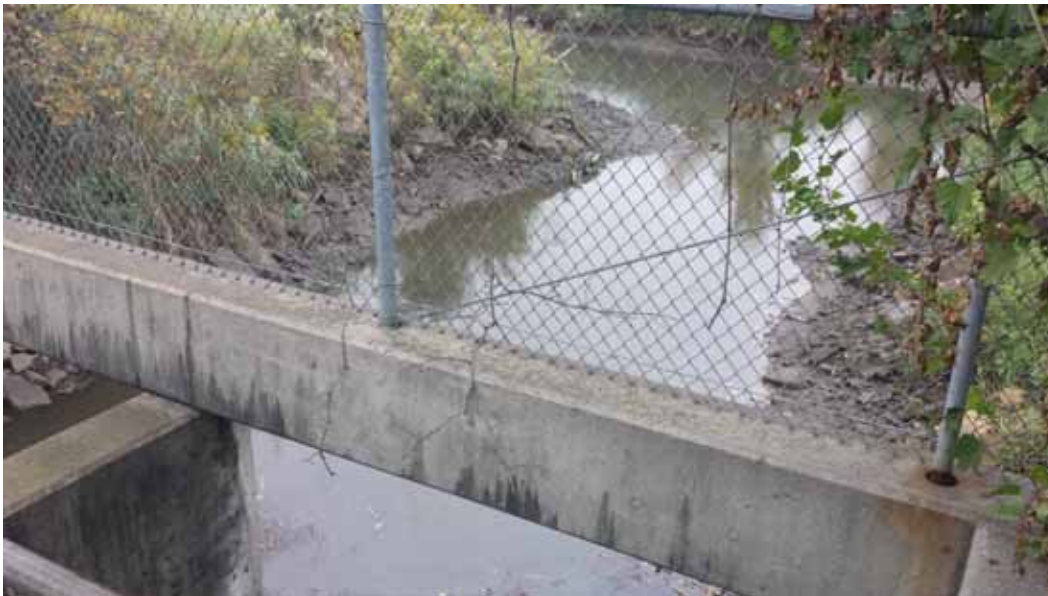
Figure 4: Upstream view of ditch from pump station

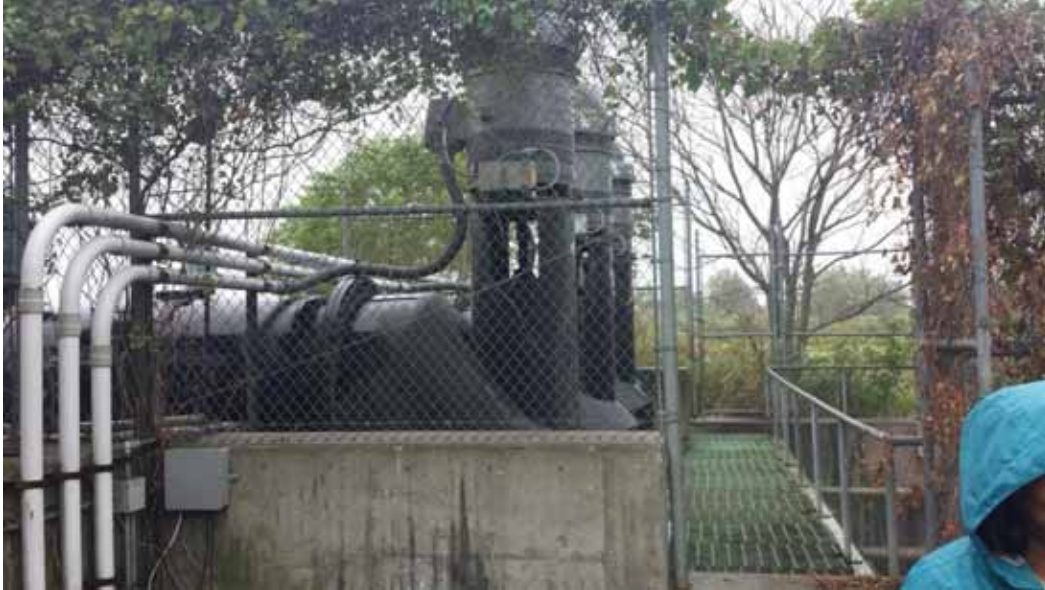
Figure 5: View of 3 pumps

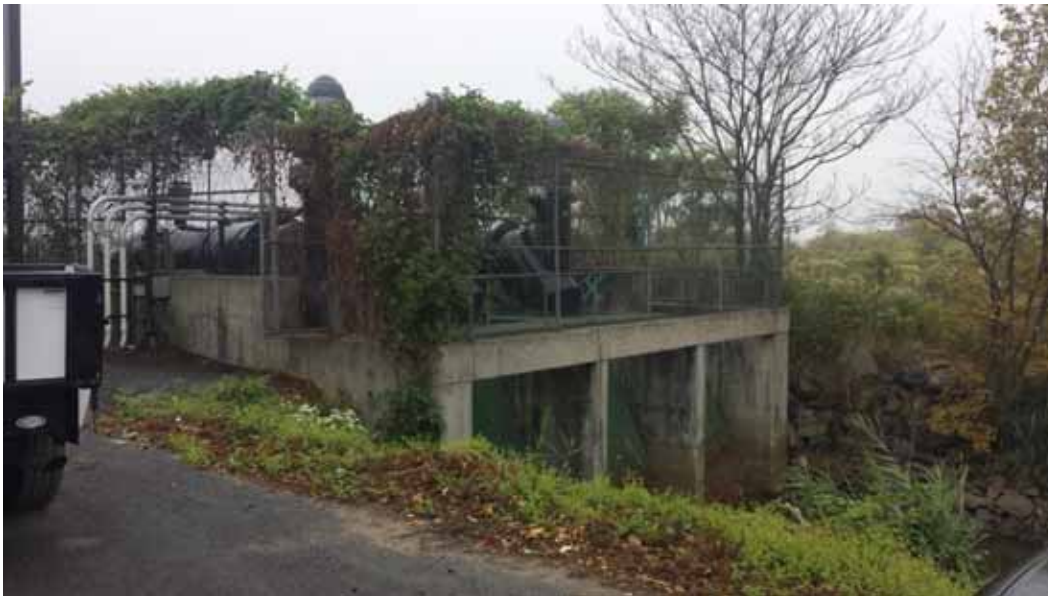
Figure 6: Overall view of pump station

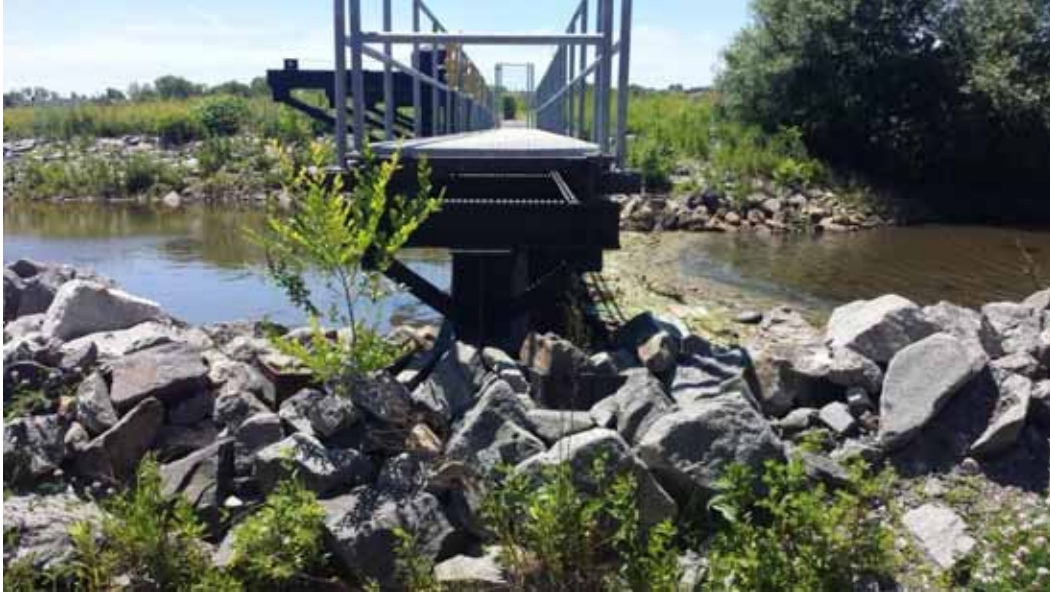
Figure 1: Side view of tide gate

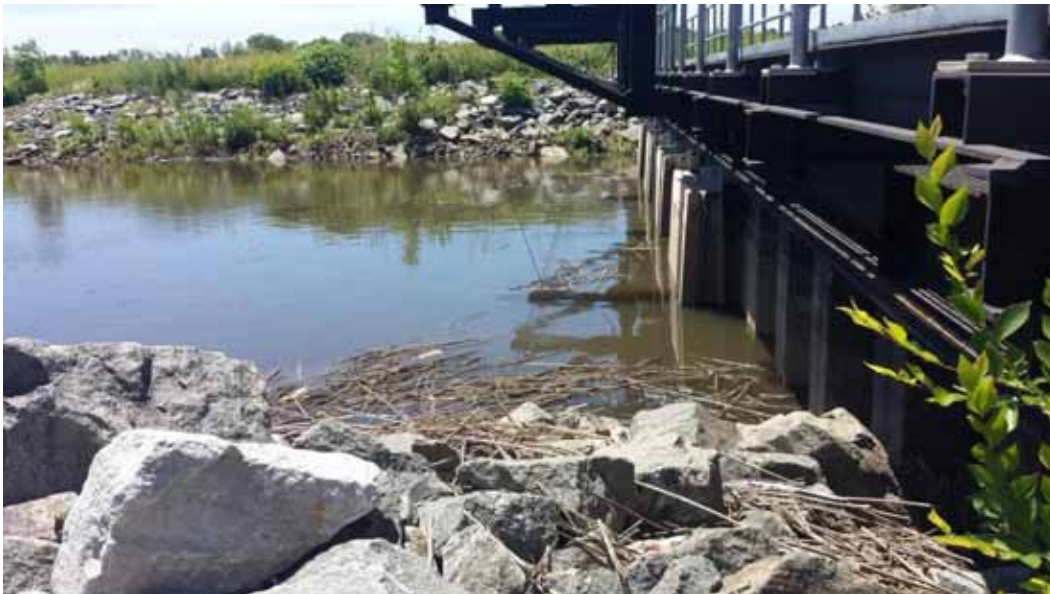
Figure 2: Side view of downstream side of tide gate

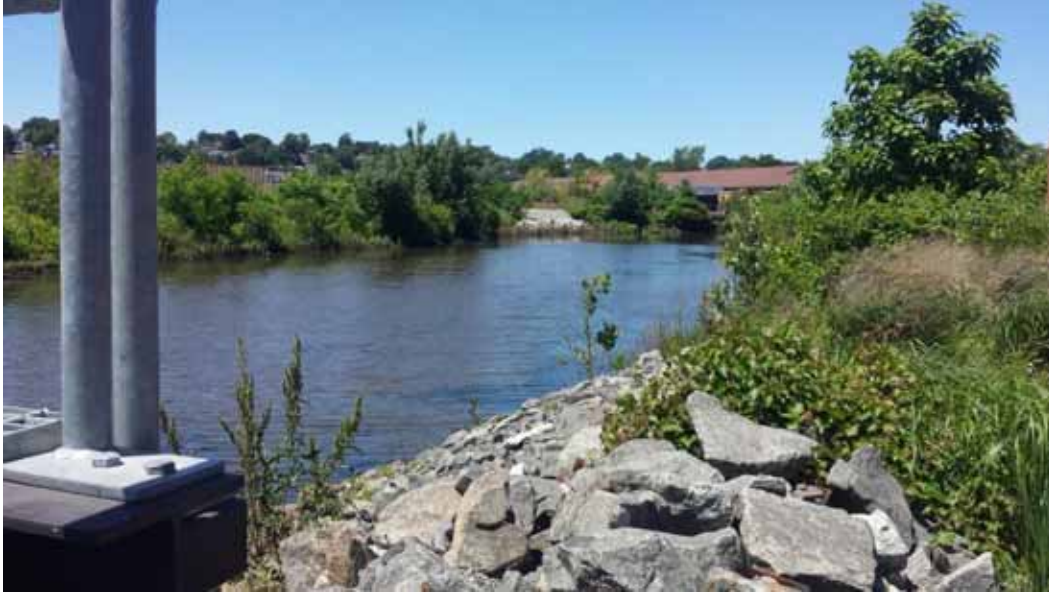
Figure 3: Upstream view of ditch at tide gate

Type of Inspection:		Notes on Condition/Problems:
<input checked="" type="checkbox"/> Yearly	<input type="checkbox"/> Ditch	Debris at trash rack
<input type="checkbox"/> Post-Storm	<input checked="" type="checkbox"/> Tide Gate	Ditches are clear upstream and downstream
<input type="checkbox"/> Complaint	<input type="checkbox"/> Pump System	
System Designation:		
<input checked="" type="checkbox"/> Natural Stream	<input type="checkbox"/> Culvert	
<input type="checkbox"/> Manmade Channel	<input type="checkbox"/> Outfall	
<input type="checkbox"/> Catch Basin	<input type="checkbox"/> Other: _____	
Overall Functionality:		Notes on Maintenance:
<input checked="" type="checkbox"/> Fully Functional	<input type="checkbox"/> High Tide	Clear trash rack
<input type="checkbox"/> Functional with Restrictions	<input checked="" type="checkbox"/> Low Tide	
<input type="checkbox"/> Non-Functional		
Maintenance Required:

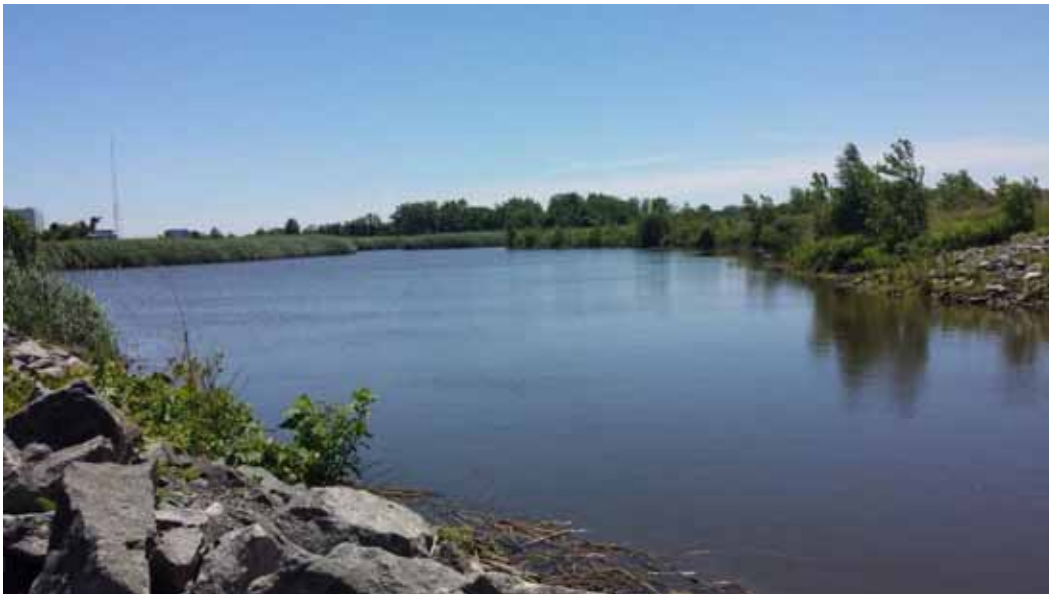
Figure 4: Downstream view of ditch at tide gate

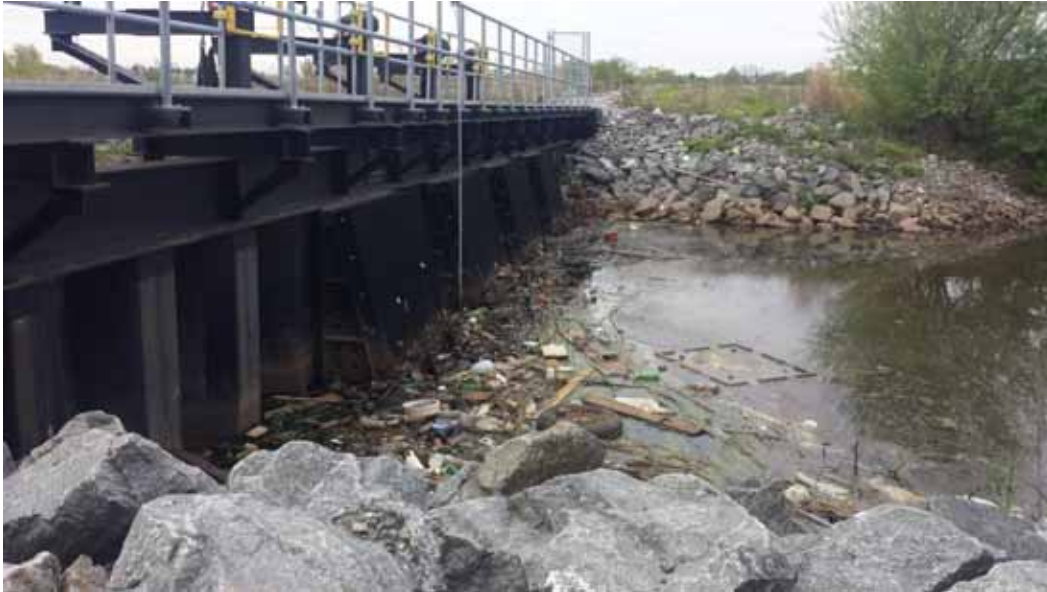
Figure 1: Side view of tide gate upstream

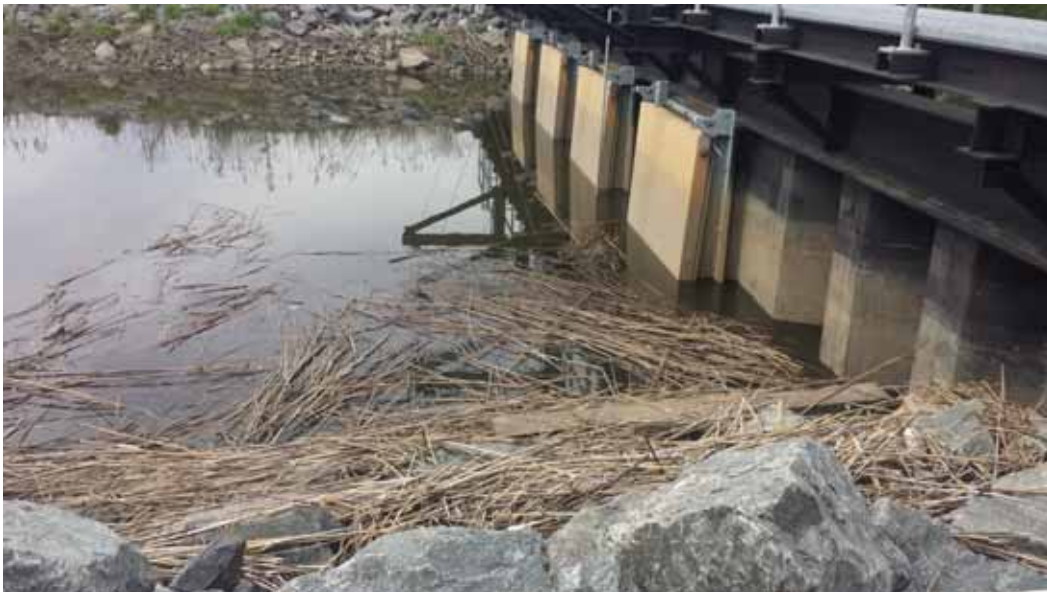
Figure 2: Side view of tide gate downstream

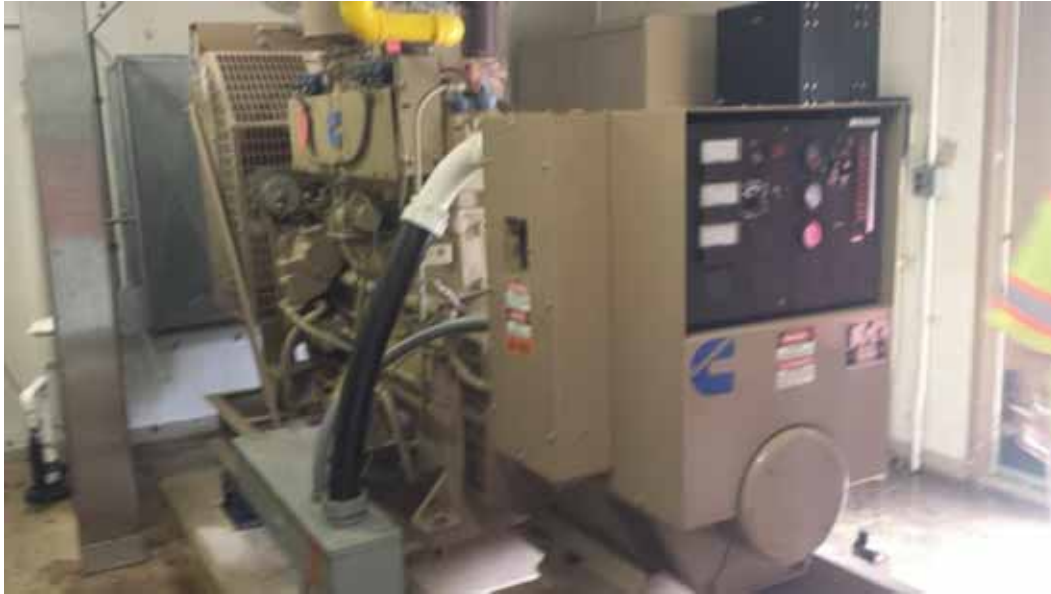
Figure 1: Interior of emergency generator building

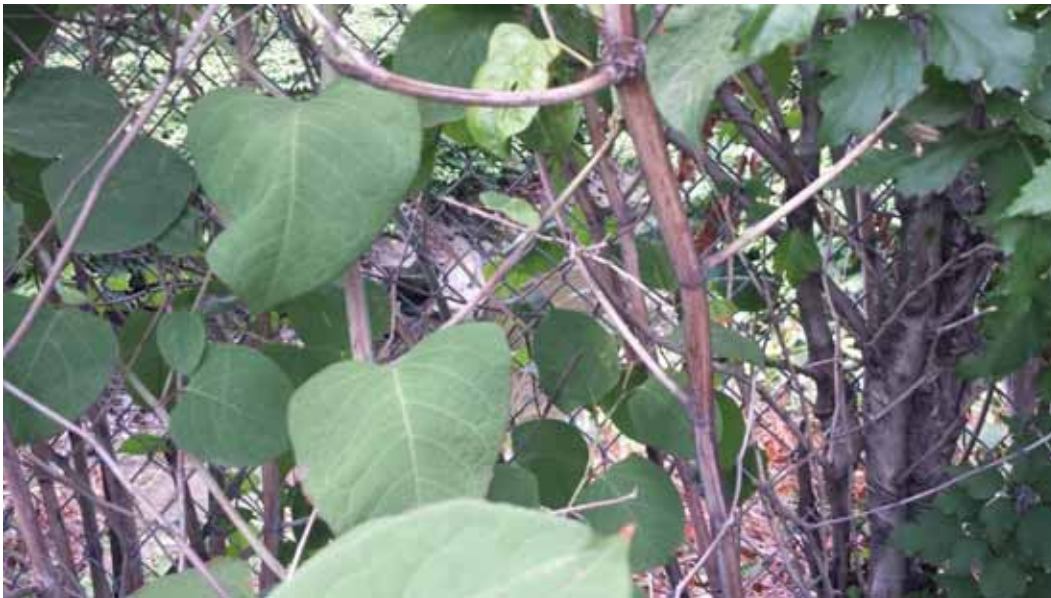
Figure 2: Exterior of emergency generator building

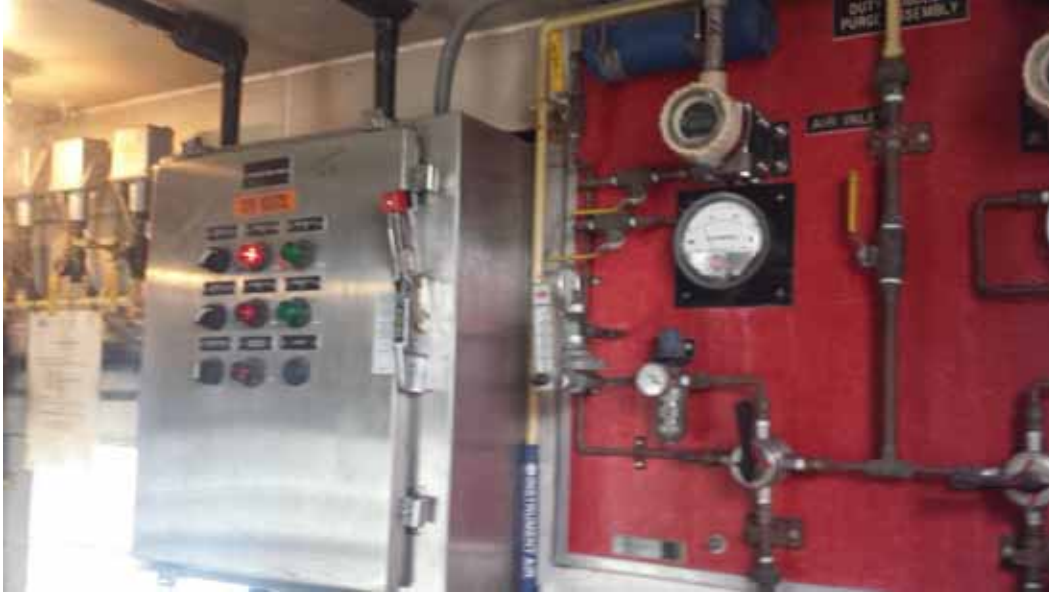
Figure 3: Interior of control room

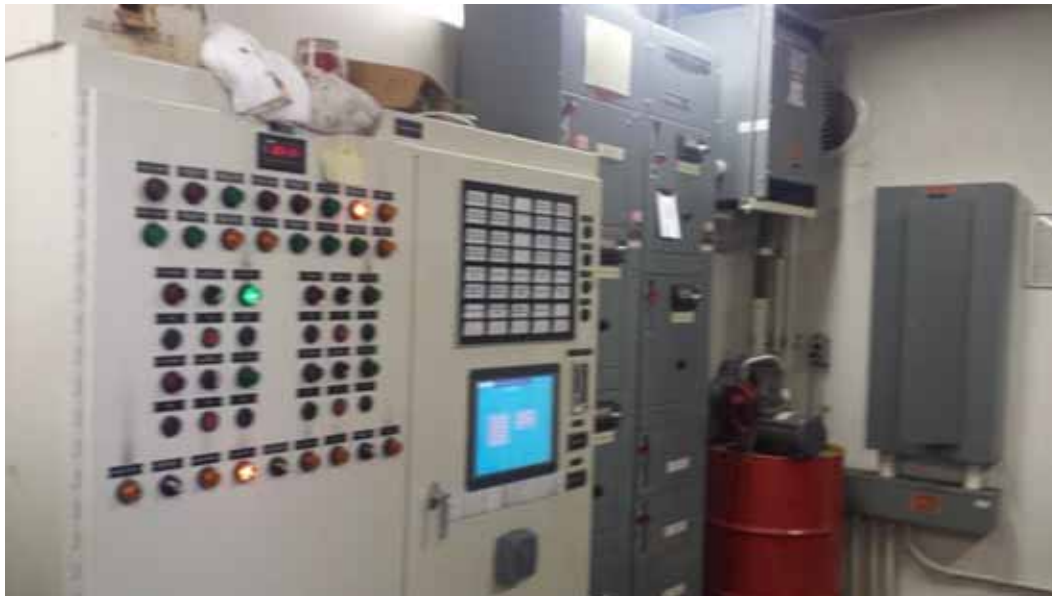
Figure 4: Interior of control room

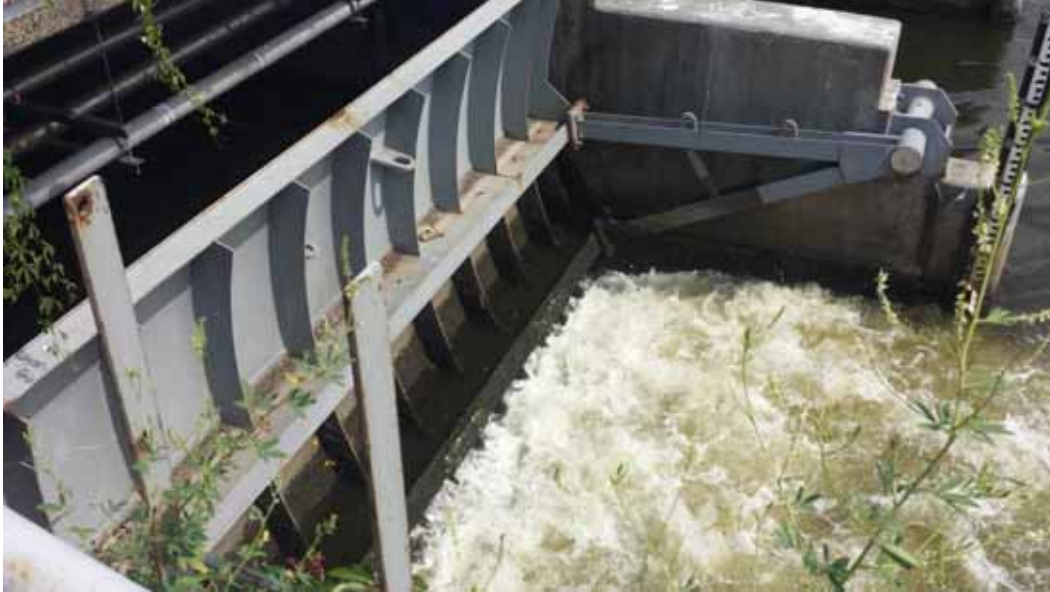
Figure 5: Close up of bascule gate

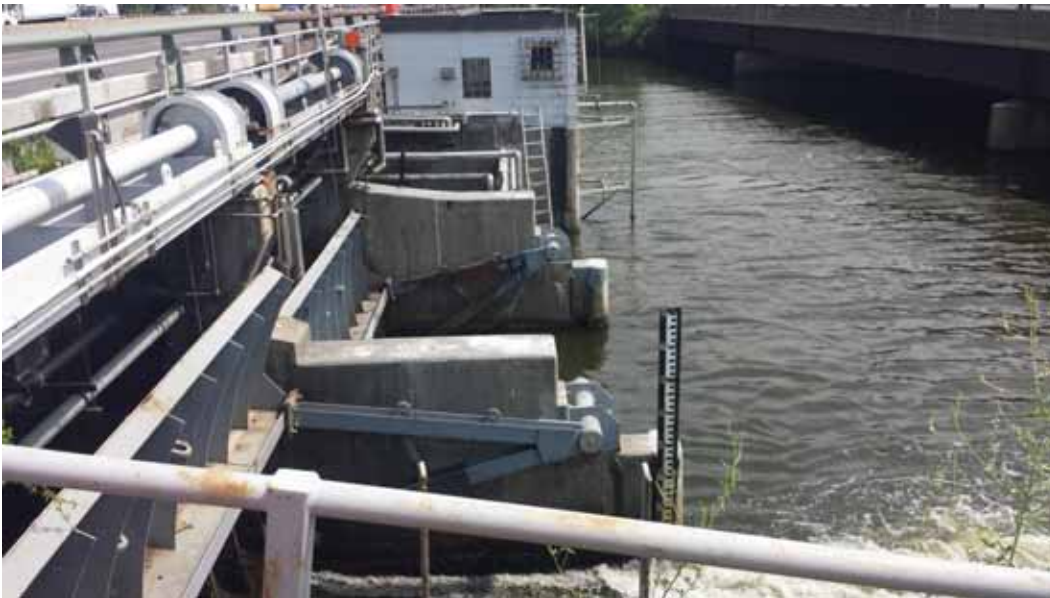
Figure 6: View of one bascule gate in operation from south of control room

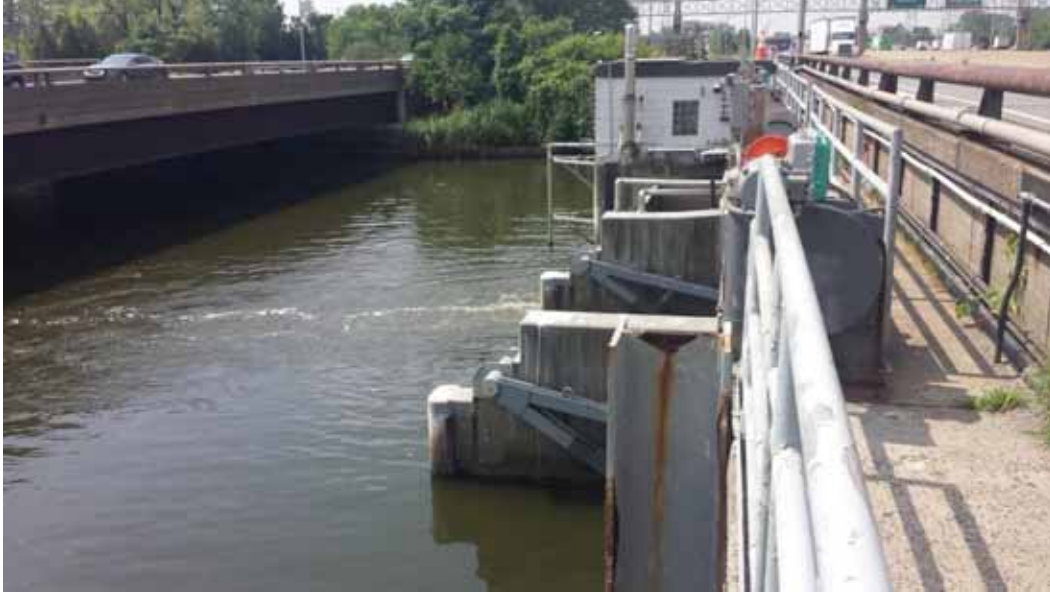
Figure 7: View from north of control room

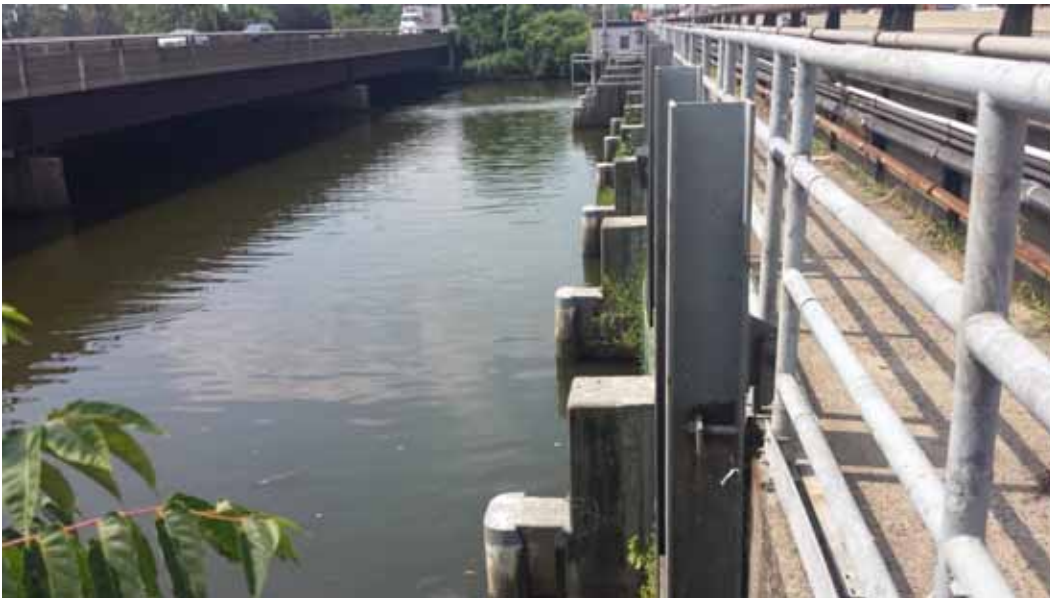
Figure 8: View down entire structure

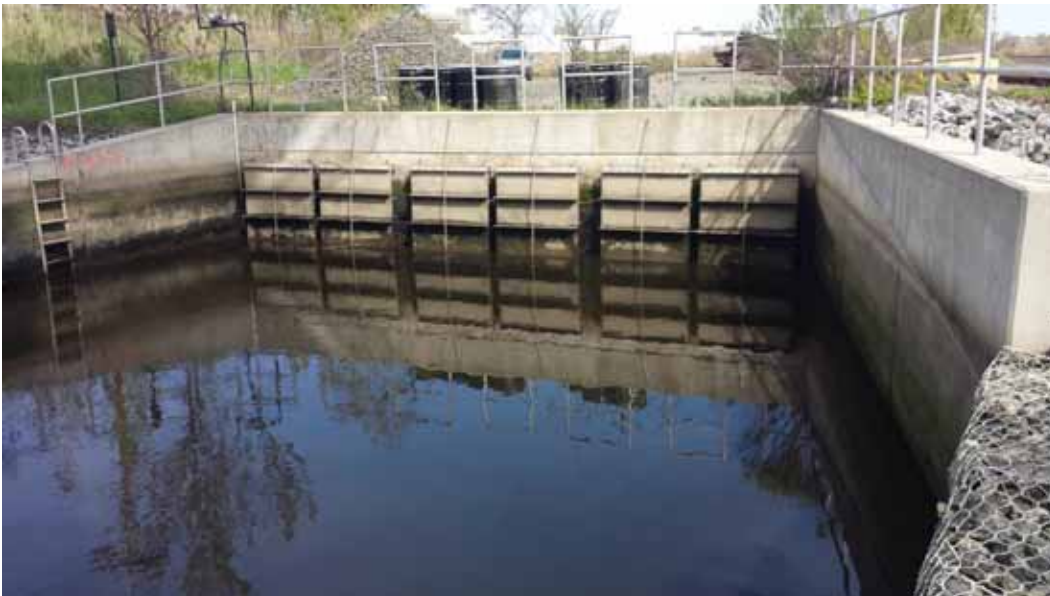
Figure 2: Downstream view of tide gate

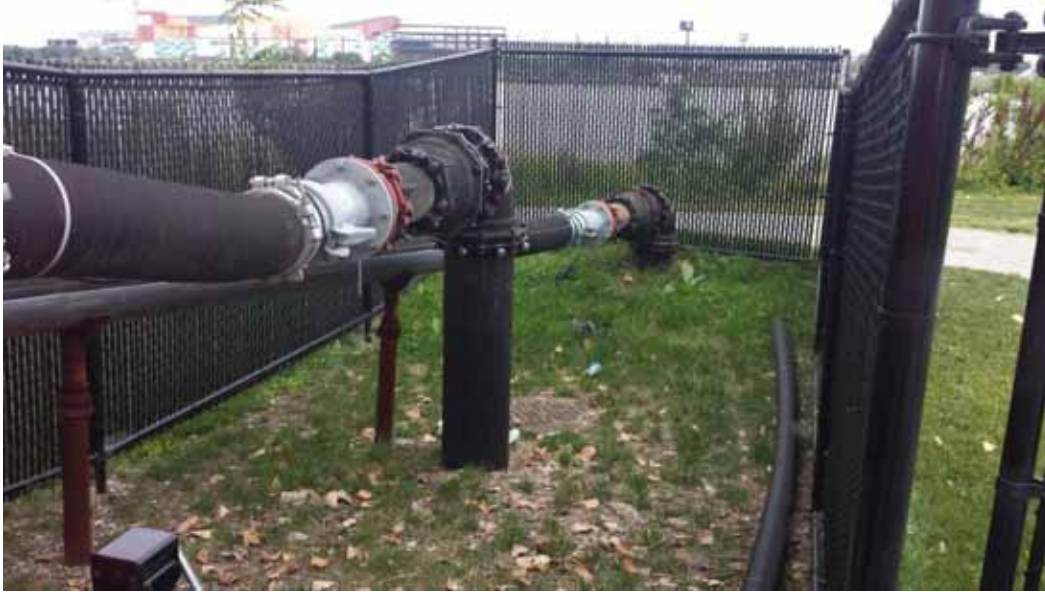
Figure 1: Exterior pipe connections
