New Jersey Sports & Exposition Authority Tide Gate Inspection Report

**The National Flood Insurance Program
Community Rating System**

The New Jersey Sports and Exposition Authority

December 7, 2016

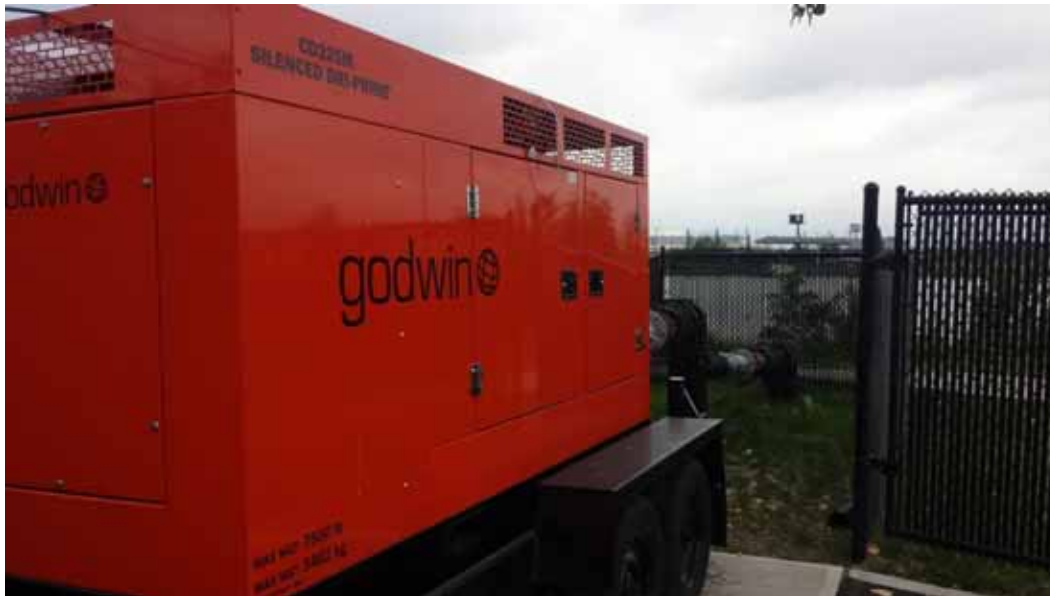
Figure 2: View of Godwin pump

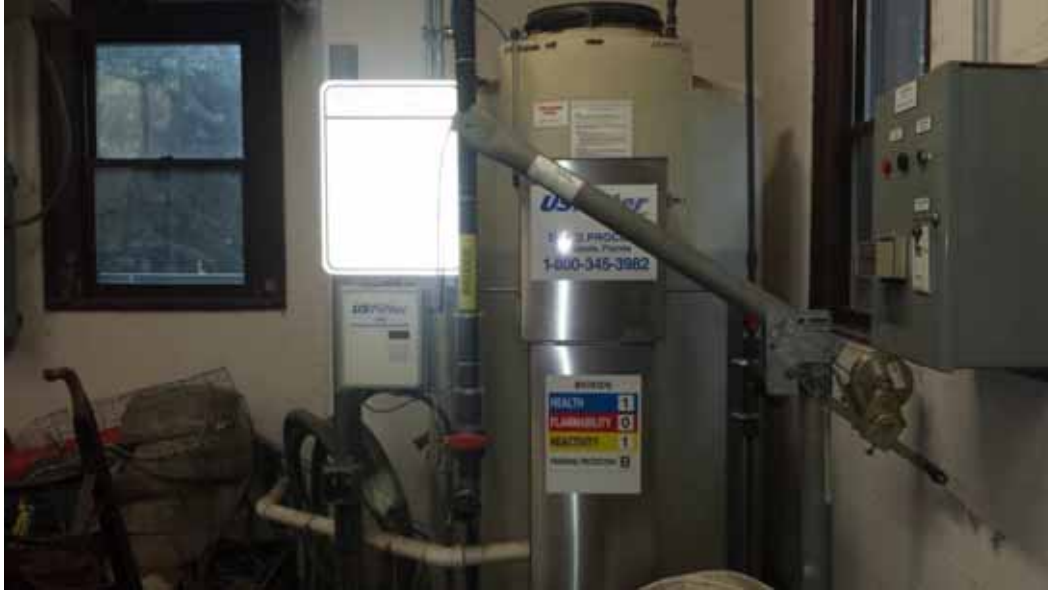
Figure 3: Interior of control room

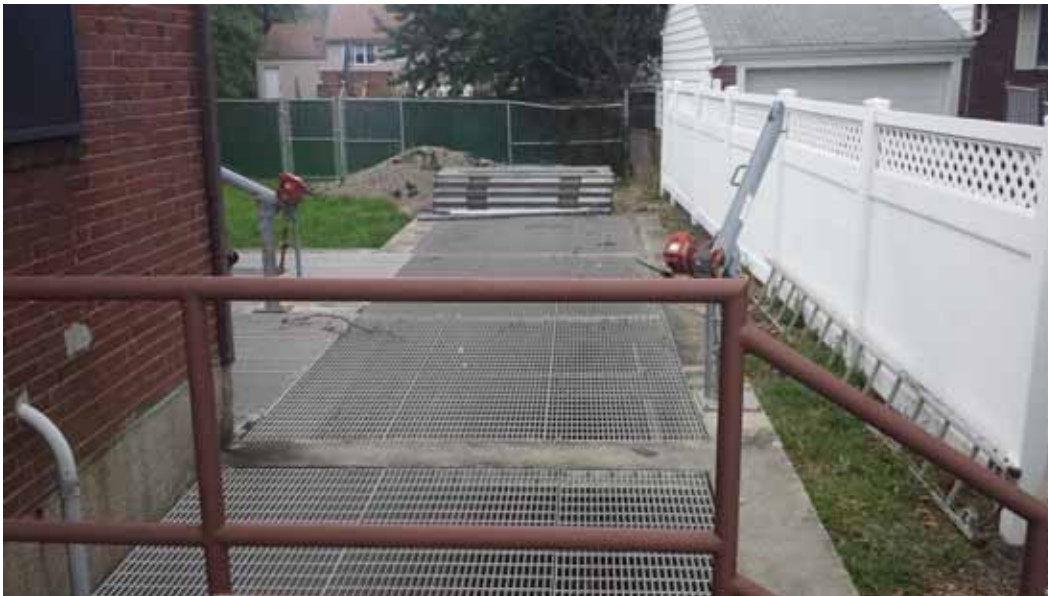
Figure 4: Exterior of pump station

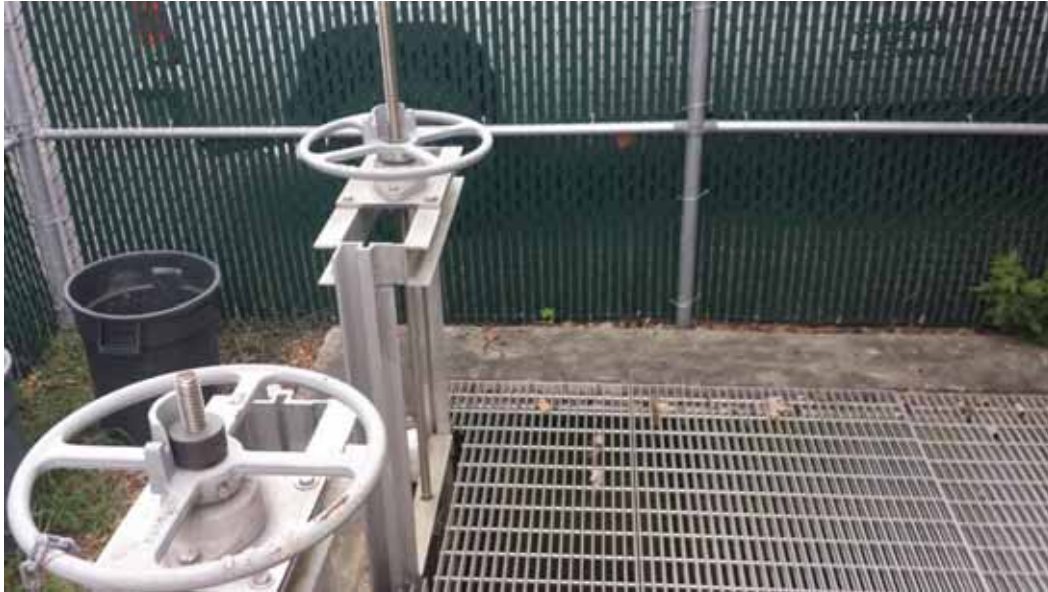
Figure 5: View of tide gate controls

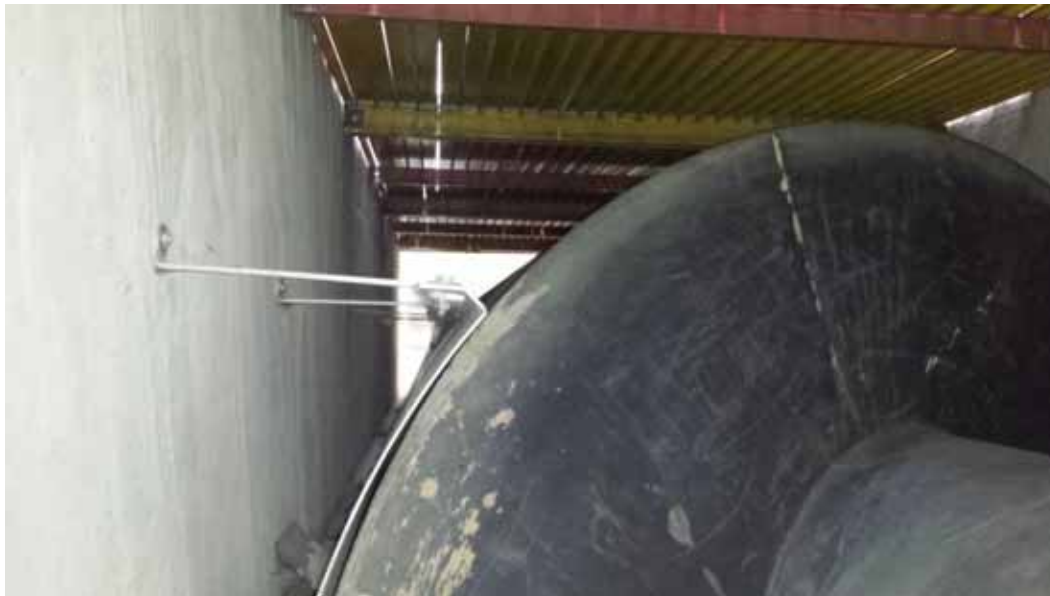
Figure 6: View of screw pump

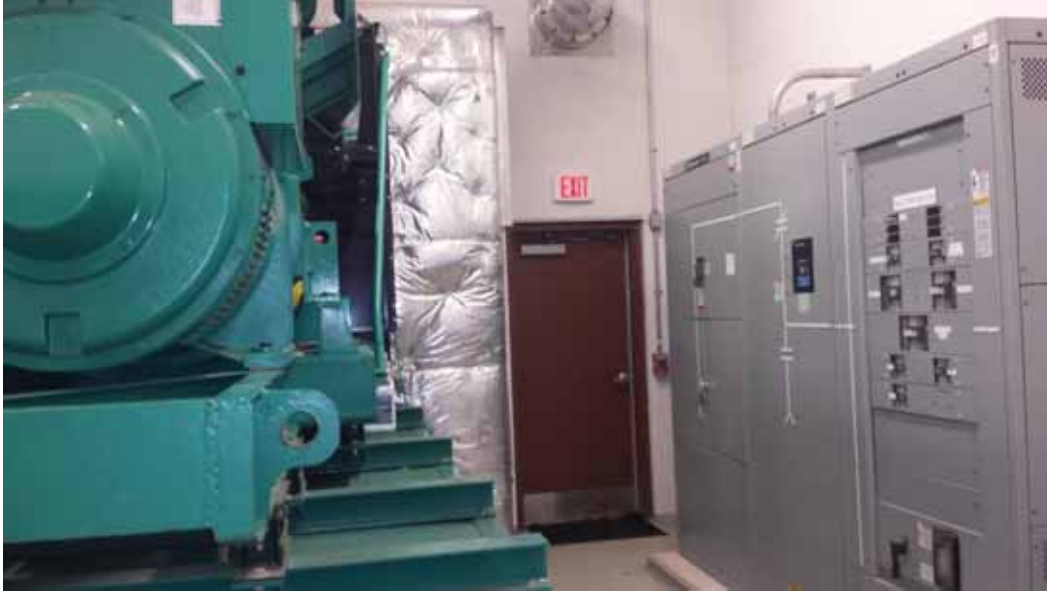
Figure 7: View of of control room

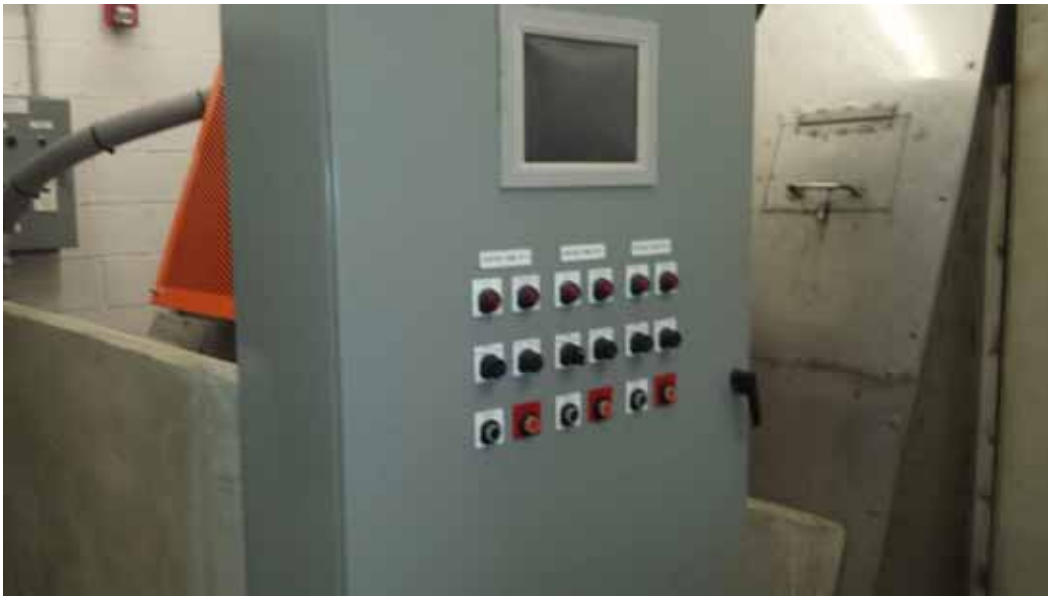
Figure 8: View of control room

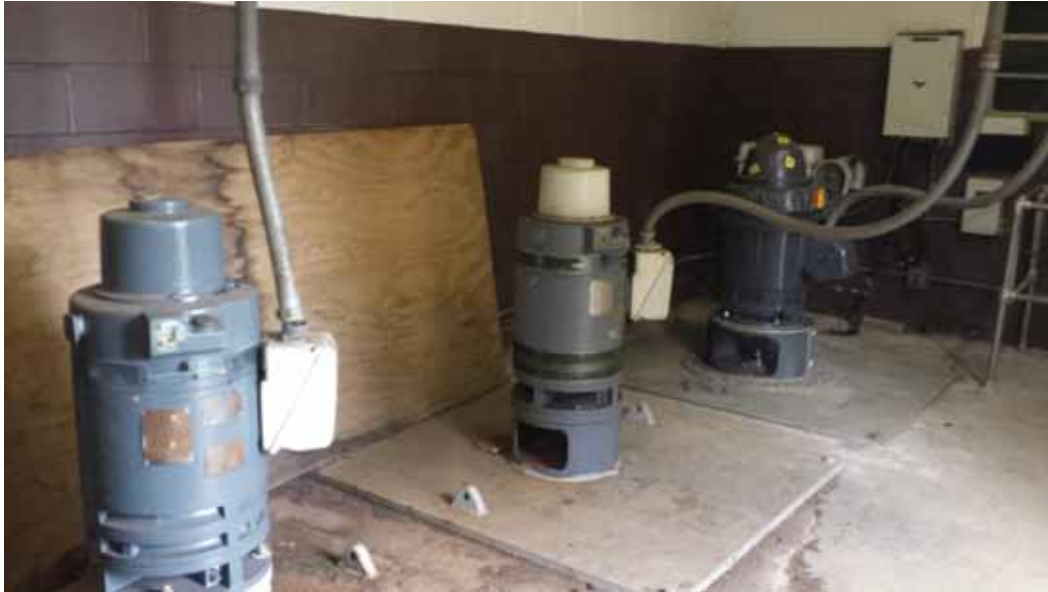
Figure 1: Interior of pump station

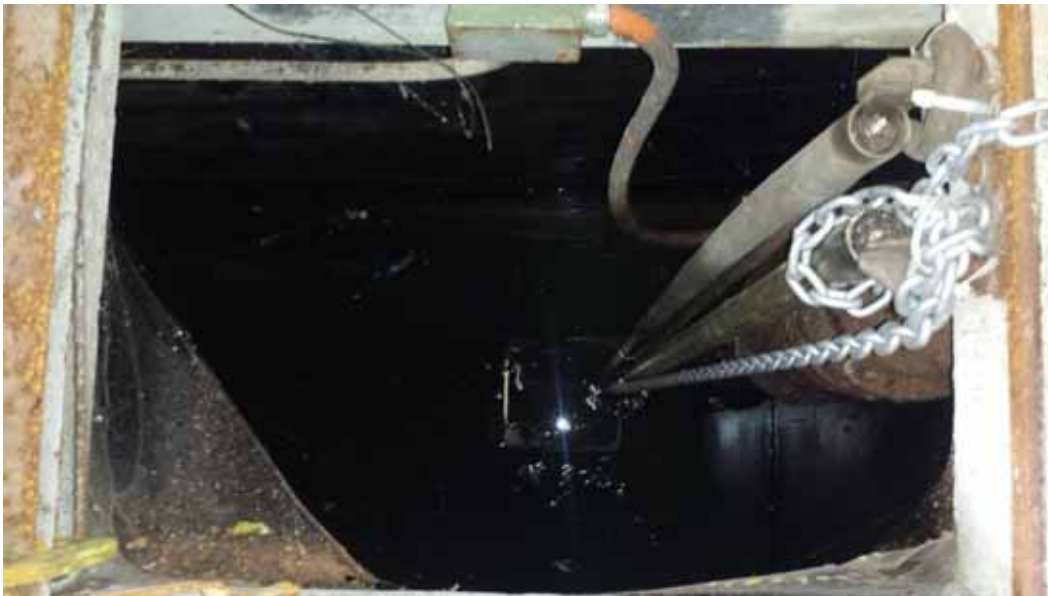
Figure 2: View of pit pump

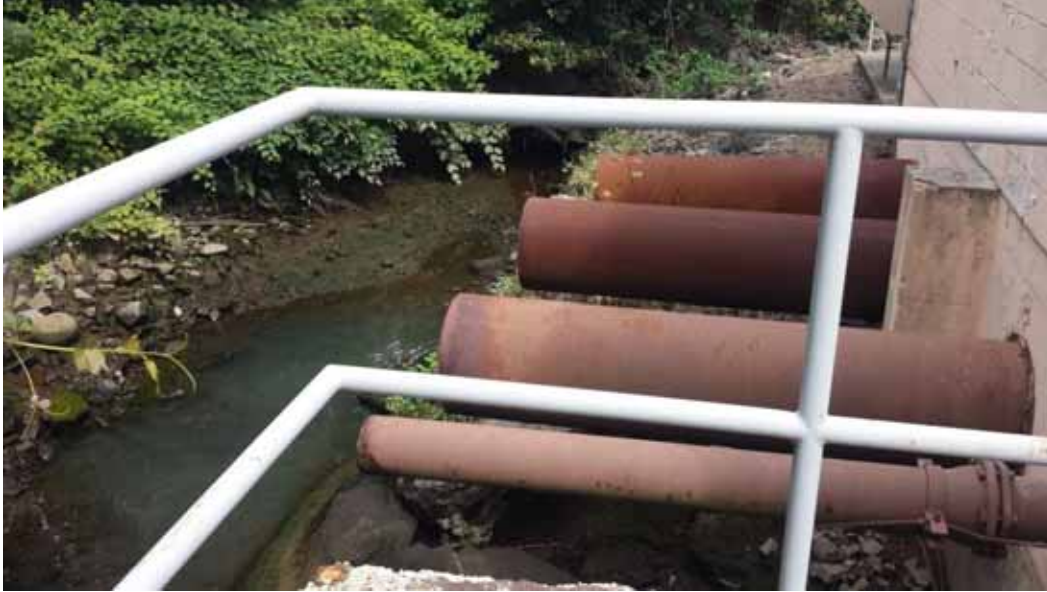
Figure 3: Pump outfalls

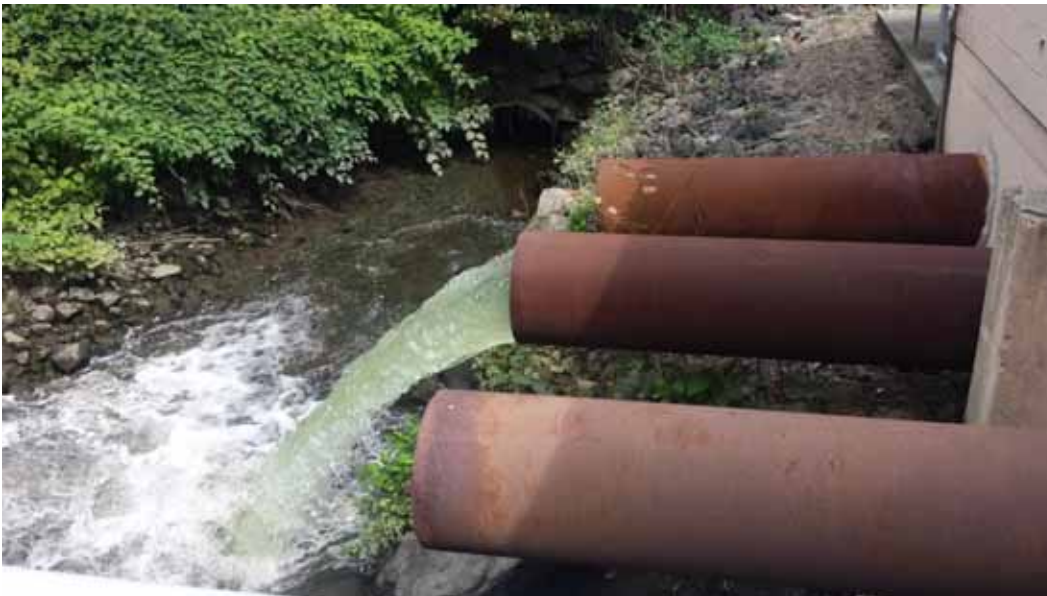
Figure 4: Vertical pump in operation

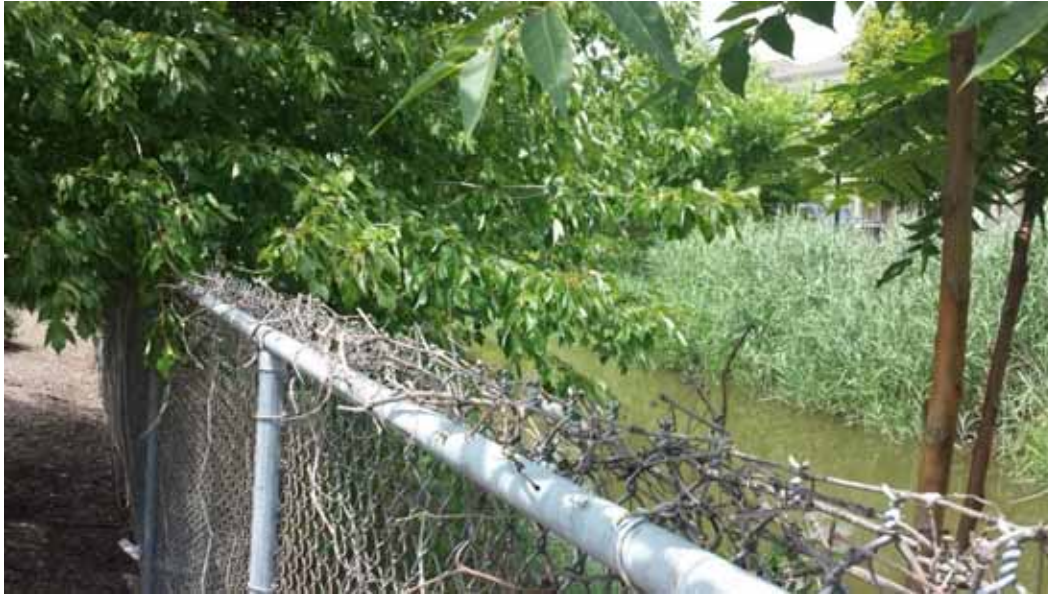
Figure 1: Downstream view at tide gate

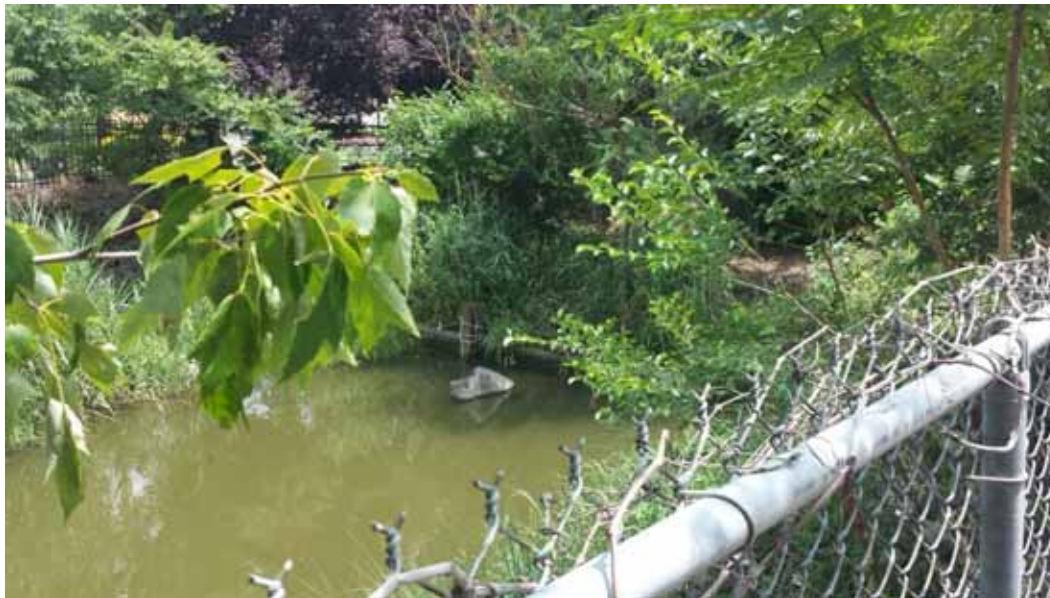
Figure 2: Upstream view of tide gate

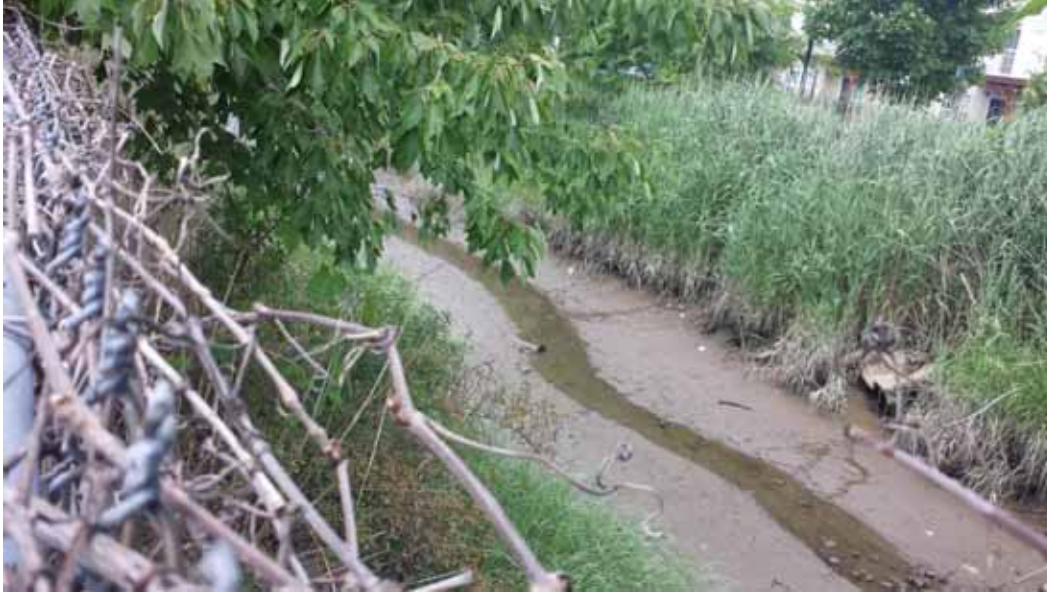
Figure 1: Downstream view at tide gate

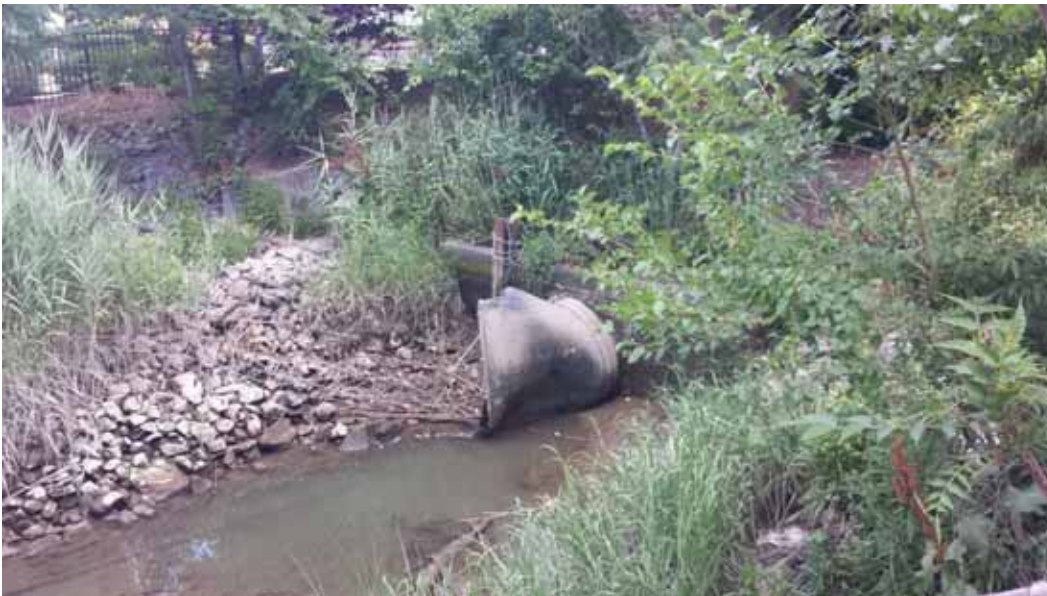
Figure 2: Upstream view of tide gate

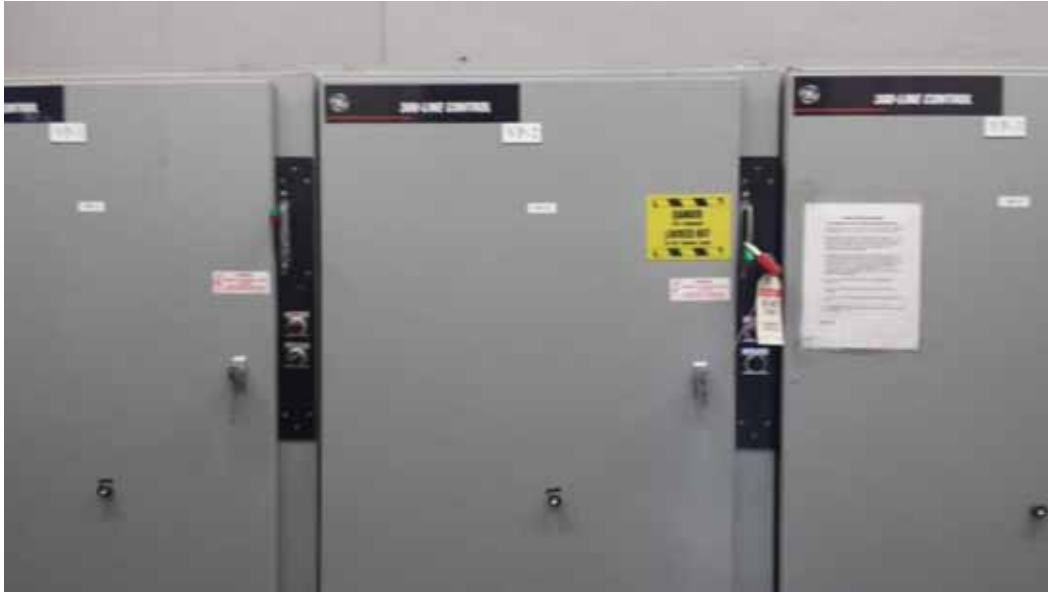
Figure 1: Interior of pump station

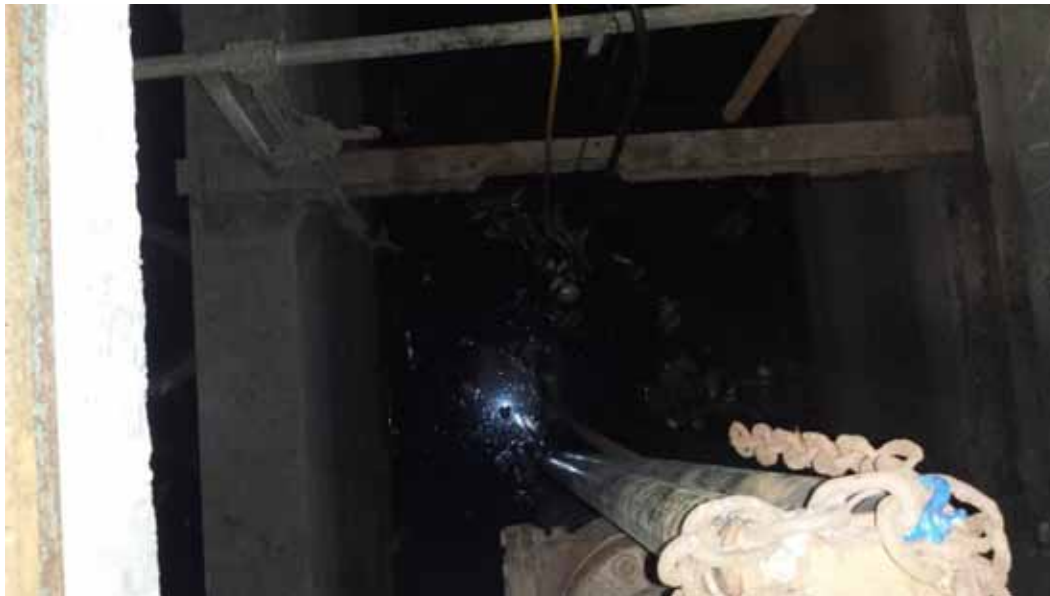
Figure 2: View of pit pump

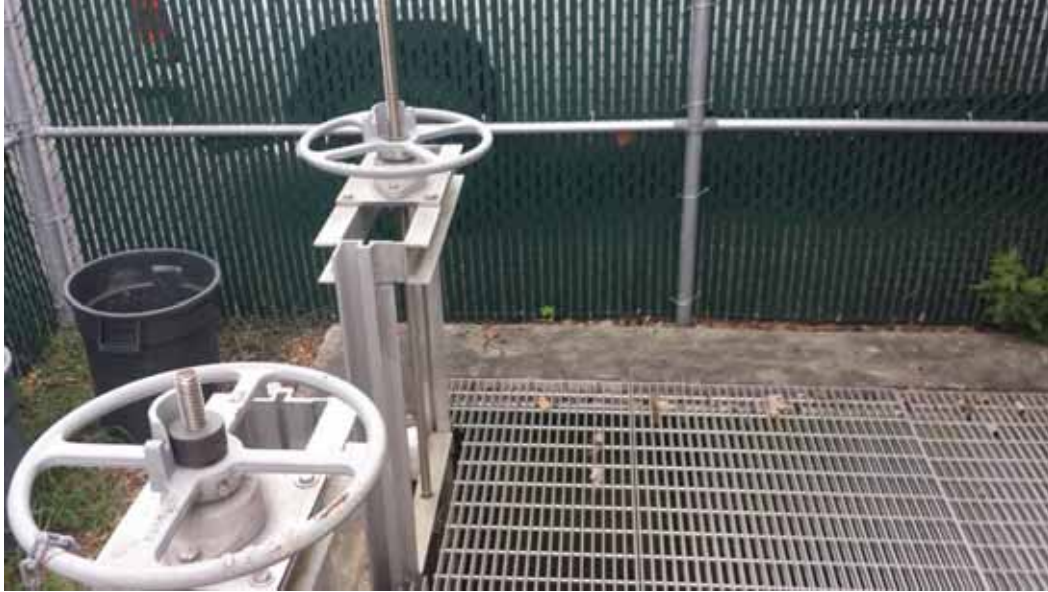
Figure 5: View of tide gate controls

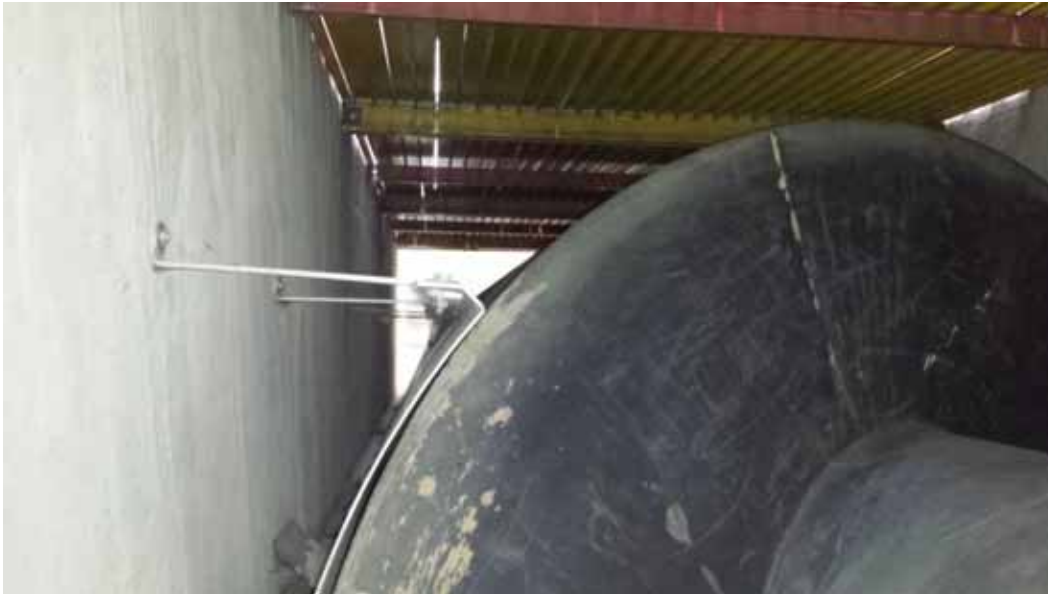
Figure 6: View of screw pump

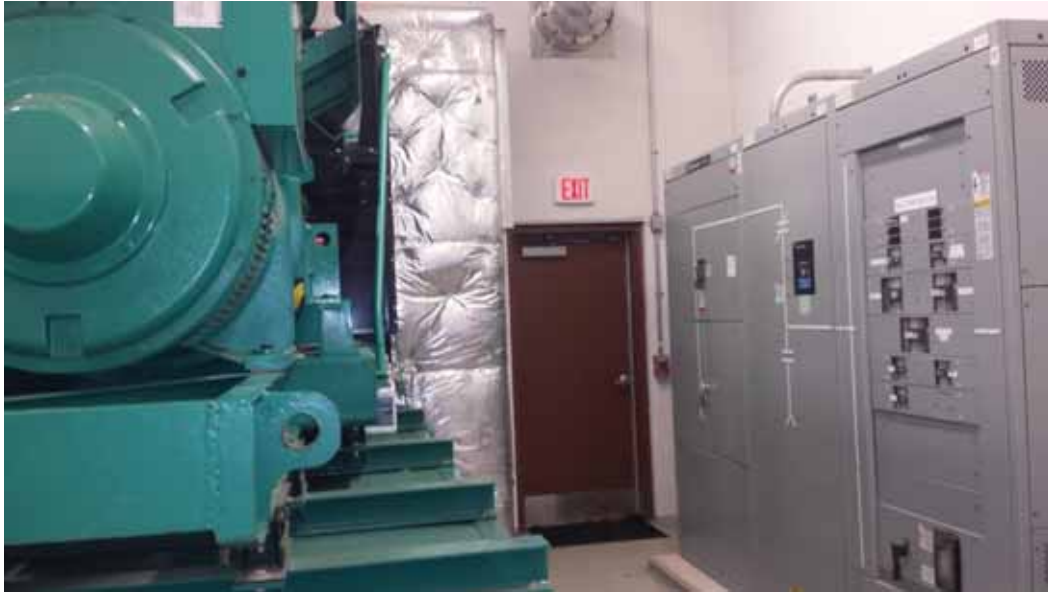
Figure 7: View of of control room

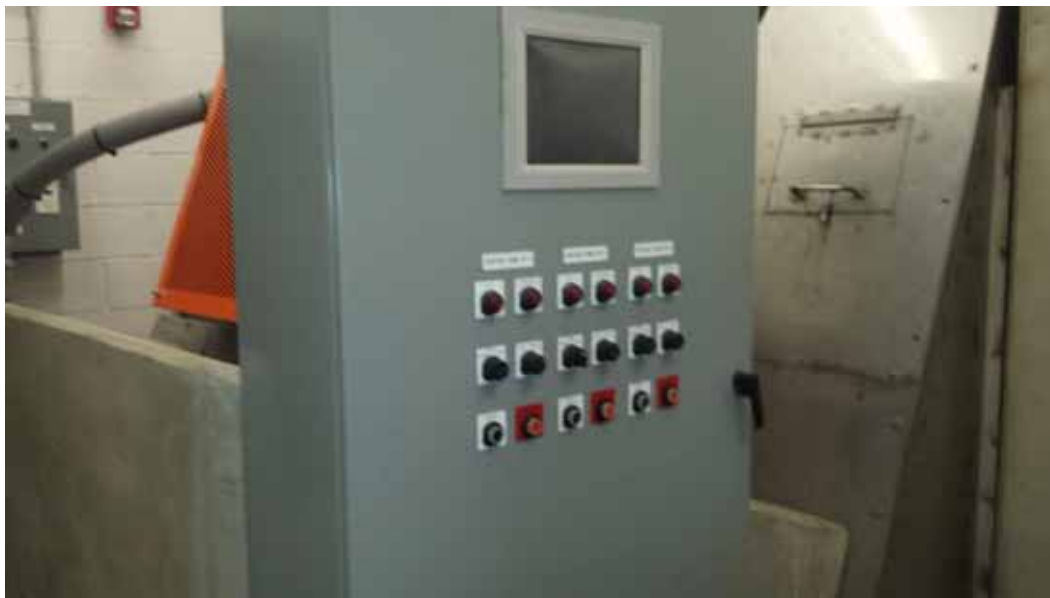
Figure 8: View of control room

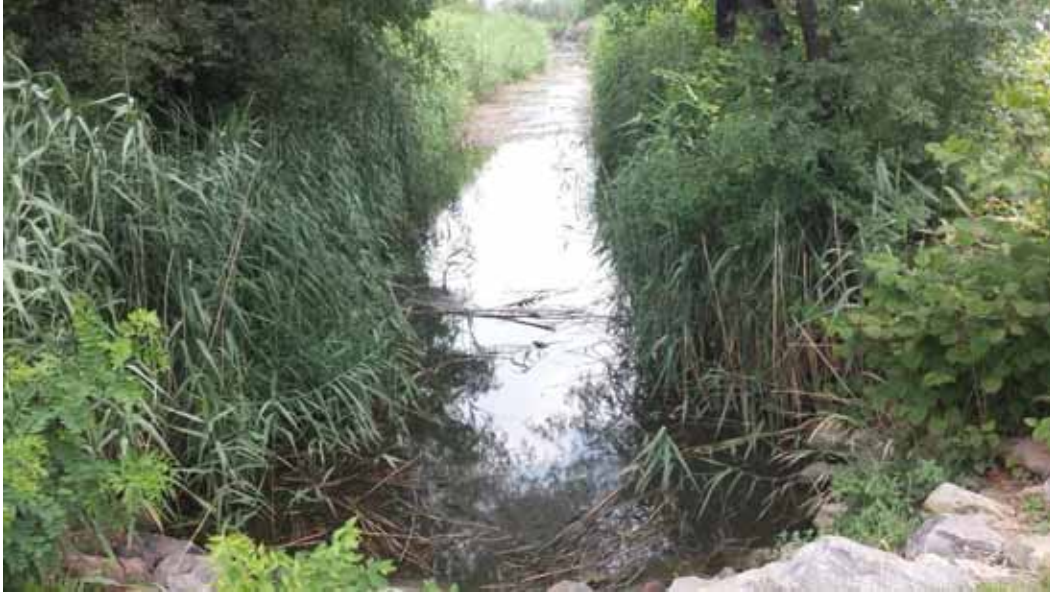
Figure 1: Downstream view at tide gate

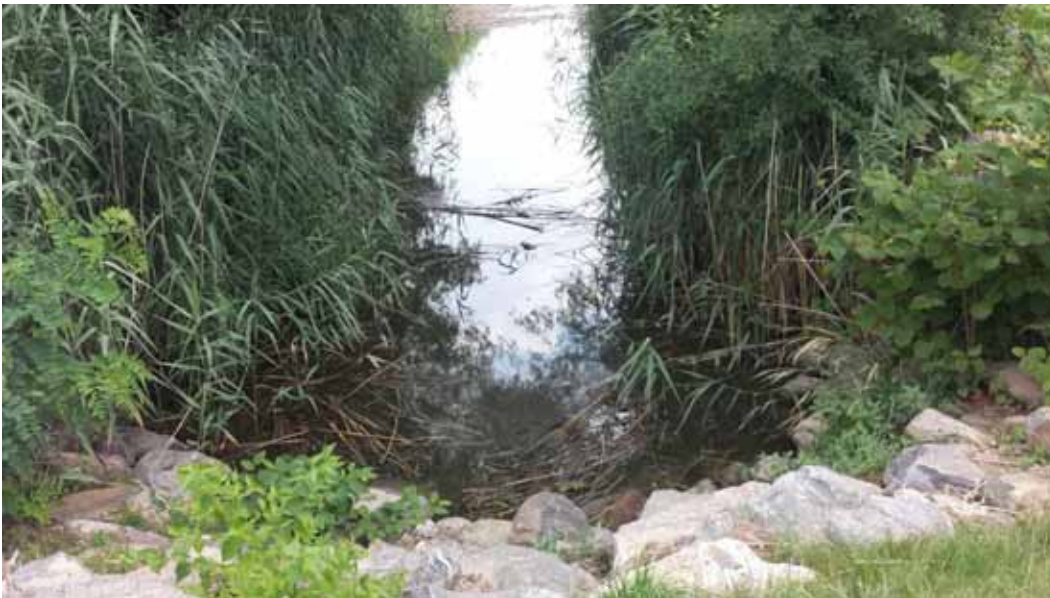
Figure 2: Top view of tide gate

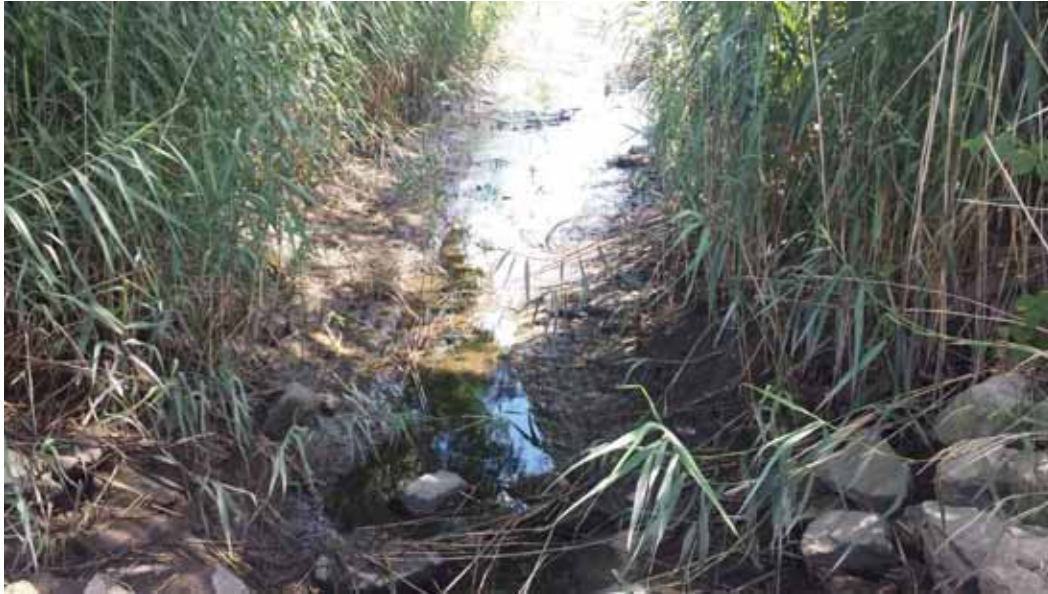
Figure 1: Downstream view at tide gate

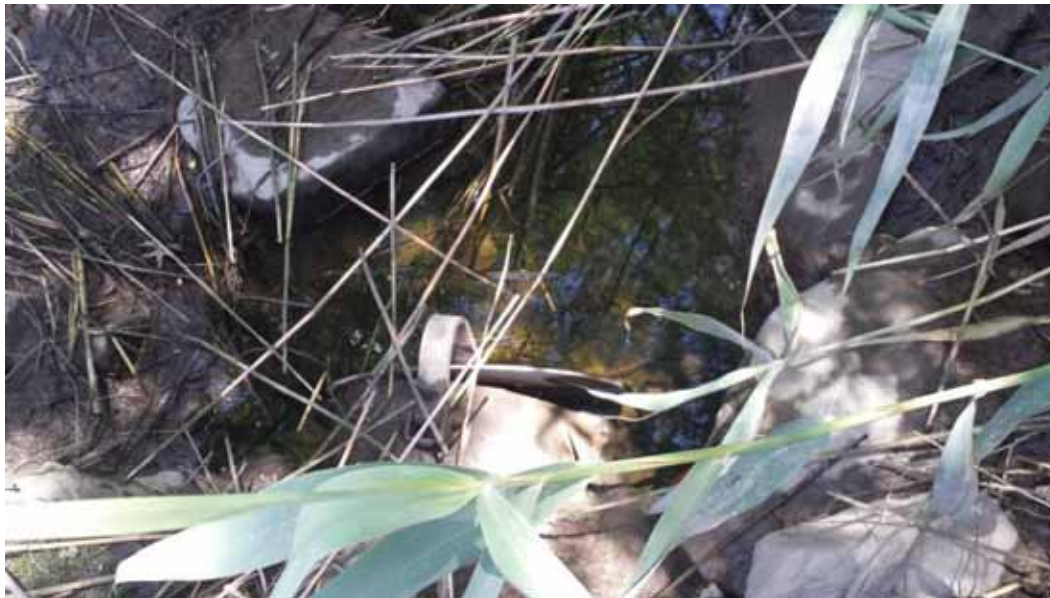
Figure 2: Top view of tide gate

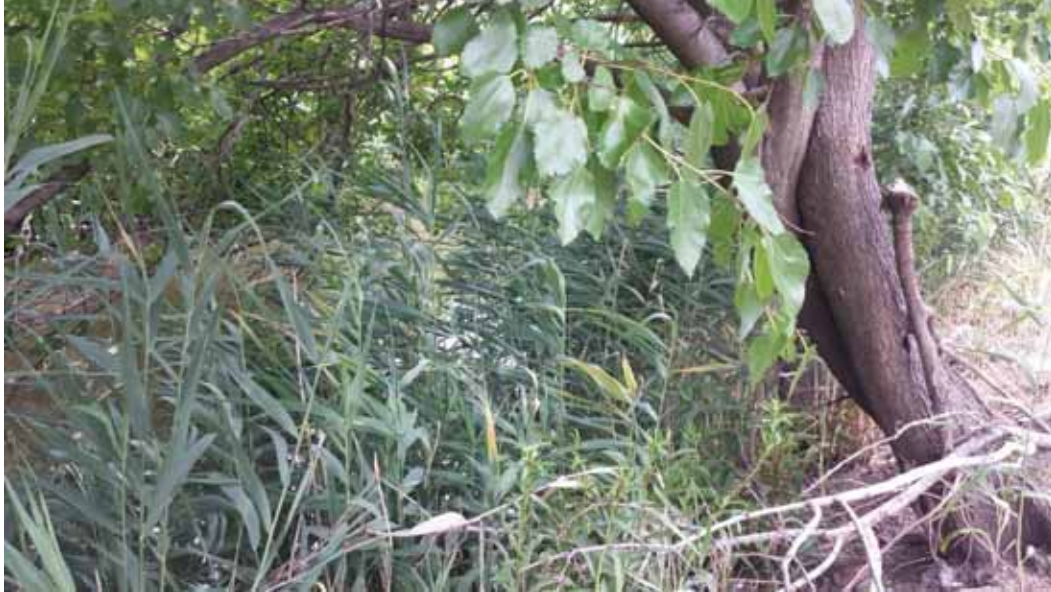
Figure 1: Downstream view at tide gate

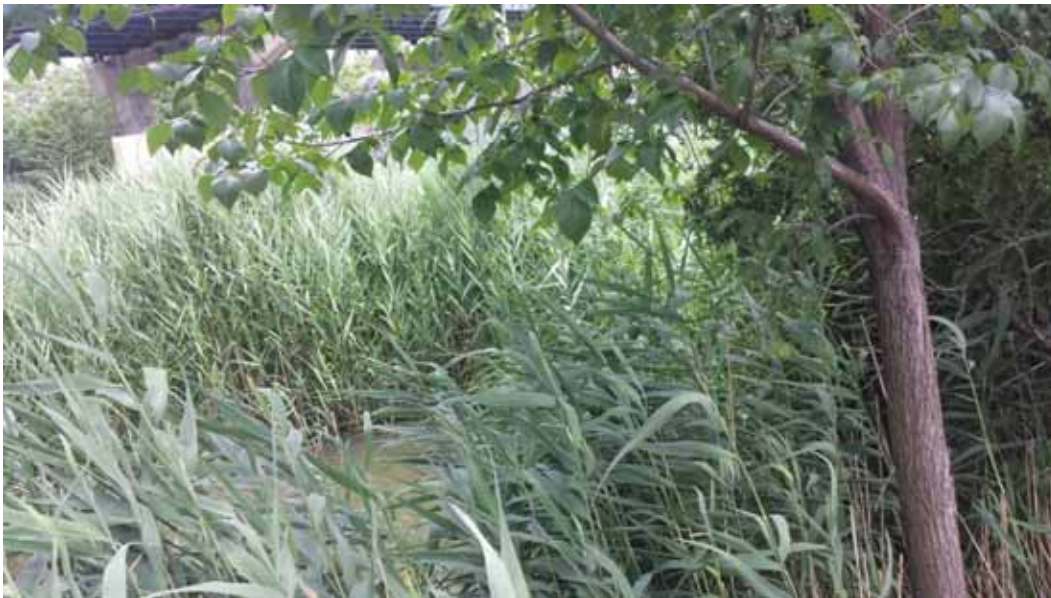
Figure 2: Upstream view of tide gate

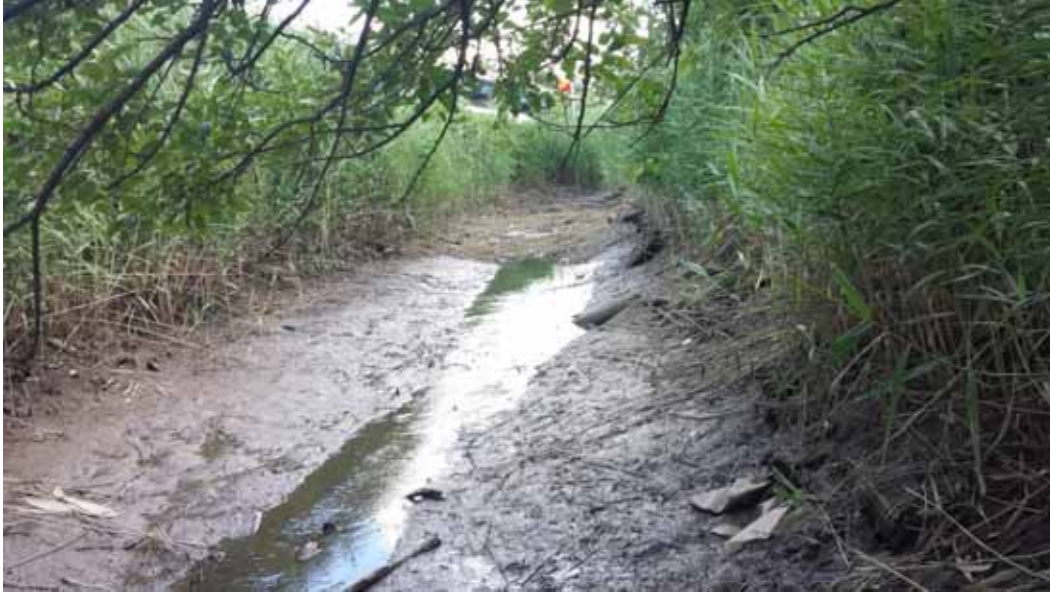
Figure 1: Downstream view at tide gate

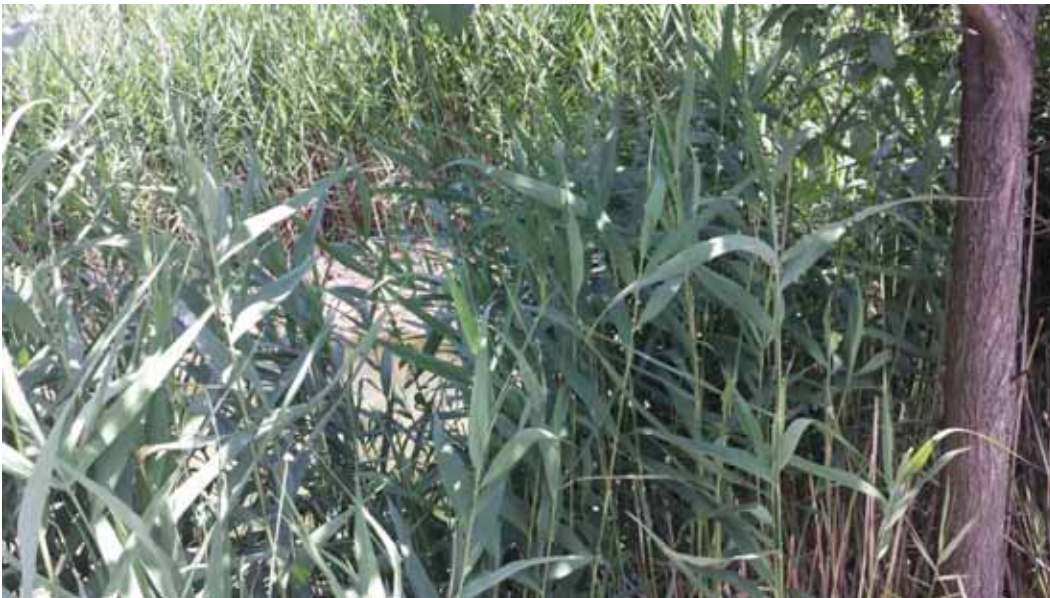
Figure 2: Upstream view of tide gate

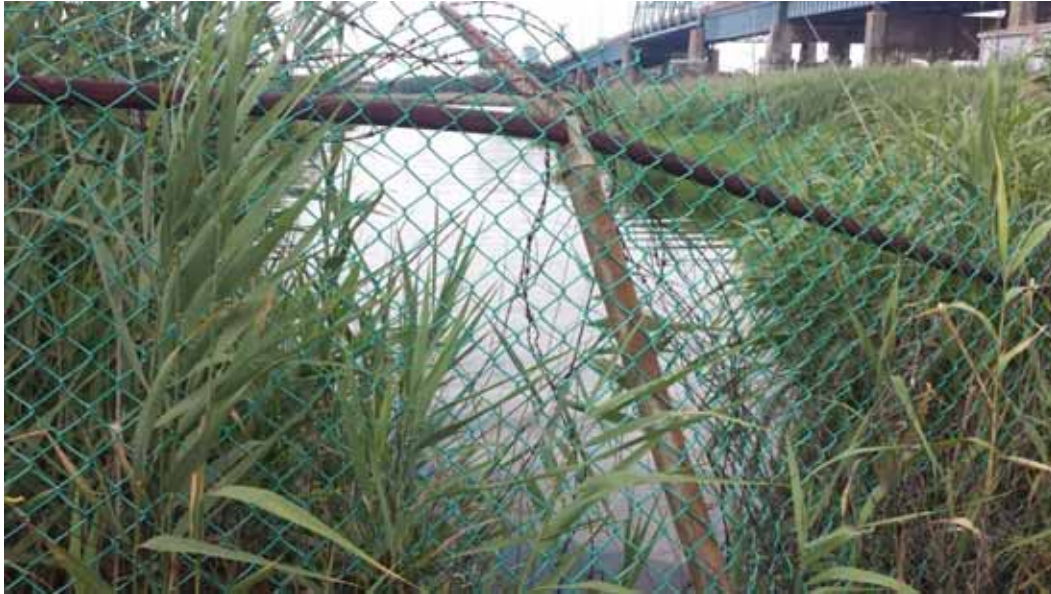
Figure 1: Downstream view at tide gate

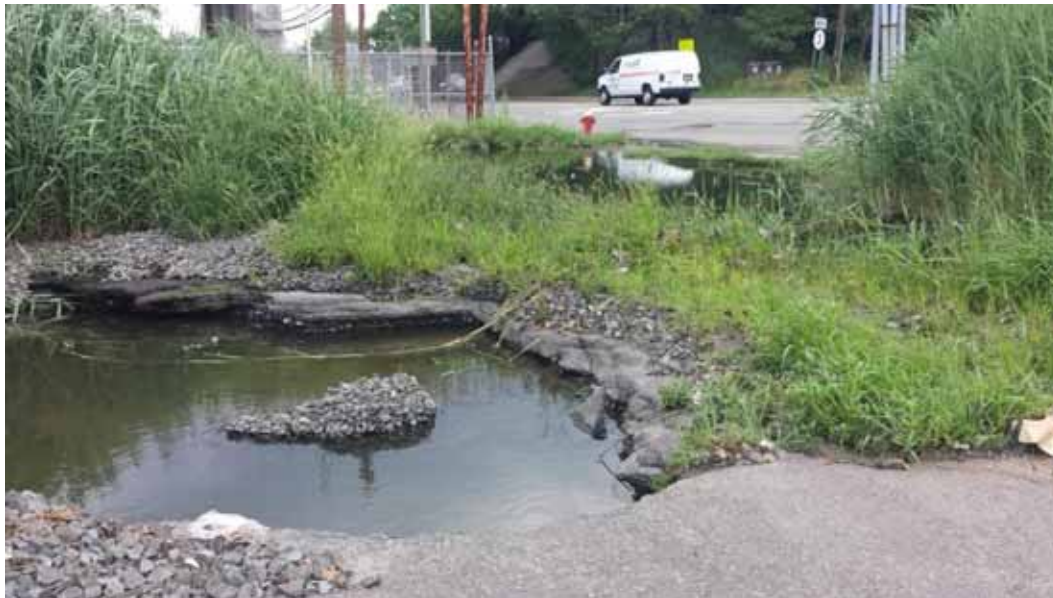
Figure 2: Area upstream of tide gate

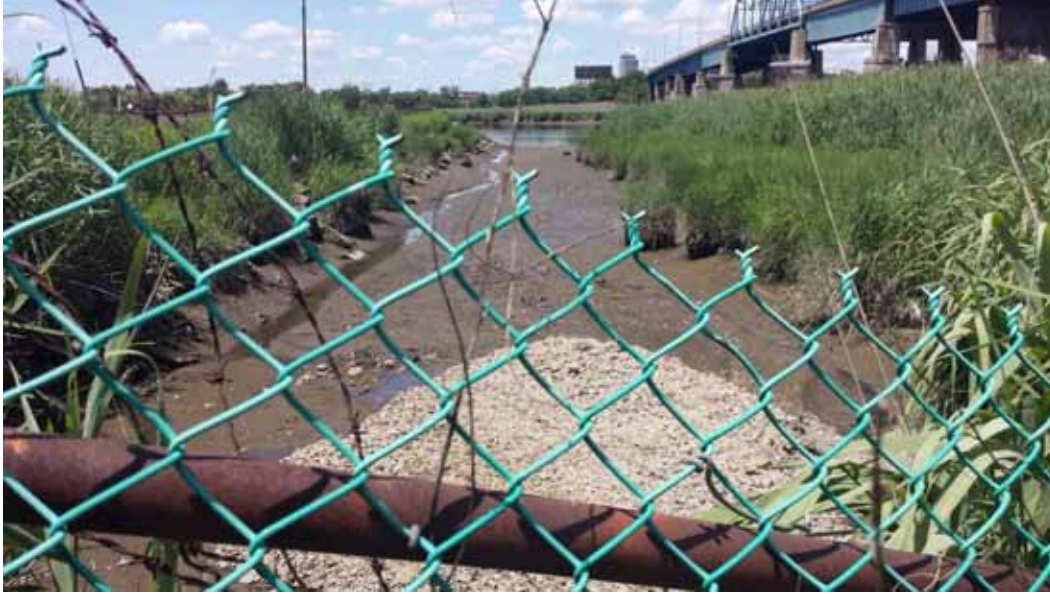
Figure 1: Downstream view at tide gate

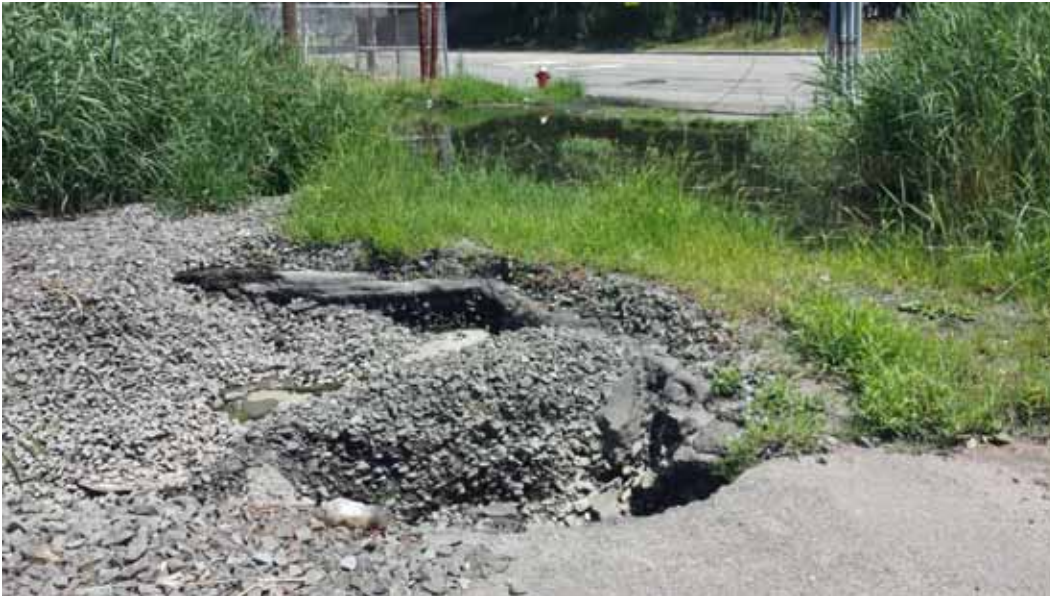
Figure 2: Area upstream of tide gate

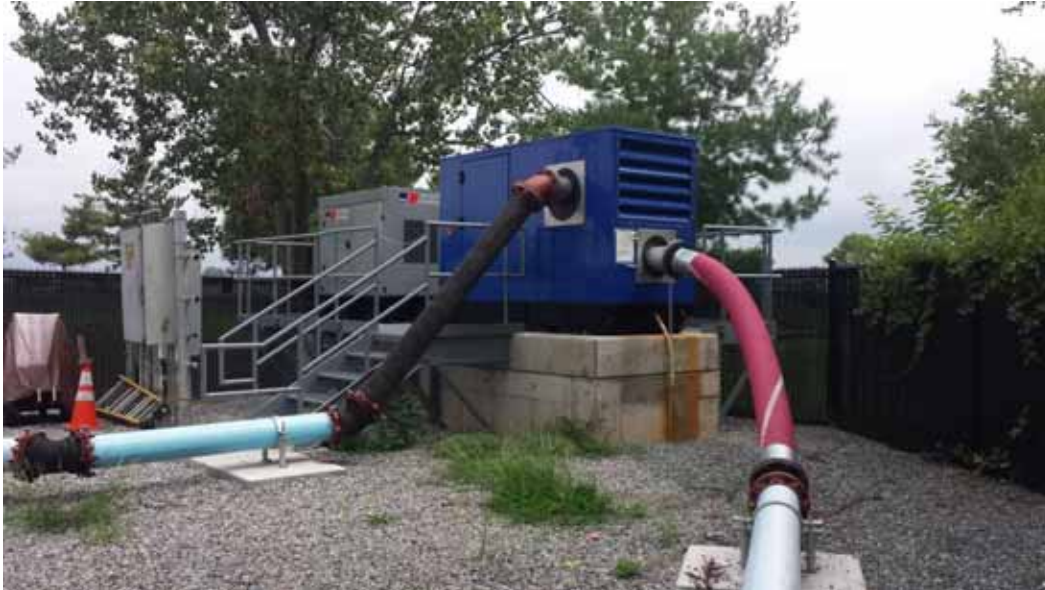
Figure 1: View of Primax above grade pump

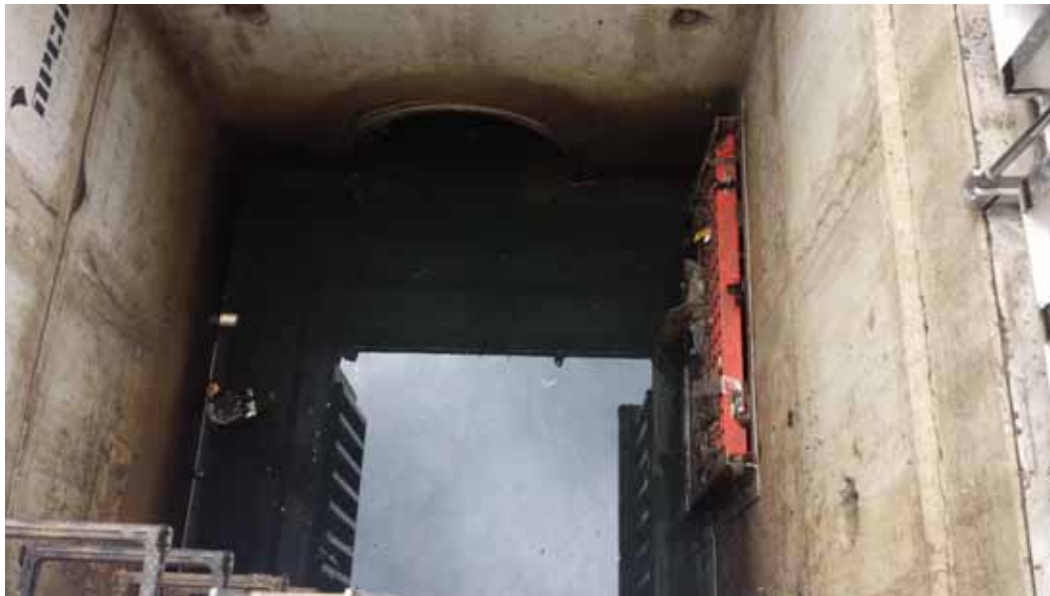
Figure 2: View of pit

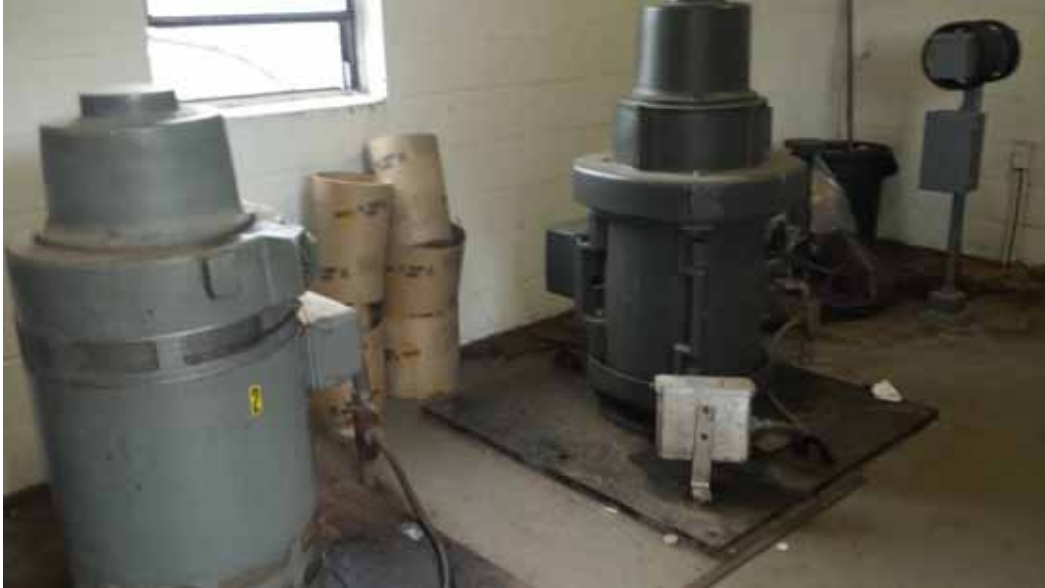
Figure 1: View of pumps at interior of pump stations
