New Jersey Sports & Exposition Authority Tide Gate Inspection Report

**The National Flood Insurance Program
Community Rating System**

The New Jersey Sports and Exposition Authority

December 7, 2016

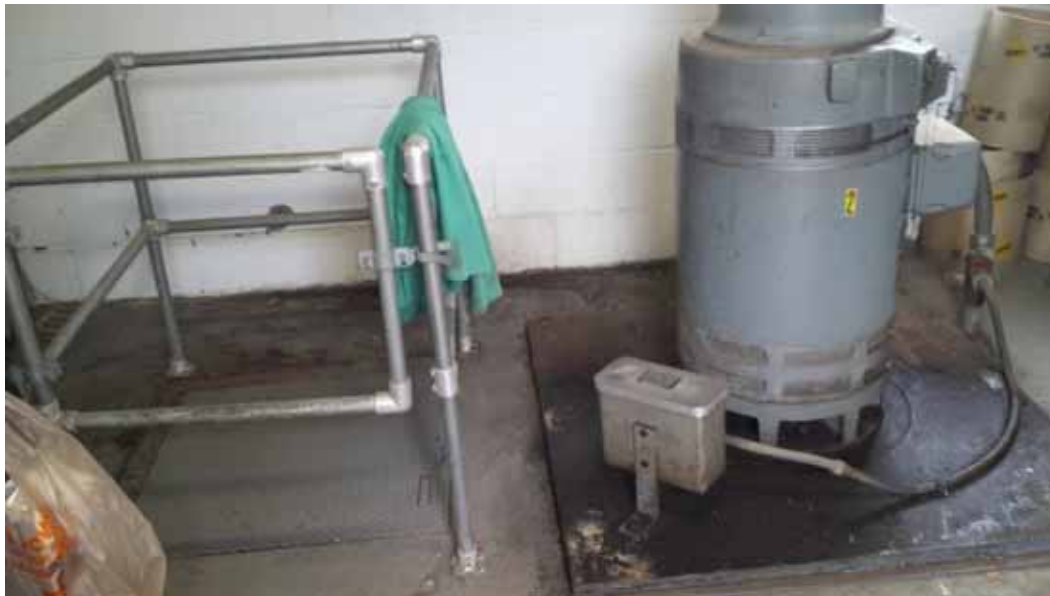
Figure 2: View of pumps at interior of pump stations

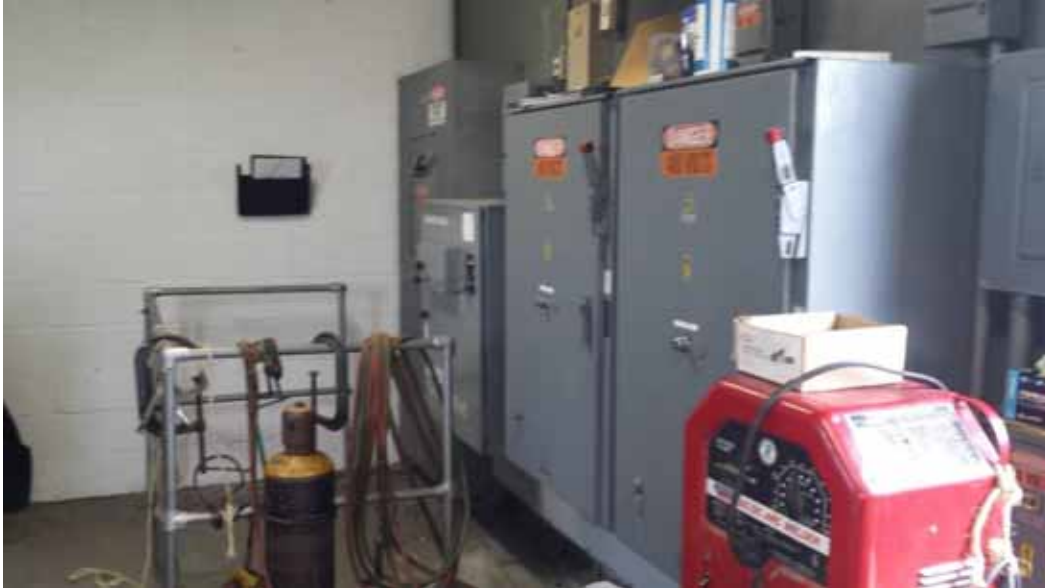
Figure 3: Interior of control room

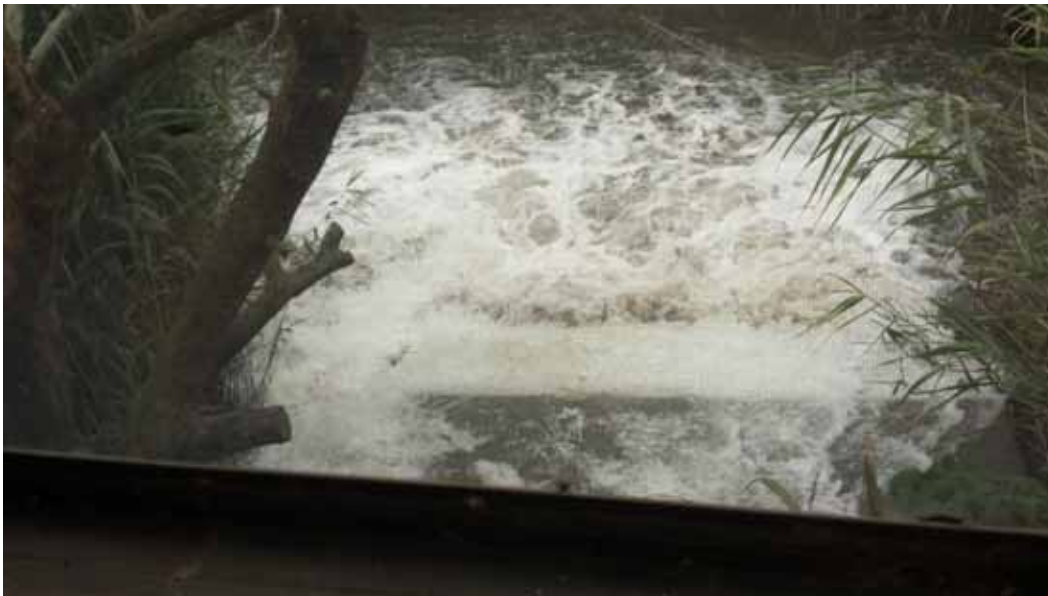
Figure 4: View of pump outfall in operation

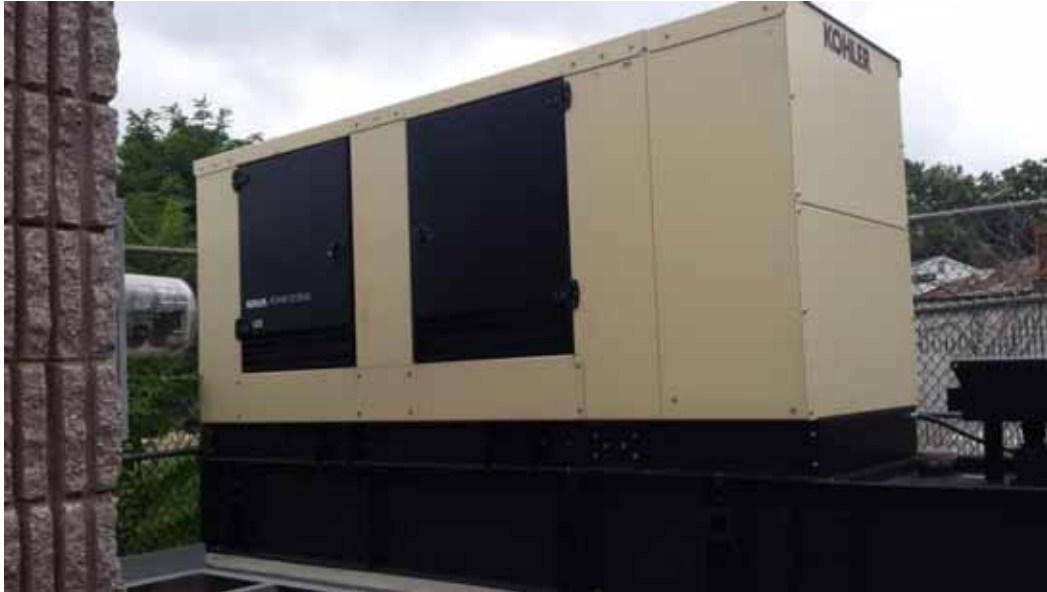
Figure 5: View of emergency generator

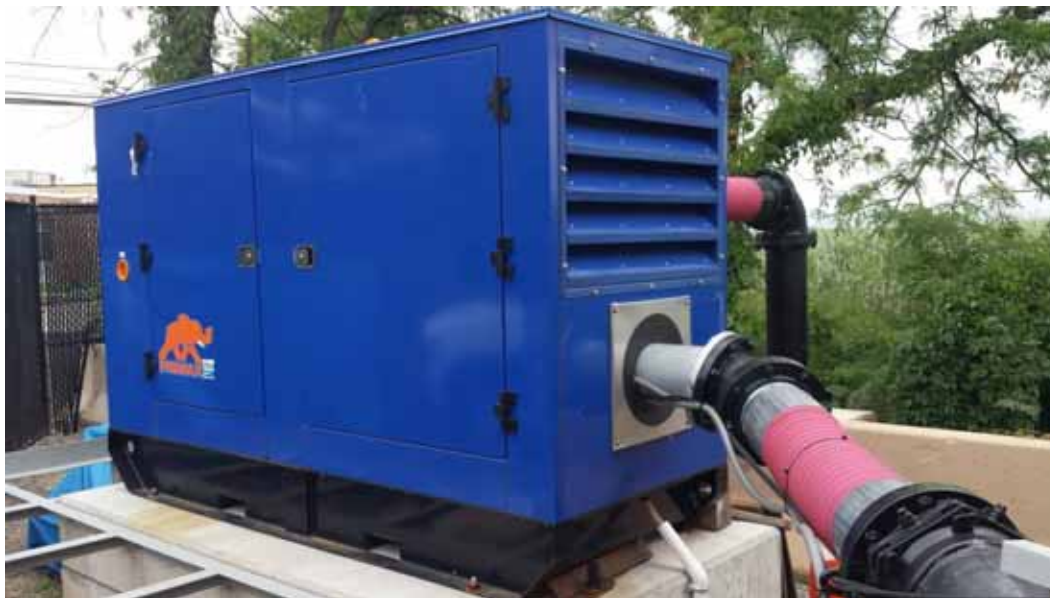
Figure 6: View of Primax backup pump
